DANISH MARITIME ACCIDENT
INVESTIGATION BOARD

STENA SCANDICA

Marine accident report on fire

**MARINE ACCIDENT REPORT ON FIRE ON BOARD STENA SCANDICA
ON 29 AUGUST 2023**

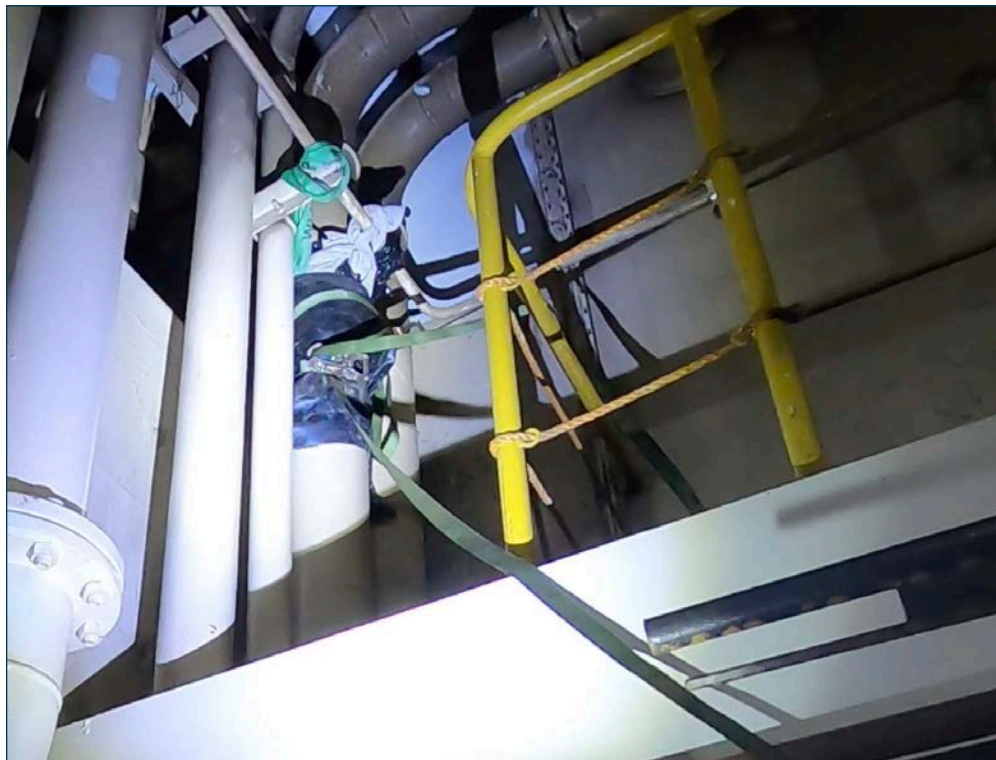
1311 ○ At 1311, the chief engineer informed the master that a drencher pipe had perforated and was leaking. The drencher pipe was located above one of the main engines and had to be repaired to avoid damage to the main engine. The master got the impression that the drenchers was stopped while repair was ongoing and thought they were now without drenchers. However, in the engine room the engine team worked on sealing off the pipe while the drencher system was pressurised.

Figure 9: Sealed off drencher pipe leakage.
Source: DMAIB

At 1324, the master received information that the engine team had managed to seal the leaking pipe above the main engine with jackets and belts (Figure 9).

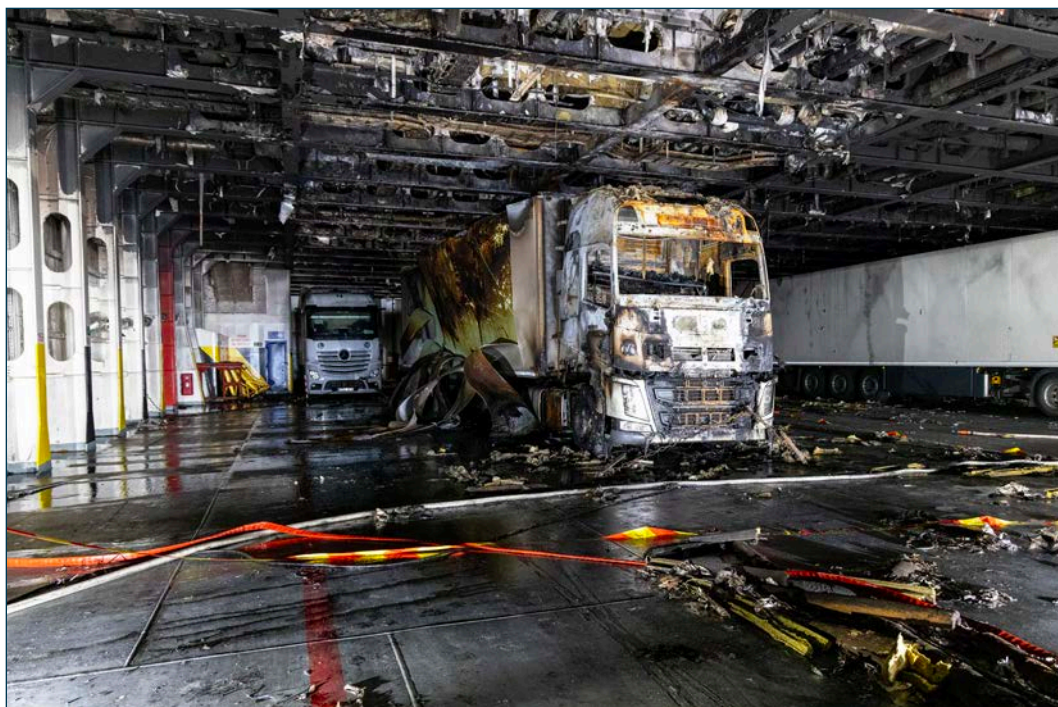
DMAIB requested the crew of STENA SCANDICA not to remove items or vehicles from vehicle Deck 4 upon the ship's arrival. When DMAIB arrived at the site of the fire, it was cordoned off while the site was examined and documented (Figure 12).

Figure 12: Fire scene on Deck 4.
Source: DMAIB

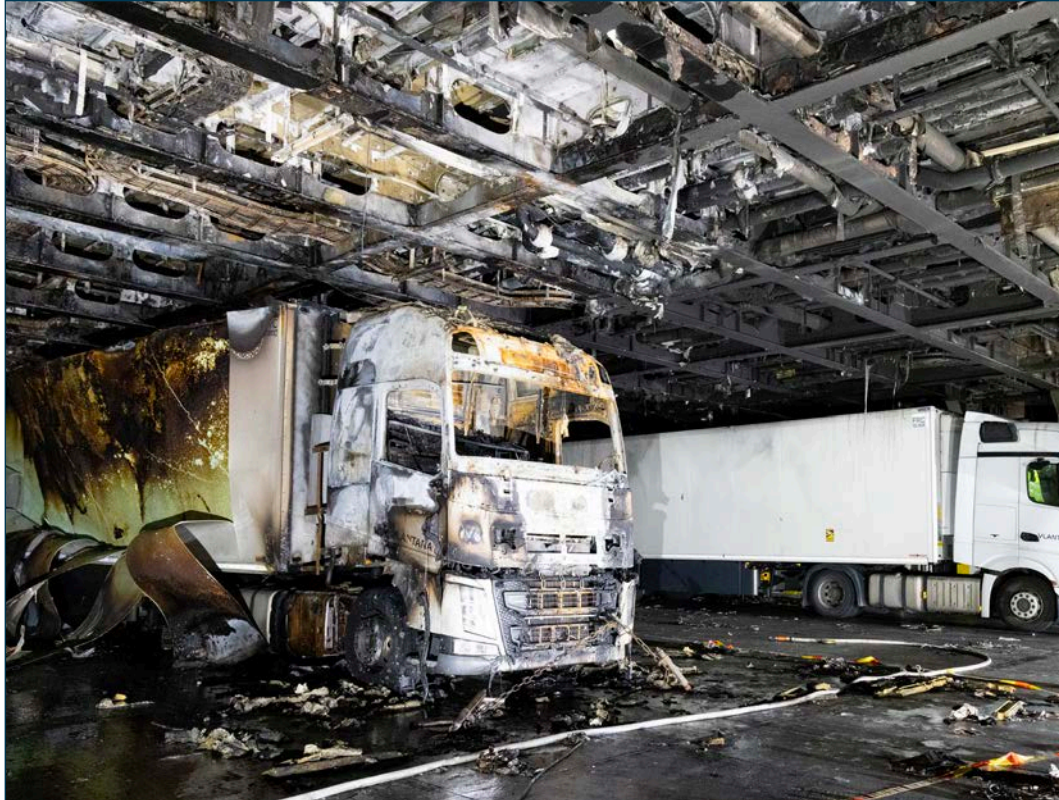
When entering Deck 4, the forward sheltered part was fire-damaged. Fireproof insulation had fallen from the deckhead onto the deck, and debris from burning material lay scattered on the deck. Some of the debris had melted onto the deck or caused superficial heat damage, but otherwise the deck structure was intact. The deckhead and upper part of the bulkhead were covered in soot, and melted plastic was hanging from fluorescent light fixtures (Figure 14).

Figure 14: Deckhead above truck burnt clean from paint and soot.
Source: DMAIB

On the port side, localised extensive fire damage was observed on the deckhead. Steel had burned clean of soot and paint, and cables fitted in cable trays on the deckhead were laid bare as the insulation had burned away. This indicated that the area had been impacted by high temperatures from radiation heat or direct exposure to a flame plume. Below this area, a truck was located with extensive fire damage on the cab and trailer.

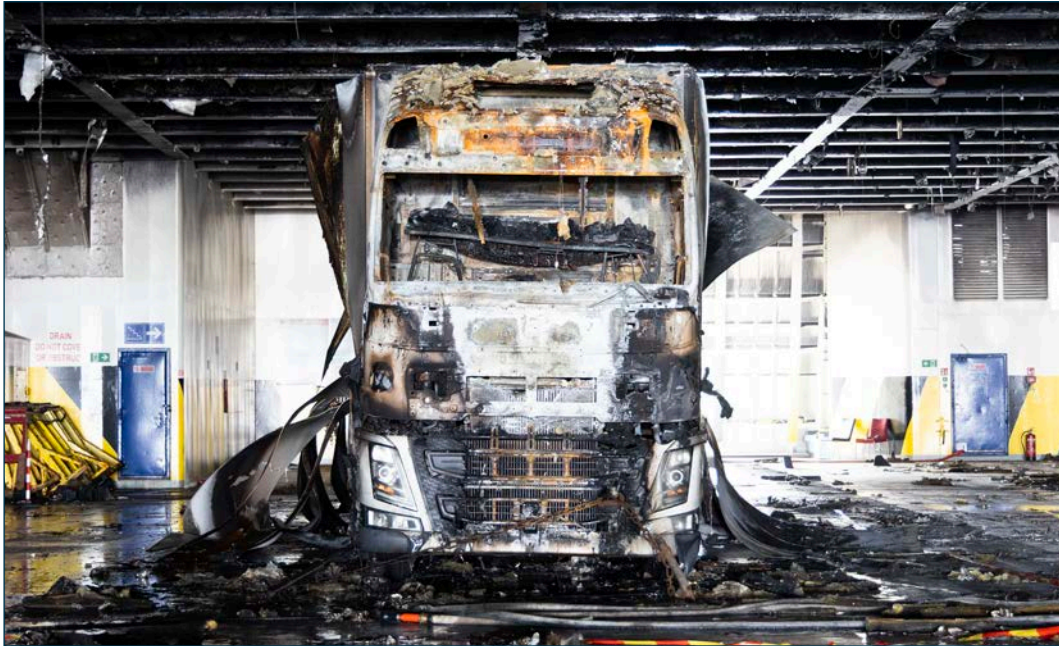
Examination of the truck showed that the truck's cab had been gutted by the fire. The fire damage centred on the front bumper, leaving the sides of the grille and the headlights intact. On the bonnet and the engine bay, the centre had burnt clean from paint and soot, while the corners of the bonnet were burnt clean from paint, but not soot. The cab's windows were missing and were found in misshapen pieces on the deck below. All combustible interior within the cab had burnt away. Both front tyres were intact (Figure 17).

Figure 17: Fire damages on truck front.
Source: DMAIB

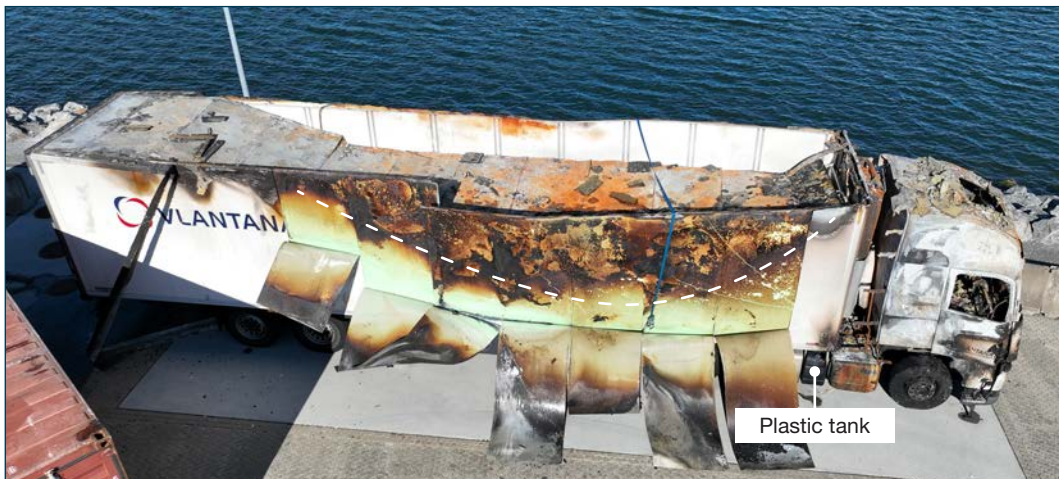
On the trailer's right-hand side (looking from behind), the top bracket had melted and was no longer holding the outer aluminium plating, and the roof had partly collapsed (Figure 18). The inner plating displayed a semi-circular burn pattern covering 2/3 of the trailer's side, starting from its top front corner. In this area, the metal had blackened and oxidised and had been deformed by the heat impact. Below the bottom front corner of the trailer, a black plastic tank was installed on the outside of the truck's chassis. The plastic tank had minor heat damages, but was otherwise intact. This indicated that the heat impact had been limited in this area.

Figure 18: Fire pattern on the truck's right side.
Source: DMAIB

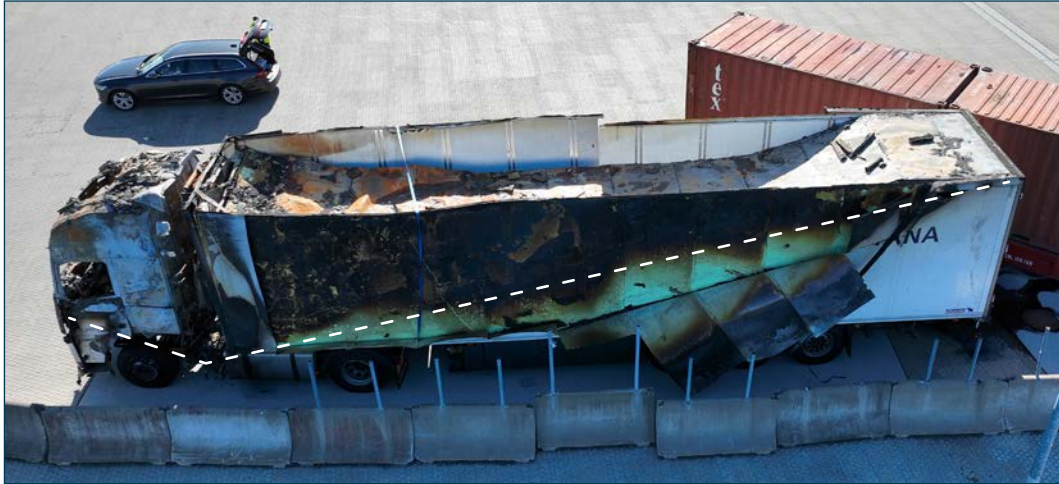
On the left-hand side of the trailer, the outer aluminium plating had similarly loosened from the collapsed top brackets (Figure 19). The inner plating was marked by a burn pattern differing significantly from the other side of trailer. The burn pattern on the trailer's left side started from the bottom front corner and fanned diagonally upwards to the rear top corner.

The fire pattern on the truck's cab and the diagonal fire pattern on the trailer's left side formed a V pattern rooted at the truck's chassis in the gap between cab and trailer. The V pattern indicated that fire had been present in the gap and spread up and out, possibly indicating the fire's point of origin. Therefore, this area was excavated from the burned debris and examined further.

Figure 19: Fire pattern on the truck's left side.
Source: DMAIB

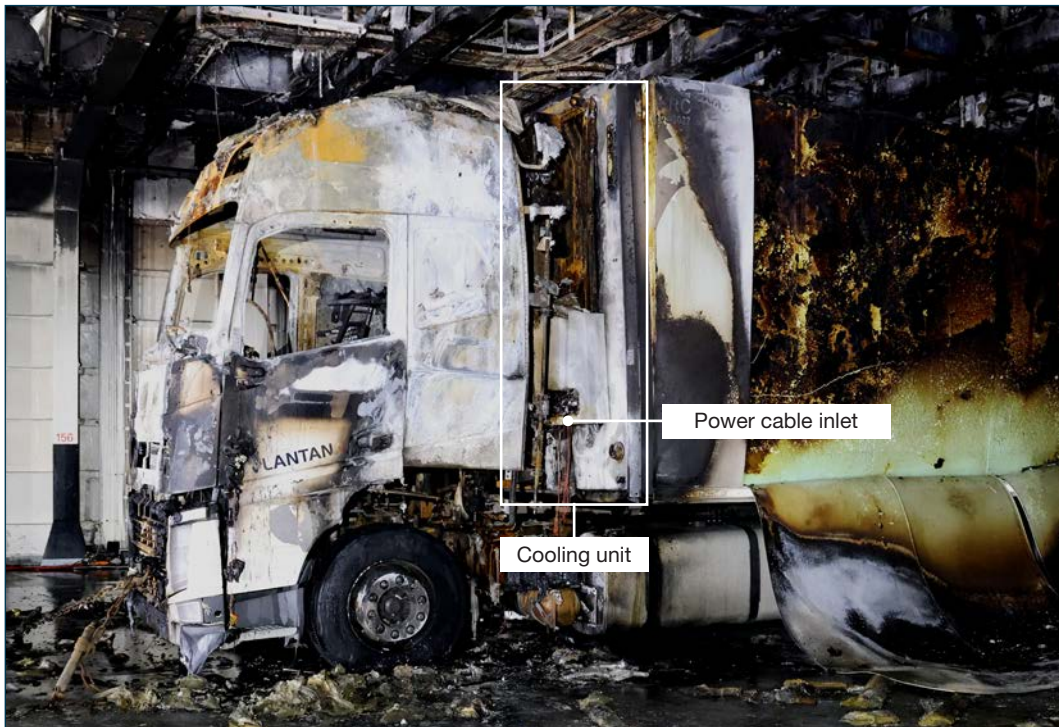
Figure 20: Fire damaged cooling unit.
Source: DMAIB

A mechanical failure in the cooling unit could develop heat and ignite surrounding flammable material. During the investigation, DMAIB did not observe any indications of a violent mechanical malfunction. However, the unit was severely damaged by the fire that it could not be ruled out that a malfunction had occurred which caused ignited material to burn through the cooling unit's casing and fall on top of the truck's battery casing igniting oil and grease residues.

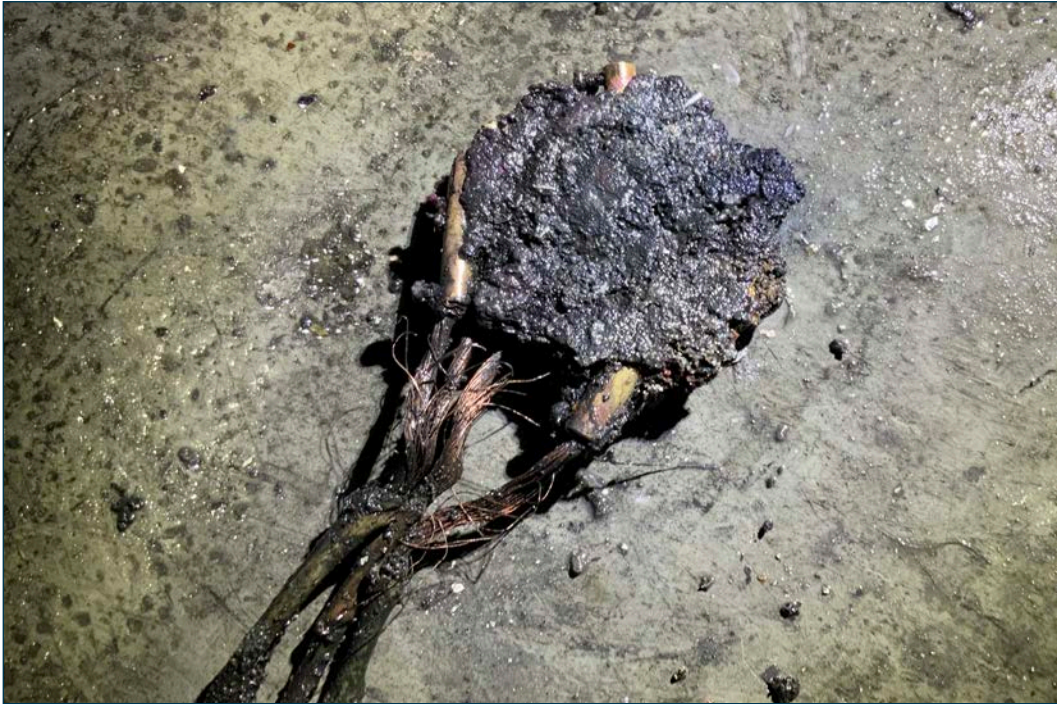
On the front of the trailer, the engine for the trailer's cooling unit was located. The inlet for the ship's power supply cable was located at the bottom of the cooling unit casing. All combustible material on the cooling unit was burned away, melted or deformed (figure 20). The part of the ship's power cable connected to the cooling unit was found melted and burned (figure 21).

Figure 21: Melted power cable inlet.
Source: DMAIB

The power cables from the ship to the cooling unit could short circuit and the arc could ignite surrounding flammable material. DMAIB found that the sockets connecting the ship's and cooling unit's power cables were melted. The cables were handed over to the Swedish Police for further forensic examination. Swedish Police did not find evidence of short circuit on the cables. Volvo subsequently carried out a fire investigation on the truck and trailer and found metallic spray resembling copper in the area of the power connection to the cooling unit. Such copper spray could indicate failure on one of the power cables. It has not been possible for DMAIB to verify the observations made by Swedish Police and Volvo. It hence remains unknown to DMAIB whether an electric fault had occurred on the power cables.

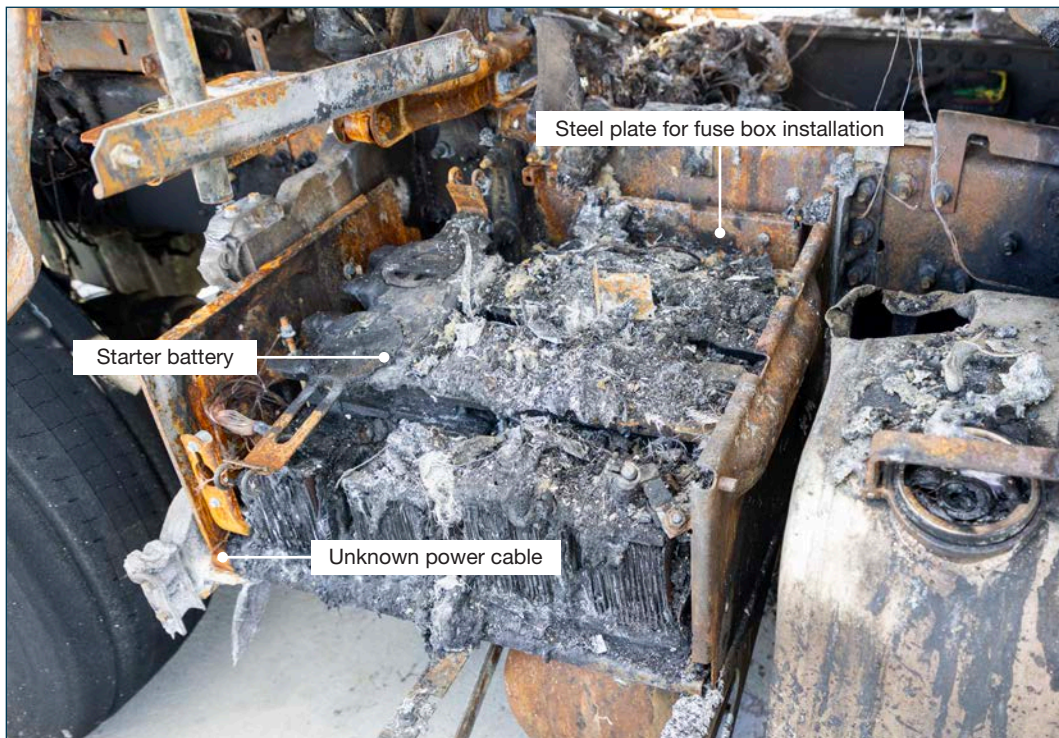
In the area between the cab and the trailer, below the cooling unit, the starter battery for the truck was mounted on a steel platform on the left-hand frame of the chassis. A power cable of unknown origin was found stuck on the left side under the batteries. Behind the battery, a steel plate was mounted on the frame on which a fuse box had been installed (Figure 22).

Figure 22: Starter battery mounted on the chassis.
Source: DMAIB

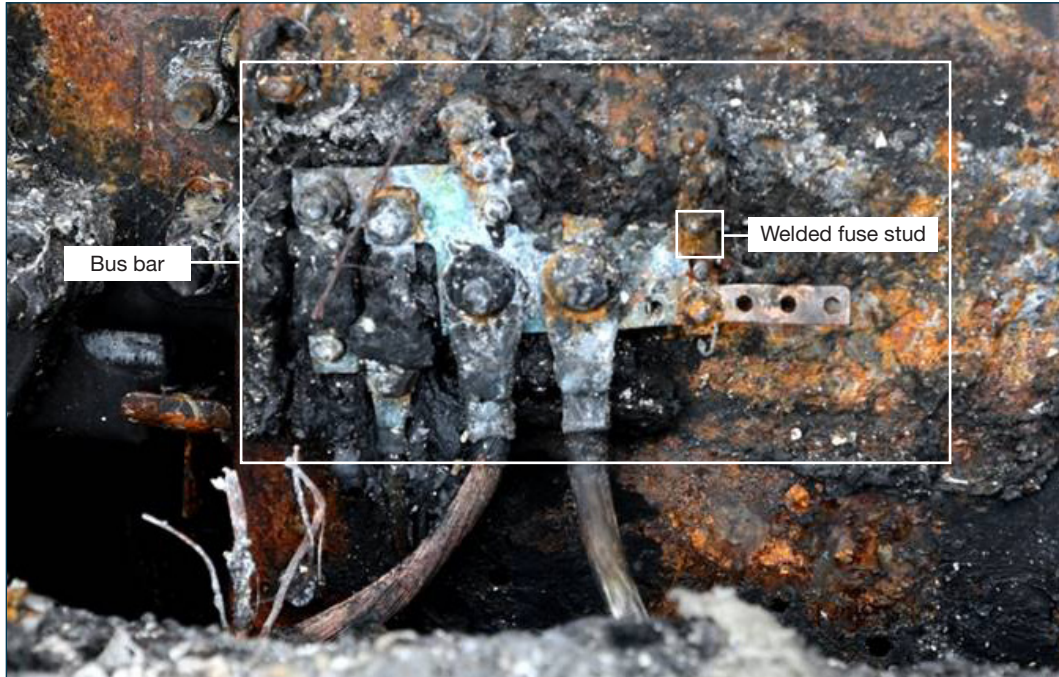
The starter battery and the fuse box installation behind on the left side of the chassis had been exposed to high heat intensity and were entirely burnt out. All plastic covers, boxes and insulation on the cables had burned away. The fuse box bus bar was found behind the battery. It was observed that one fuse stud was found welded to the steel plate, which the fuse box had been mounted on (Figure 23 and 24). In order for steel to weld, temperatures of a minimum of 1,538°C are required. A fire plume normally has a maximum temperature of 1,400°C, whereas electrical faults can result in much higher temperatures. Therefore, DMAIB determined that a short circuit had occurred in the fuse box.

Figure 23: Remains of fuse box bus-bar.
Source: DMAIB

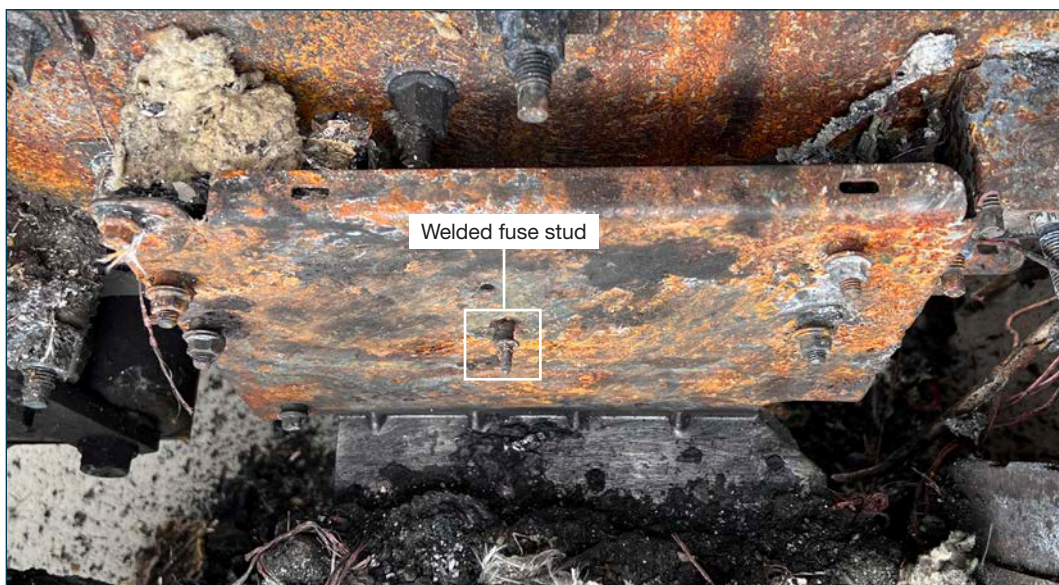
Figure 24: Fuse stud welded to steel plating.
Source: DMAIB

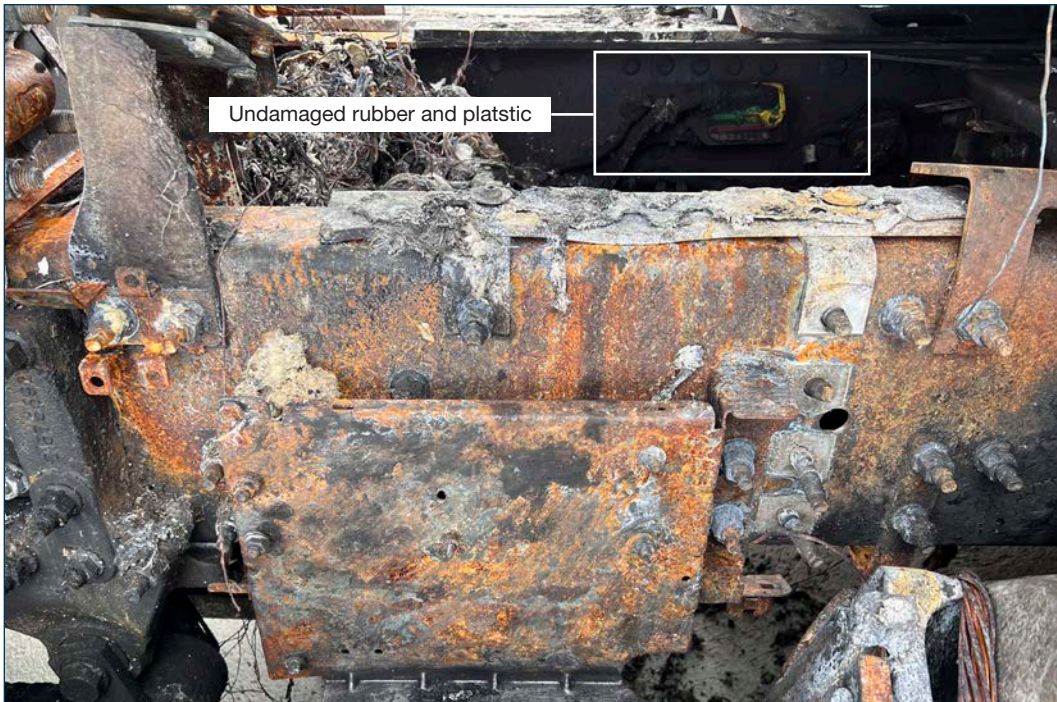
On the right-hand side of the chassis, insulation on the cables remained intact (Figure 25).

Figure 25: Undamaged plastic and rubber components on right-side chassis.
Source: DMAIB

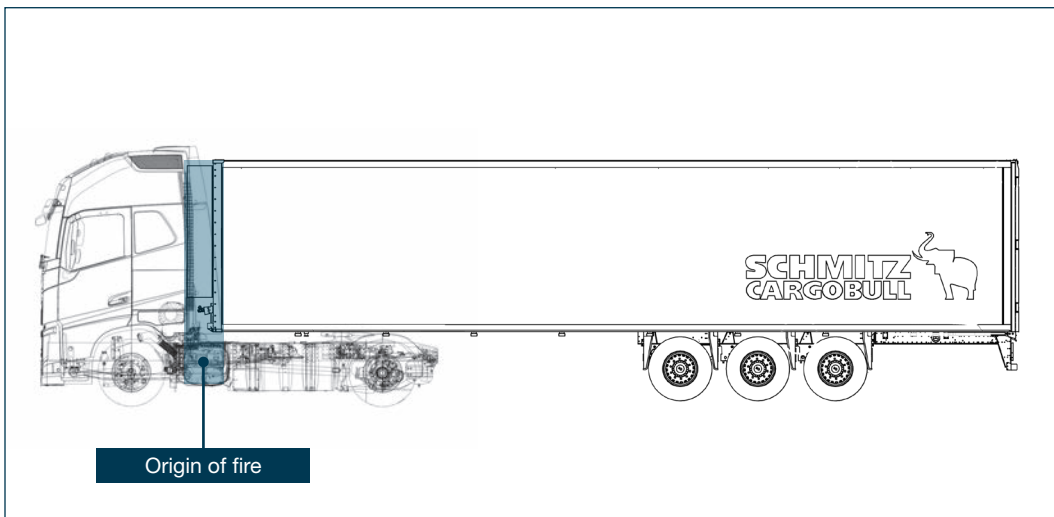
The damage and the fire pattern in the gap between the cab and the trailer showed that the highest temperatures and fire load had been present locally on the left side of the chassis by the starter battery, and that the fire had spread up and out from this point.

Consequently, the gap between the truck and trailer was the origin of fire (figure 26).

Figure 26: Origin of fire.
Source: VOLVO Denmark/Schmitz Cargobull, modified by DMAIB

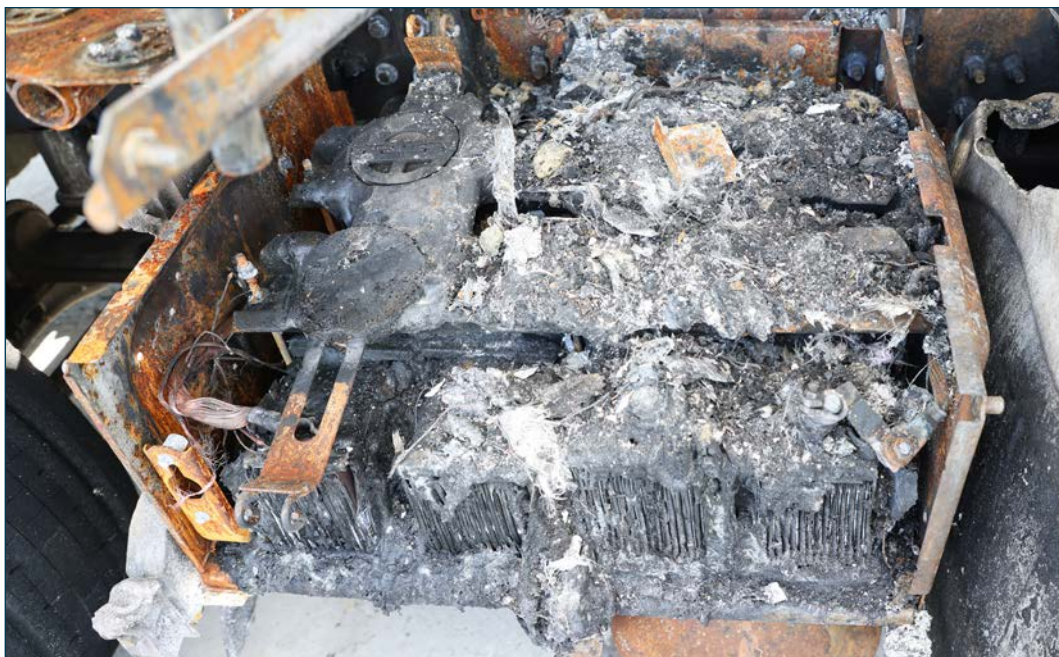
The truck's starter battery could malfunction and develop hydrogen and heat which could ignite surrounding flammable material. However, the battery was destroyed by the fire and a failure stemming from before the fire could not be observed (figure 27).

Figure 27: Damaged starter battery.
Source: DMAIB

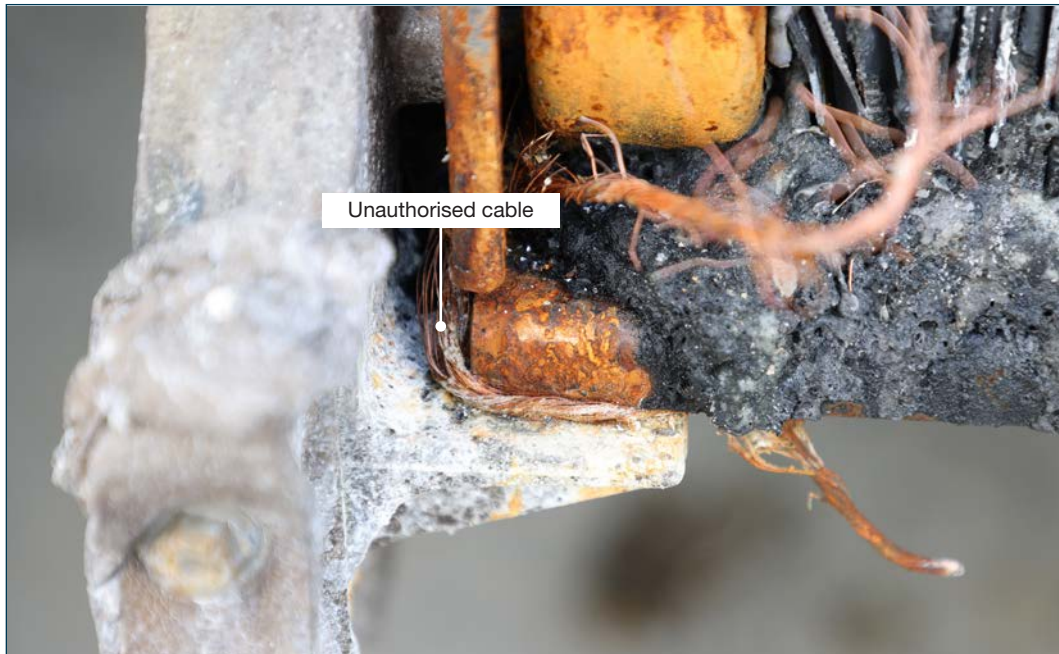
The cable of unknown origin found stuck under the battery frame indicated that an unauthorised installation had been made. The nature of such an installation could not be determined due to the extensive damage caused by the fire. No indications of a short circuit related to the fire were observed (Figure 28).

Figure 28: Unauthorised power installation.

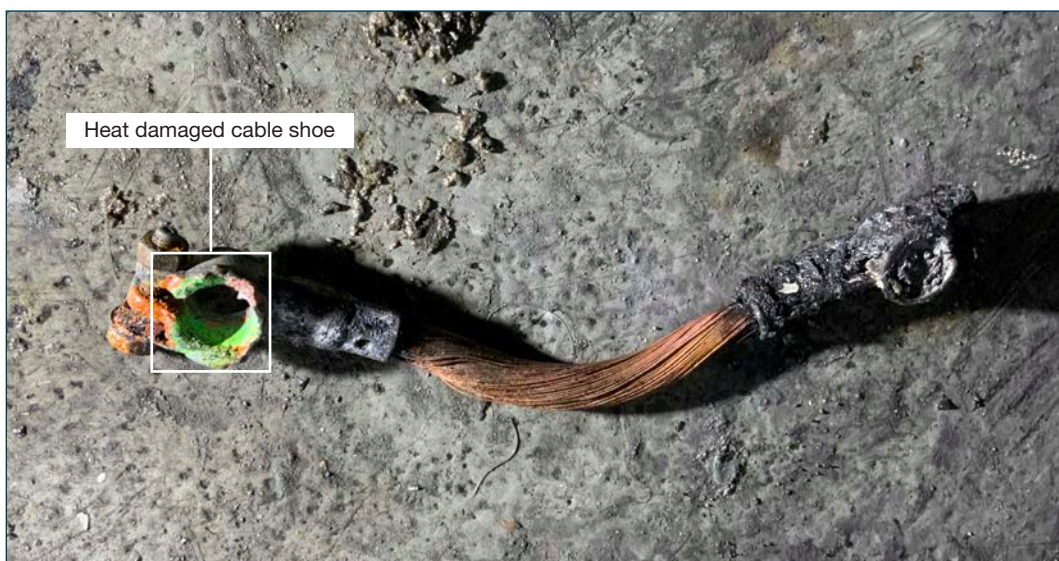
The starter battery consisted of two 12V batteries connected in series. A cable shoe on the cable joining the two batteries was affected by high temperature which could indicate a fault on the wire connection. However, it could not be determined whether this failure occurred as the primary ignition or was secondary. (Figure 29).

Figure 29: Heat damaged cable shoe on battery wire connection.

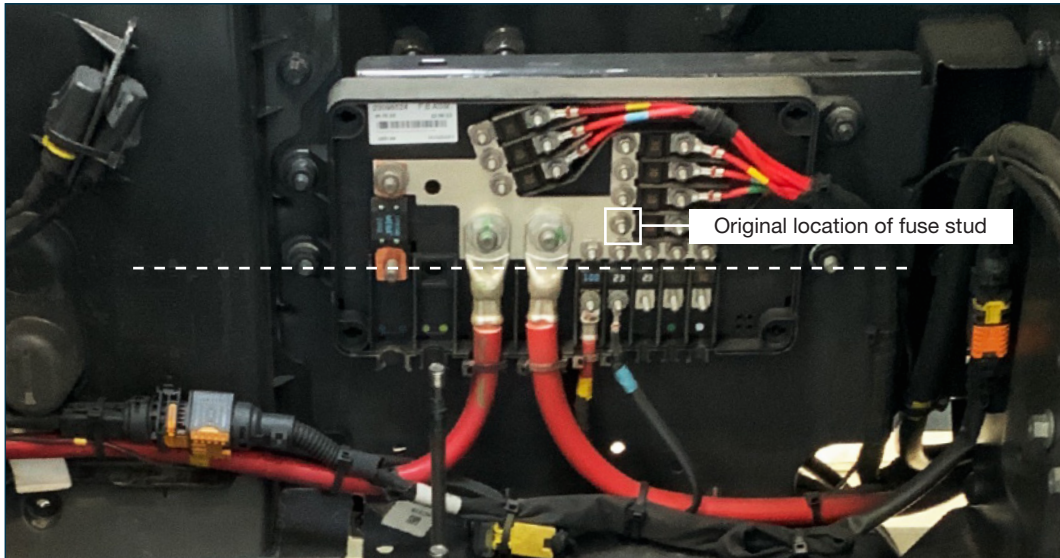
The plastic casing ensured that the conductor charged from the battery's positive terminal was isolated from the negative grounded chassis. If a breach occurred on the casing, a short-circuit electric arc could occur. As one of the fuse studs was found welded to the chassis, DMAIB found it that an arc flash had occurred due to failed insulation on the fuse box. However, it was found that the fuse stud was not welded in its original place indicating that the fuse box had been deformed by the fire and shifted its position before fuse stud welded to the steel plating (Figure 30 and 31). This means that the short circuit in the fuse box most likely was secondary.

Figure 30: Location of fuse stud
Source: DMAIB

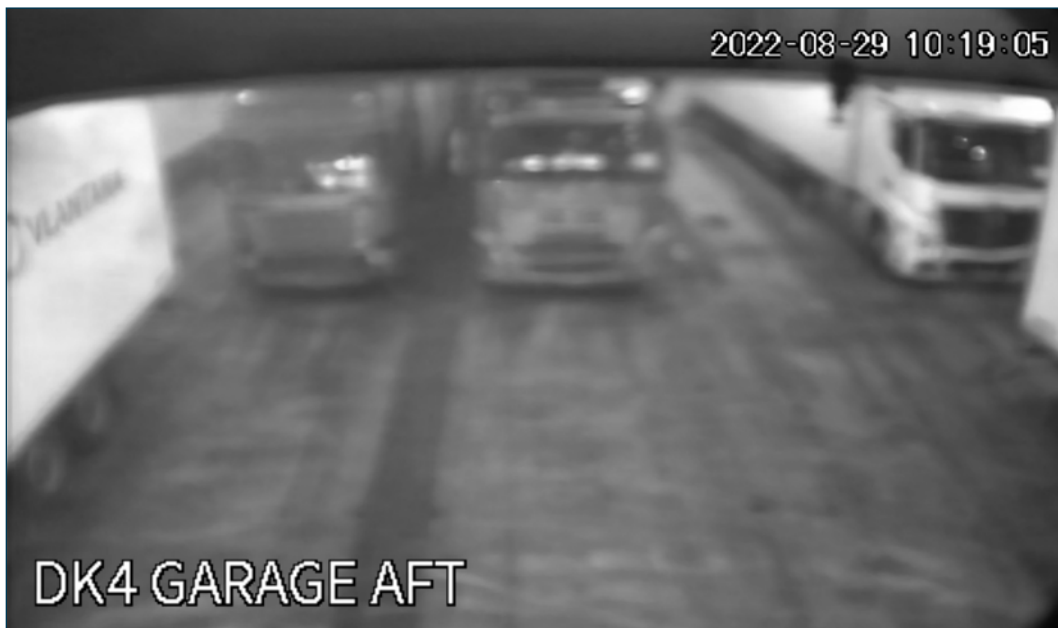
Figure 33: Deck 4 at 12:16:05. Visible smoke.
Source: DMAIB

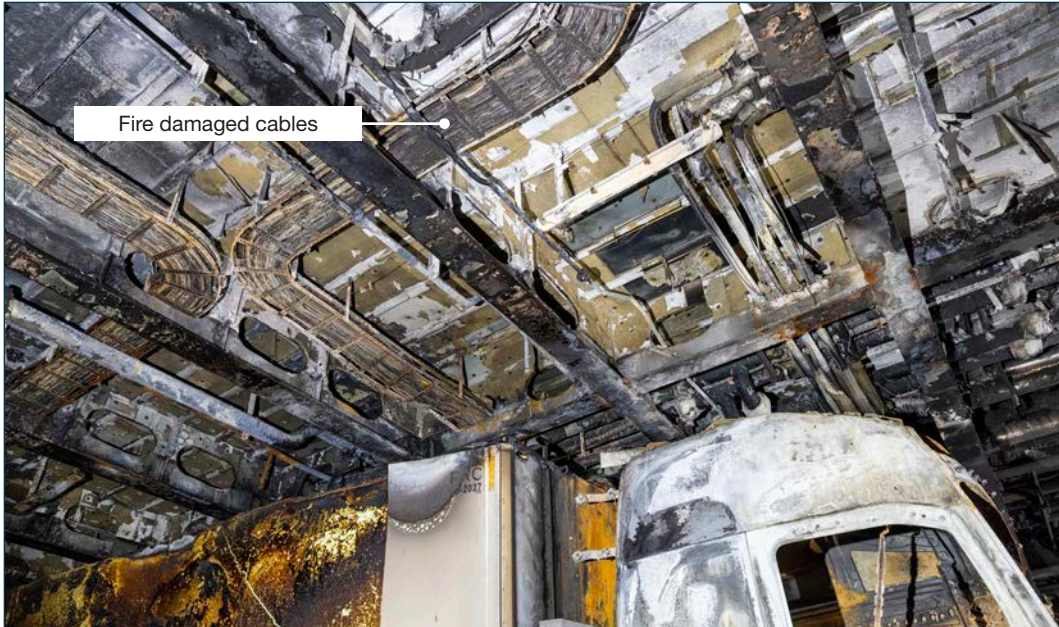
In the area above the opening between cab and trailer, soot was burned away, indicating that the deckhead was subjected to high temperatures which damaged the insulation on the cables installed in trays on the deckhead (Figure 36).

Figure 36: Fire damages to the deck head above the burning truck.
Source: DMAIB

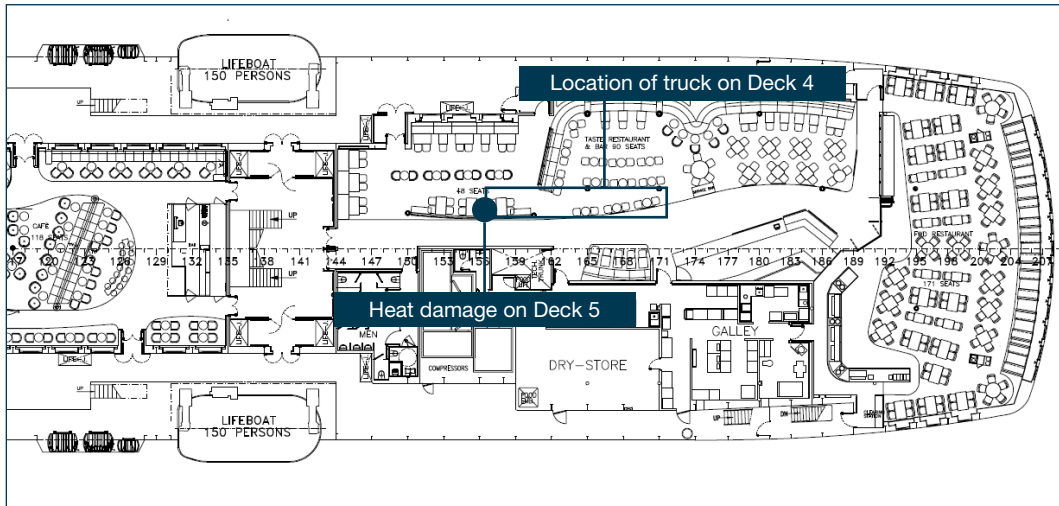
On Deck 4, water from the firefighting soaked and loosened the fastenings of the fireproof insulation which separated from the deckhead and fell to the deck. With the steel exposed to the heat from the fire, heat radiation occurred in the passenger area above the burning truck. During the fire, crew members monitored the temperatures in the compartments adjacent to the fire scene using a thermal scanner. On Deck 5 in the lounge and reception area, surface temperatures of 60°C were read, and boundary cooling was initiated at 1253. When the carpet in the lounge area was removed following the fire, significant heat damage to the carpet adhesive was found at a covered cable duct located just above the fire scene on Deck 4 (Figure 37).

Figure 37: Location of heat damage in lounge area on Deck 5 and indication of truck position on Deck 4.
Source: Stena Rederi A/S, modified by DMAIB

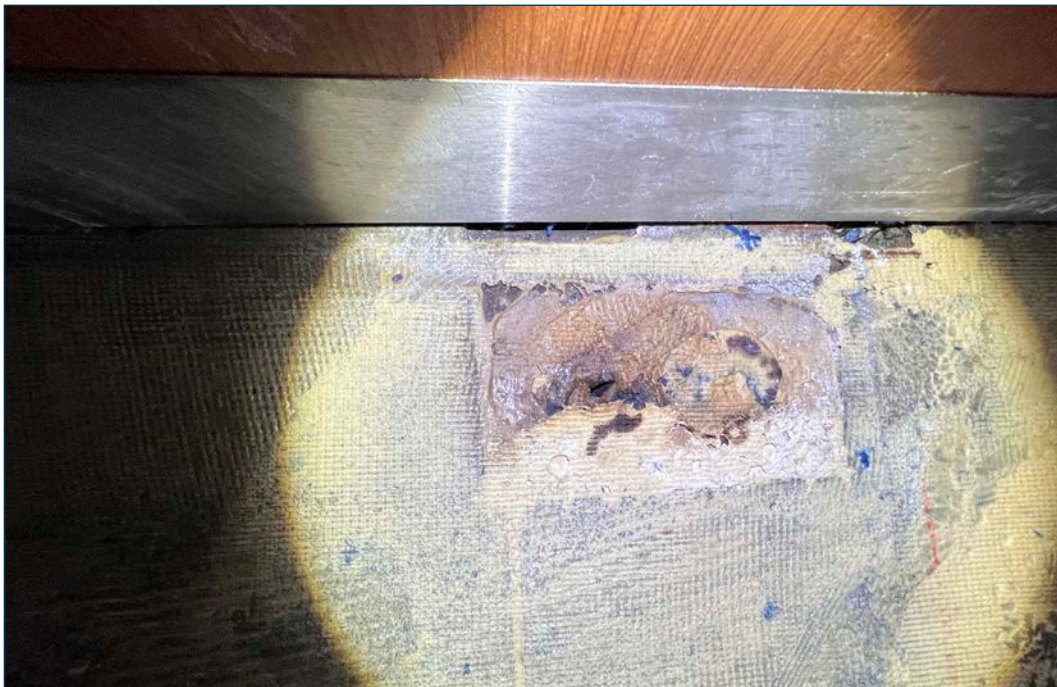
Figure 38: Heat damage to the adhesive.
Source: DMAIB

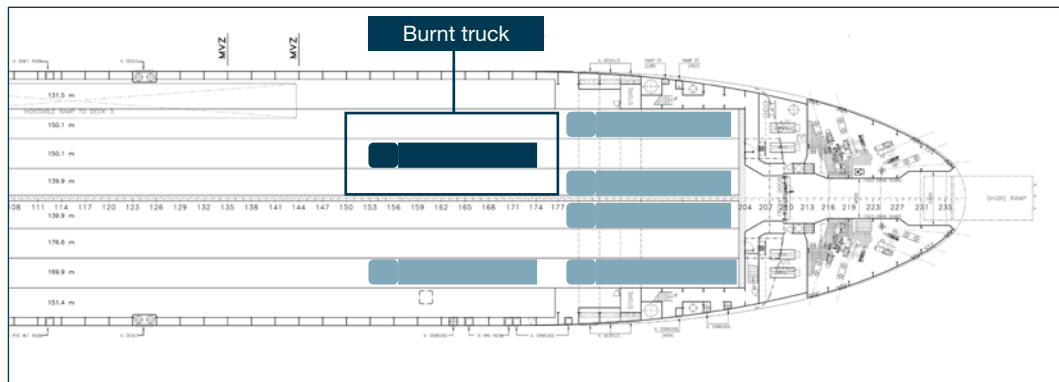
The fire did not spread to other vehicles because the sheltered part of Deck 4 was not stowed to its full capacity, and the burning truck had empty lanes either side (Figure 39). Furthermore, no vehicles were stowed directly in front of the truck and, although two trucks were stowed behind, they were not affected by flames because the fire did not spread to the rear of the trailer of the burnt truck.

Figure 39: Stowage of trucks in the sheltered part of Deck 4.
Source: Stena Rederi A/S, modified by DMAIB

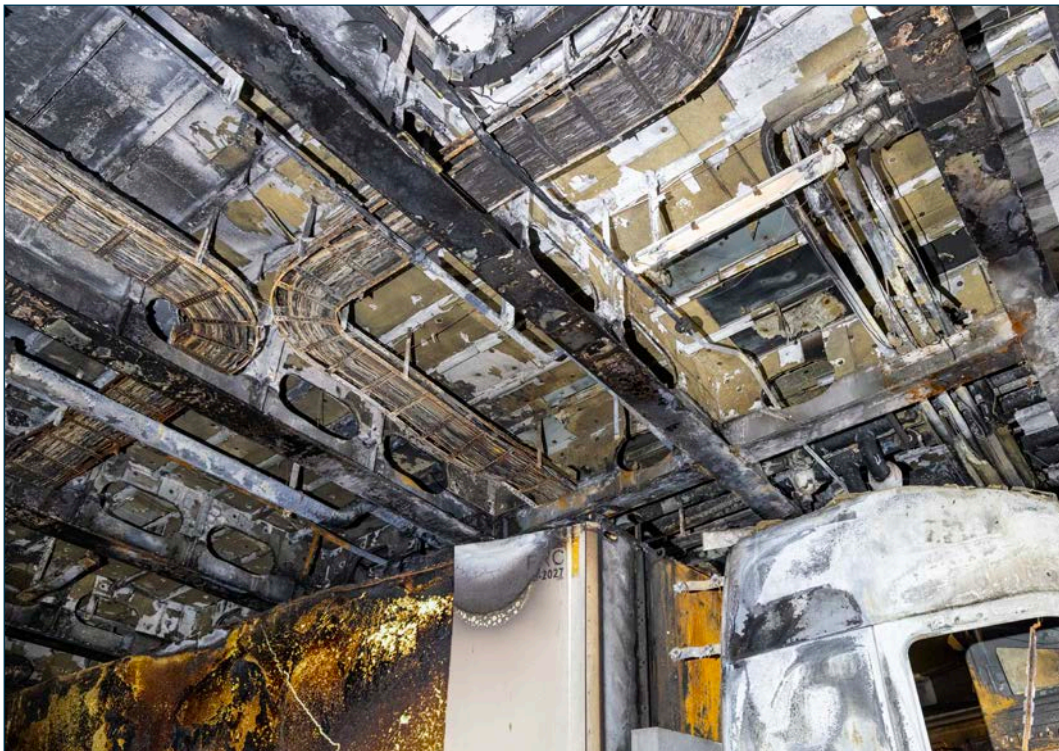
Figure 42: Burnt cable trays visible directly above the truck.
Source: DMAIB

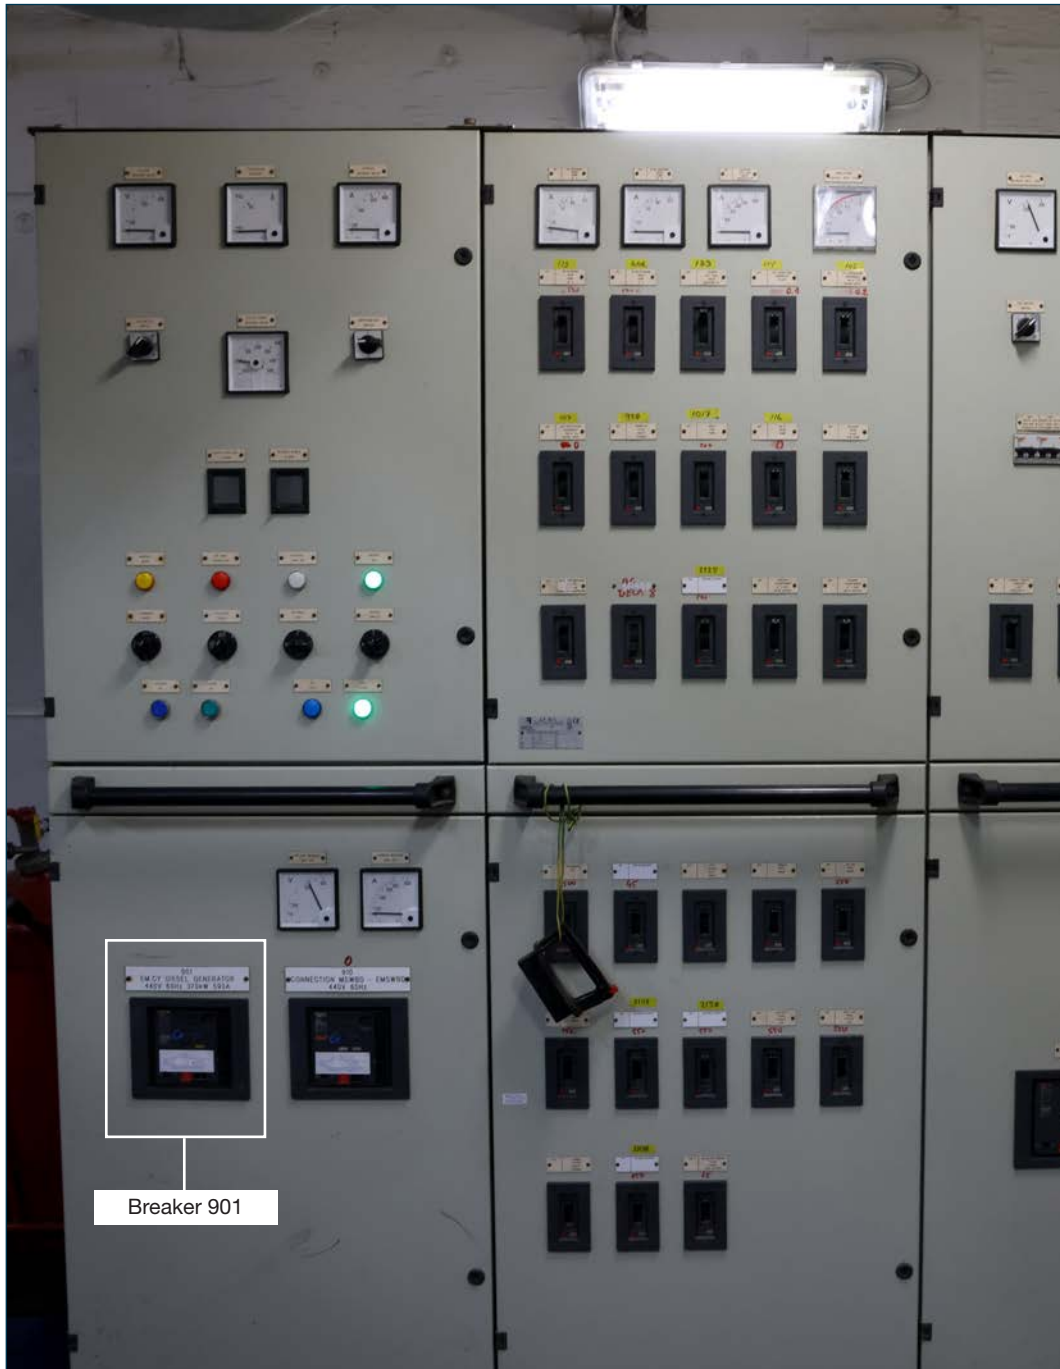
Meanwhile, the ETO had reached the emergency generator room on Deck 8. He observed that the emergency generator was running, but the breaker connecting the emergency generator to the emergency switchboard had not closed as it was supposed to and was therefore not supplying the emergency switchboard. This explained why the 24V UPS batteries were discharging. The ETO made several attempts to close the breaker, but each time the breaker tripped. While operating the breaker, he was informed on the UHF radio that sparks were coming from the cables on the deckhead on Deck 4. He rushed back to the ECR to isolate additional services and to discuss the issue of the tripping breaker with the chief engineer.

Figure 49: Breaker 901 on the emergency switchboard for emergency diesel generator.
Source: DMAIB

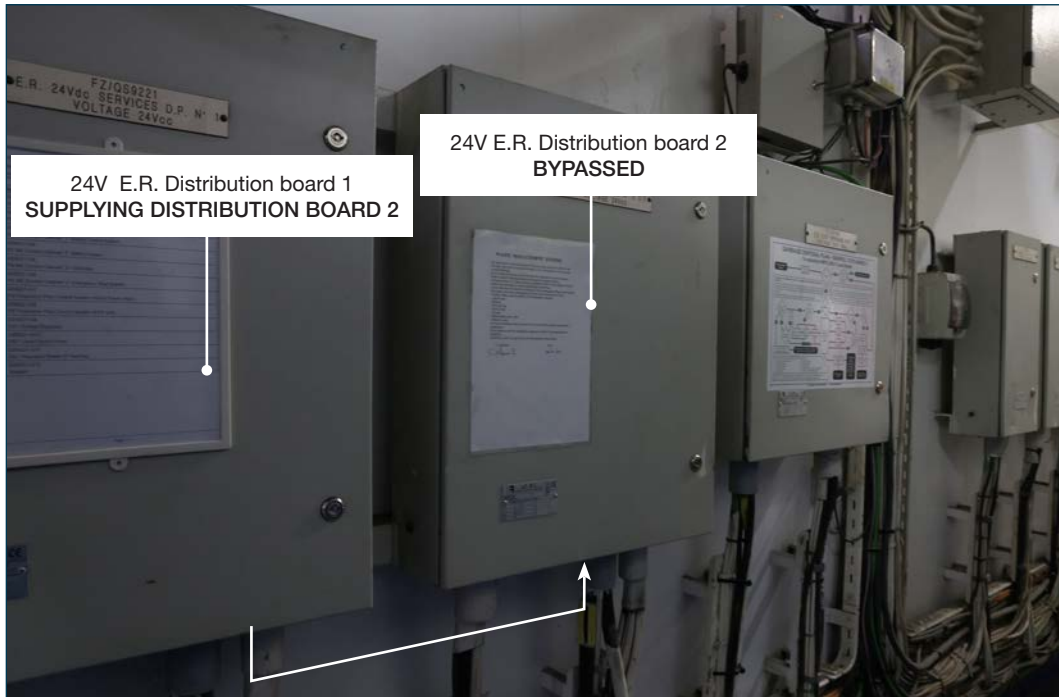
Figure 53: Distribution board for 24 V services in engine room bypassed.
Source: DMAIB

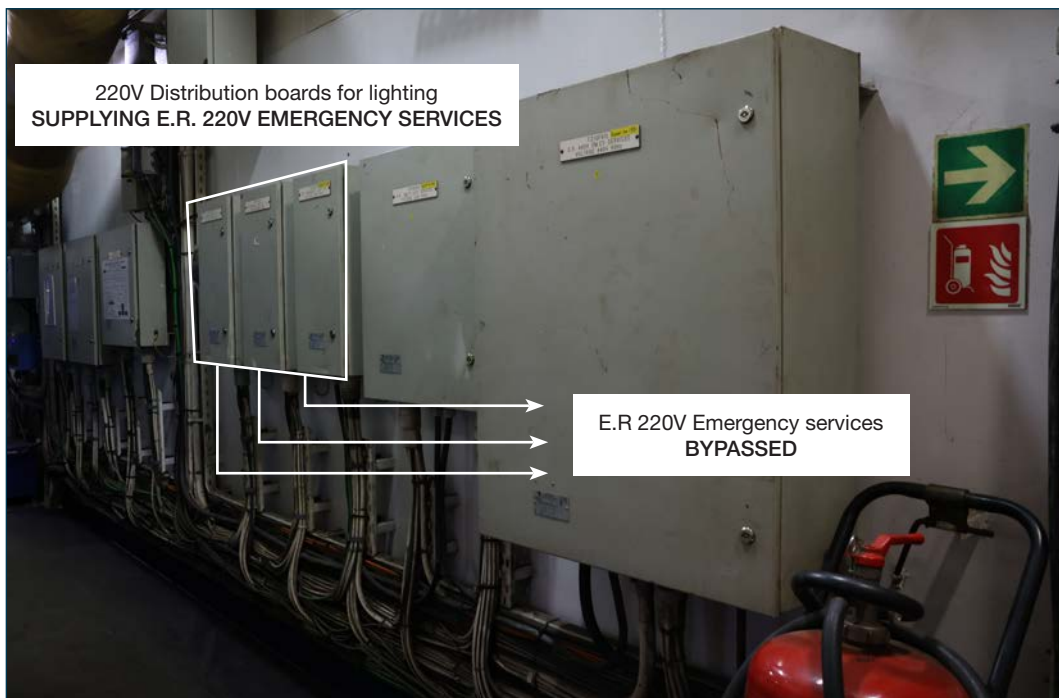
Figure 54: Distribution board for 220V emergency services in engine room bypassed.
Source: DMAIB
