Danish Maritime Accident  
Investigation Board

# MARINE ACCIDENT REPORT

**VESTURLAND**  
**Fire on 7 January 2017**

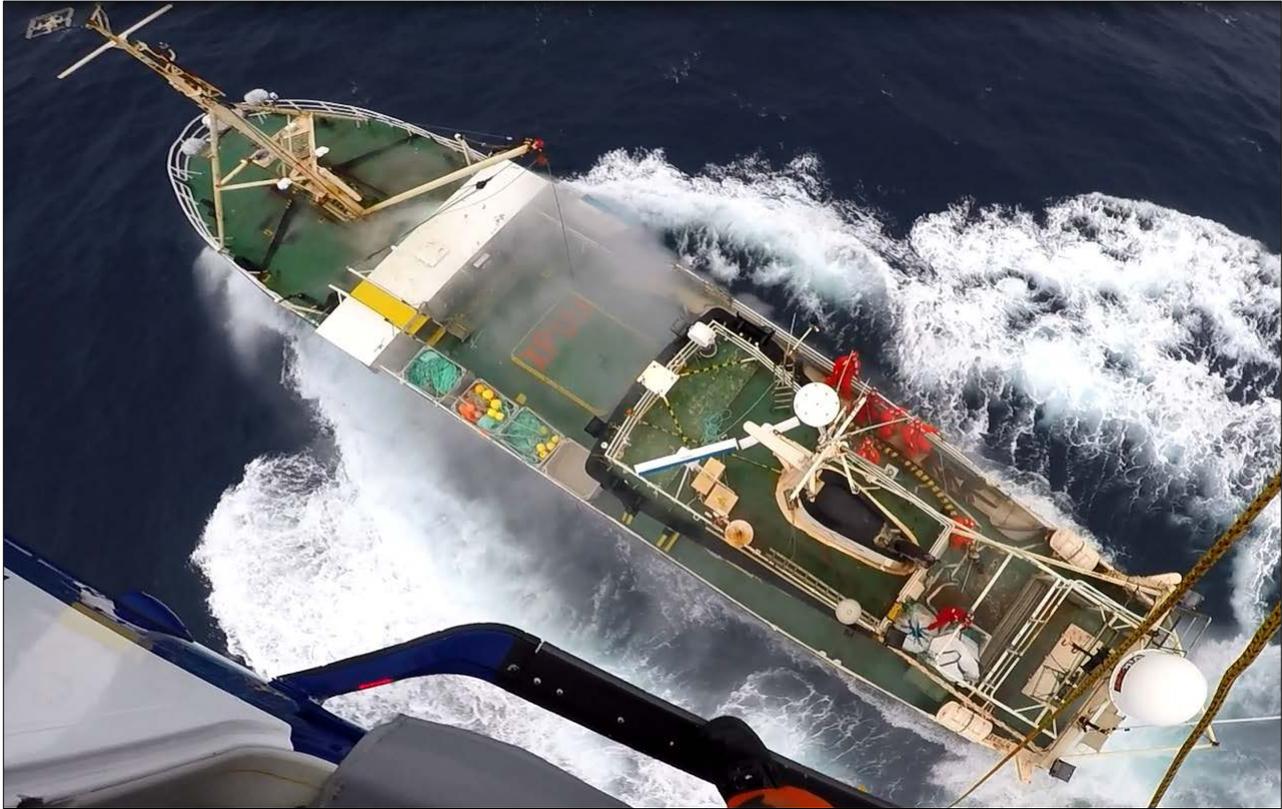
The rescue helicopter was on site at 1338 and communicated with the master over the VHF radio. The helicopter pilot requested the master to change the course to a southerly course before the evacuation could start. By then, the entire crew were standing on the starboard side of the main deck (figure 4).

*Figure 4: VESTURLAND seen from helicopter moments before the evacuation.  
Source: Atlantic Airways*

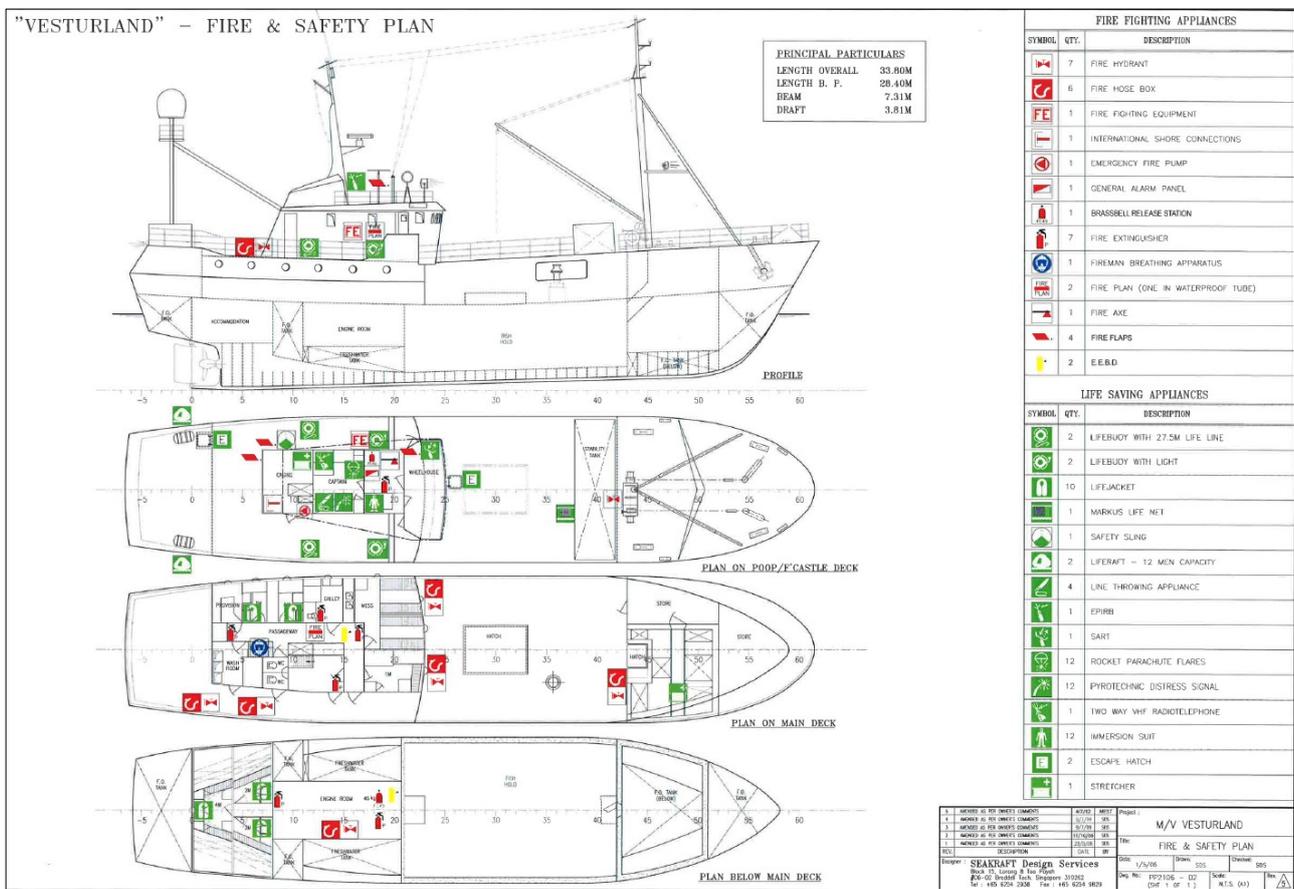
Figure 6: Fire and Safety Plan – VESTURLAND  
 Source: Thor P/F

There were two measures for fighting a fire on VESTURLAND. The engine room was equipped with a fixed fire extinguishing plant<sup>4</sup> and fire hydrants, including fire hoses, were located on the main deck, the bridge deck and in the engine room (figure 6). The water for extinguishing fire was delivered by the ship's general service pump. However, the pump and the fire hydrants on deck were also used for supplying water for cleaning the deck and fishing gear. Therefore, the fire hydrants on deck were permanently mounted with rubber hoses, which were well suited for the daily cleaning on deck. If the fire hydrants were to be used for firefighting, the permanently mounted rubber hose connections were to be replaced with fire hoses. There were twelve portable fire extinguishers located in various compartments on the vessel.

Equipment for two firefighters was located on the main deck, including four bottles of compressed air, but there was no compressor for filling the bottles. It was not a mandatory requirement for this size of fishing vessel to be equipped with firefighter equipment, but the previous

VESTURLAND had not been designed with structural fire protection in the forecabin, e.g. insulated bulkheads and/or fire doors. Furthermore, there was no fire and/or smoke detection systems connected to an alarm panel, which made it impossible to have a systematic early detection and containment of a smouldering fire. When fighting fires on ships, it is essential that they are detected and contained early because the on-board firefighting equipment provides a limited capacity for the crewmembers to extinguish a fire, e.g. there is a limited number of breathing apparatuses and fire hoses. On VESTURLAND, there were two breathing apparatuses with two spare air bottles and no compressor to refill them. This meant that each firefighter would have approximately 1/2-1 hour of air available for extinguishing the fire. In the smoke-filled environment on deck it was not possible to use a fire hose without being equipped with a breathing apparatus. Having two sets of firefighter's equipment did not allow for having a back-up team to assist the firefighters if something unexpected occurred or to have redundant equipment if one of the breathing apparatuses malfunctioned. Furthermore, the time available to extinguish the fire was limited because it would adversely affect the vessel's stability to fill the forward storage rooms and the cargo hold with water from the fire hoses.

The operator of VESTURLAND has notified DMAIB that the companies' other fishing vessels are equipped with fire detection systems providing the crew with an early warning about a developing fire. This provides the crew with the necessary time to assess the most appropriate way of fighting the fire or the need for an immediate evacuation of the vessel.

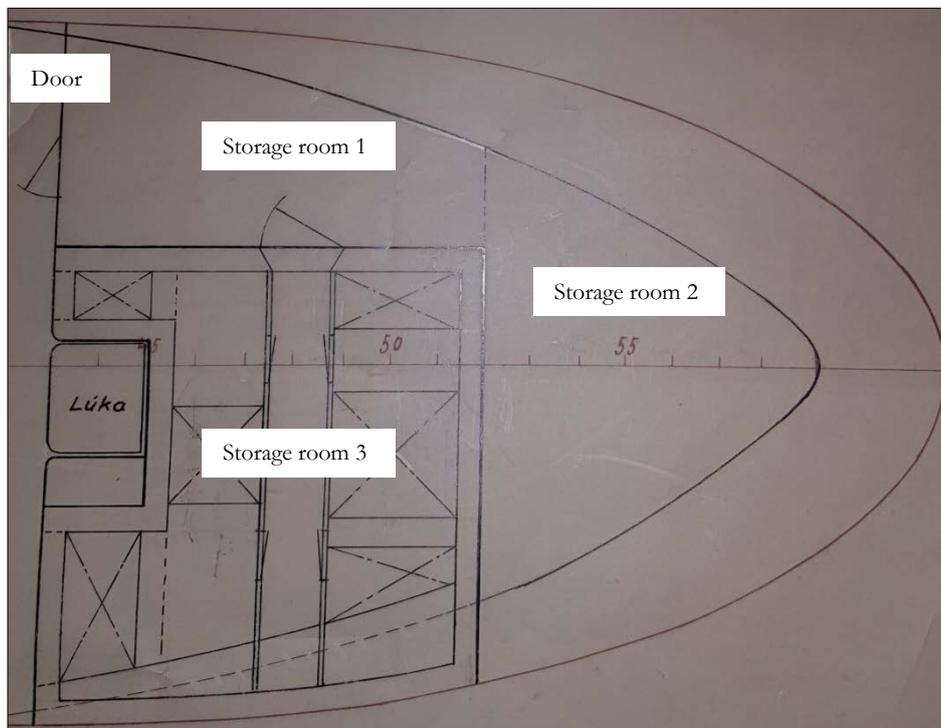
Figure 7: Extract from GA plan  
Source: MEST Shipyard

Testimonies from the crewmembers indicated that the light grey smoke came from the storage rooms in the forecabin and that the smoke had a distinct smell of burning wood. Figure 7 below shows a layout of the forward storage rooms.

The storage room was accessible by a door on the port side. Usually the door to the storage was open and secured with a hinge if the weather was good. All three storage rooms were used only for storing provisions, engine parts, ropes and other items used in the daily operation of the vessel.

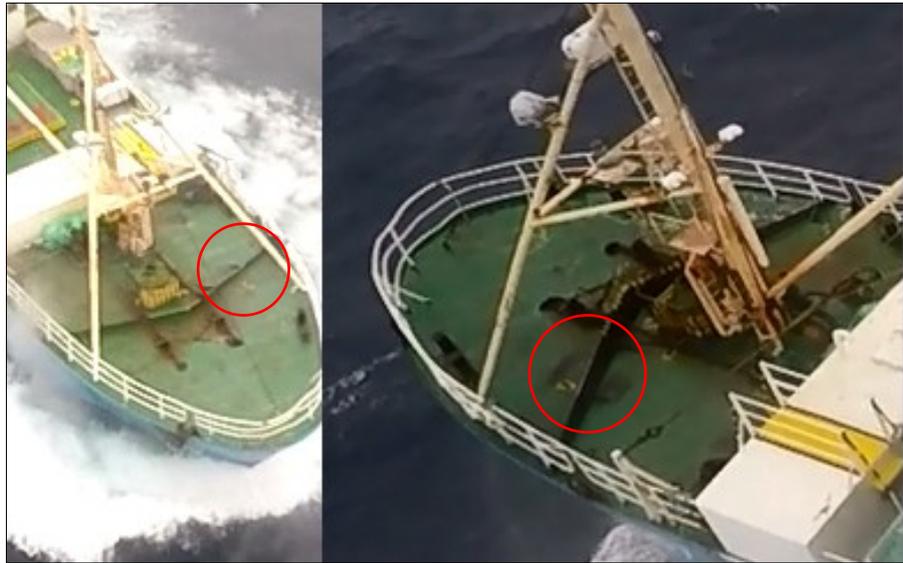
rooms in the forecastle, which was lined with wood planks. Video recordings from the rescue helicopter, which arrived at the ship approximately 90 minutes after the smoke was detected, also indicated that the smoke originated from the forward part of the ship. From the recordings, minor changes in the ships paint could be observed which were most likely caused by heat radiating from the storage room under the forecastle deck (figure 8). The time difference between the two pictures was approximately 20 minutes.

*Figure 8: Extract recording from helicopter  
Source: Atlantic Airways*

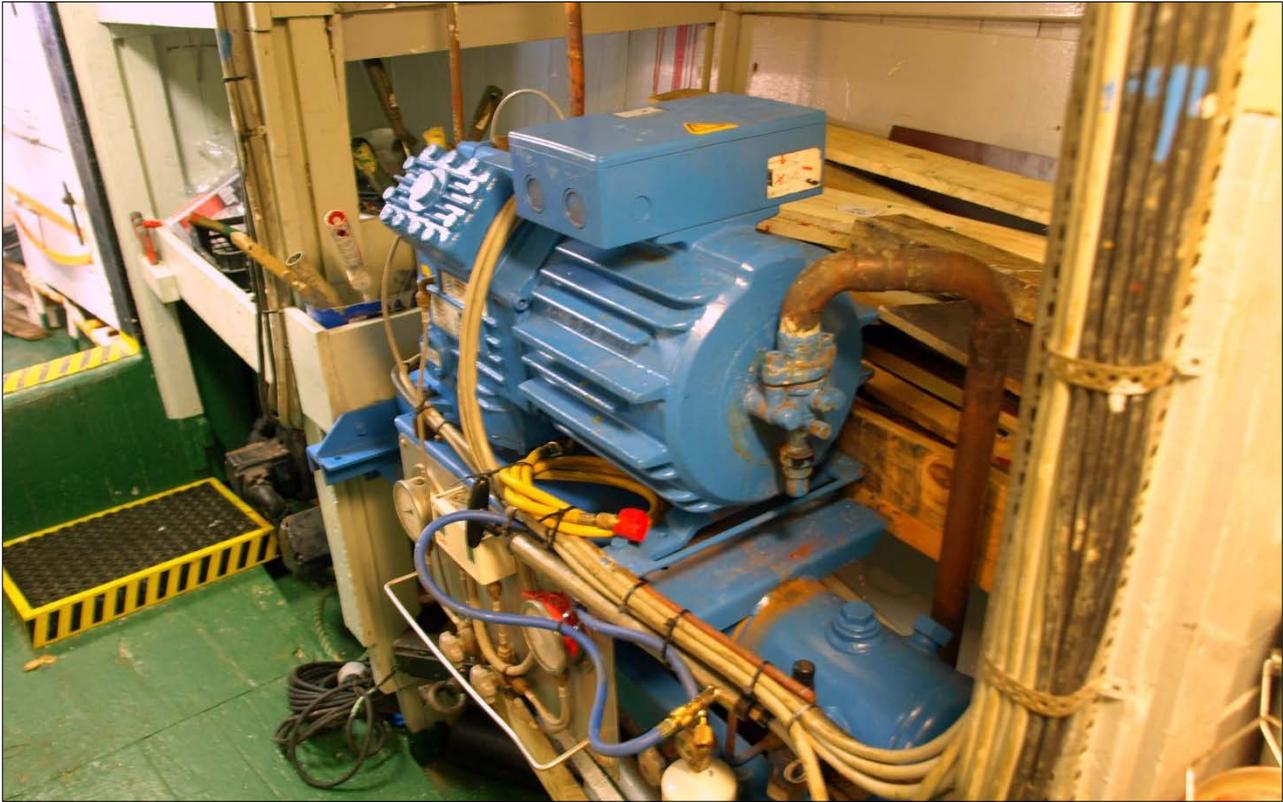
*Figure 9: Disconnected compressor in storage room before the fire*  
Source: THOR P/F

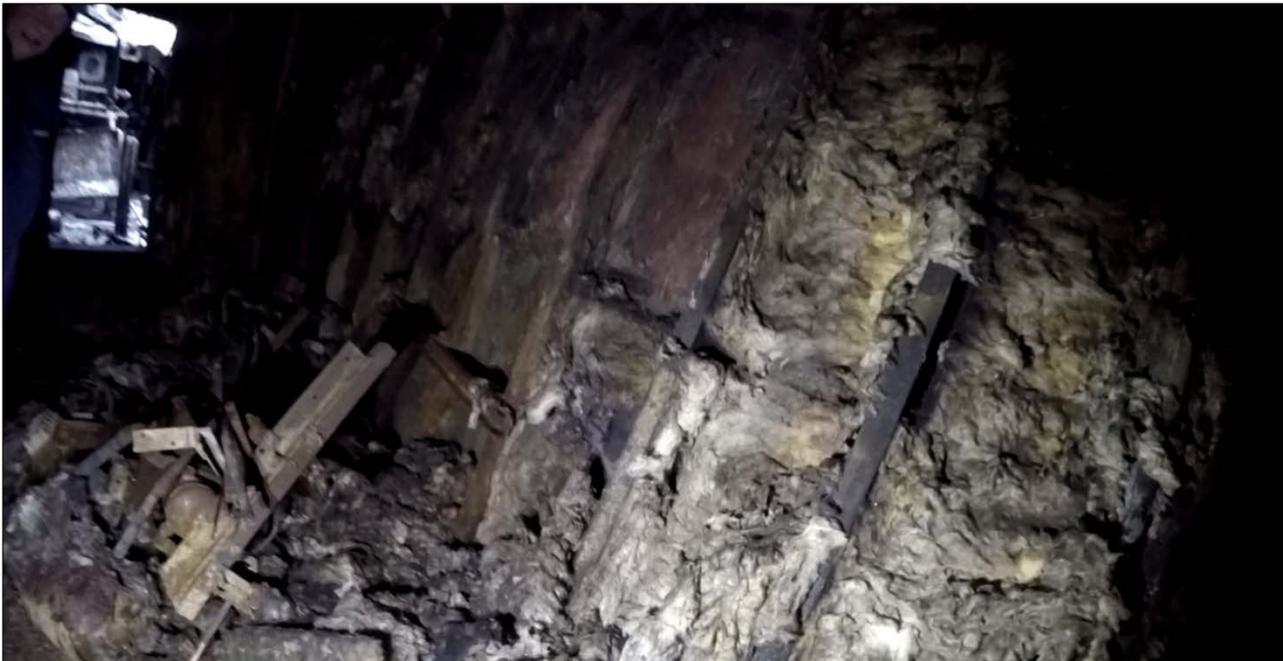
The source of the fire was not readily visible during the inspection of the storage rooms in the fore-castle because the fire had destroyed the wooden lining and shelves (figure 9 and 10), which caused the shelves to collapse, scattering the stored items throughout the rooms. The electrical wiring and lighting which was mounted on the wooden lining was for the most part incinerated, and it was not possible to reconstruct the origin of the remaining wiring (figure 11). The only electrical equipment in use in the storage rooms was the lighting fixtures. A freezing compressor was located in storage room 1, but was not in use, and in storage room 3 a portable electrical heater was located which was not in use either.

*Figure 10: Location of the disconnected cooling compressor in storage room 1 after the fire*  
Source: DMAIB

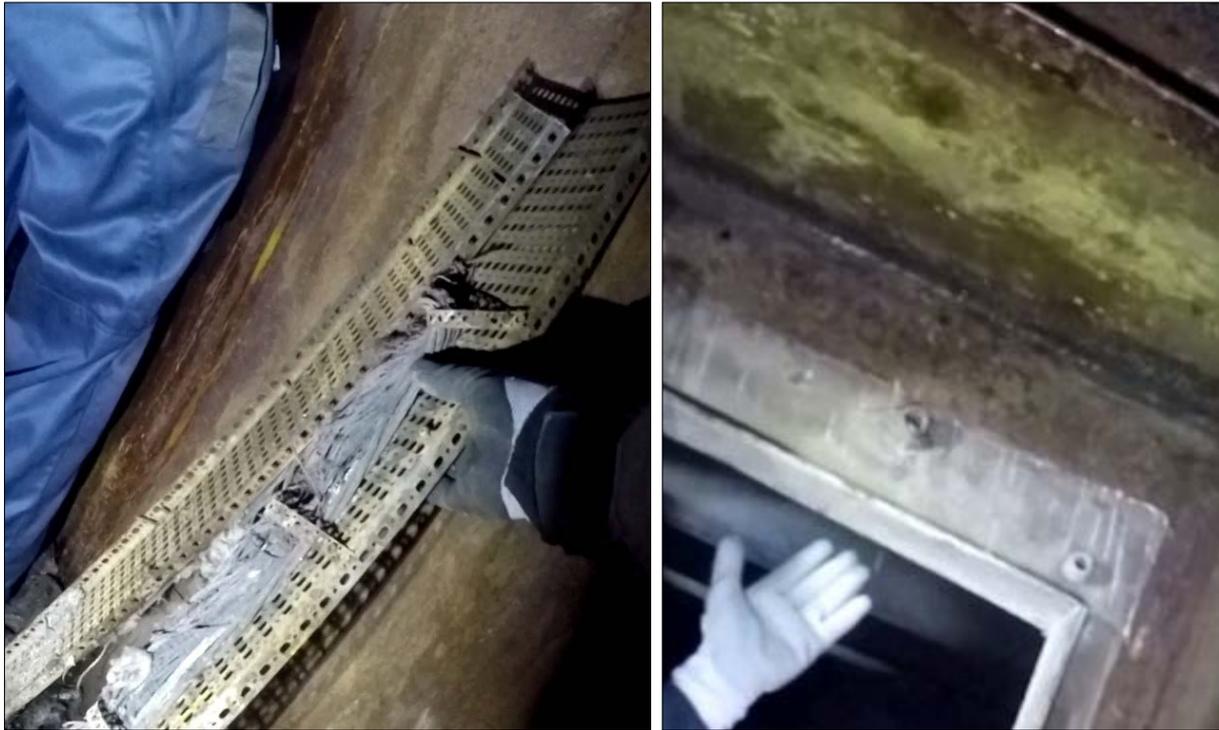
*Figure 11: Cable tray in storage room 1 and cable penetration between storage rooms 1 and 2*  
*Source: DMAIB*

Testimonies by the shipping company's inspectors and crewmembers stated that the rooms were used only for storage and therefore did not have any machinery in use which could produce heat or ignite a fire. The investigation of the storage rooms did not contradict these statements. There was no immediately visible source of heat and ignition which could provide sufficient temperatures to ignite the materials present in the storage rooms. On that basis, it can be assumed that the fire originated from a lightning arc in the electrical system, e.g. lighting fixtures, loose wiring in junction boxes, etc. The phenomenon of electric arcing occurring in light fixtures is known from other accidents<sup>5</sup> and the black colouring of the deck on the forecastle (figure 8) could be an indication that the light fixture below in storage room no. 1 had ignited and oxidized the wooden lining in the ceiling that later ignited.

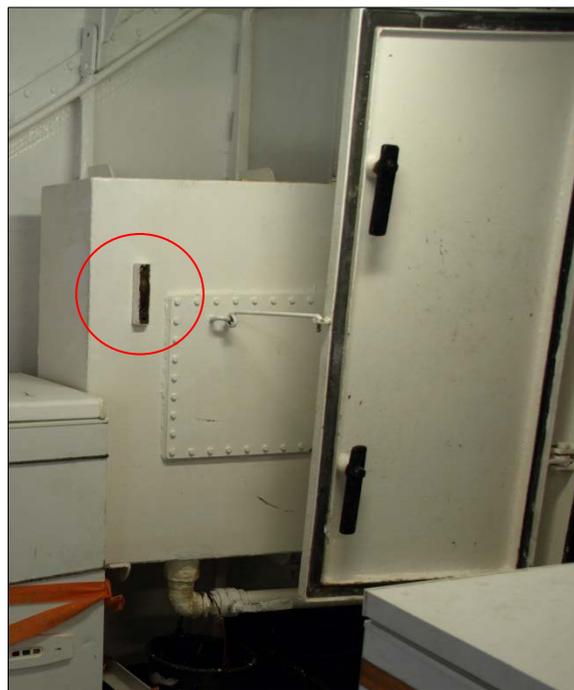
*Figure 12: Picture showing the hydraulic oil tank outside storage room prior to the fire. Sight glass in the red circle.*

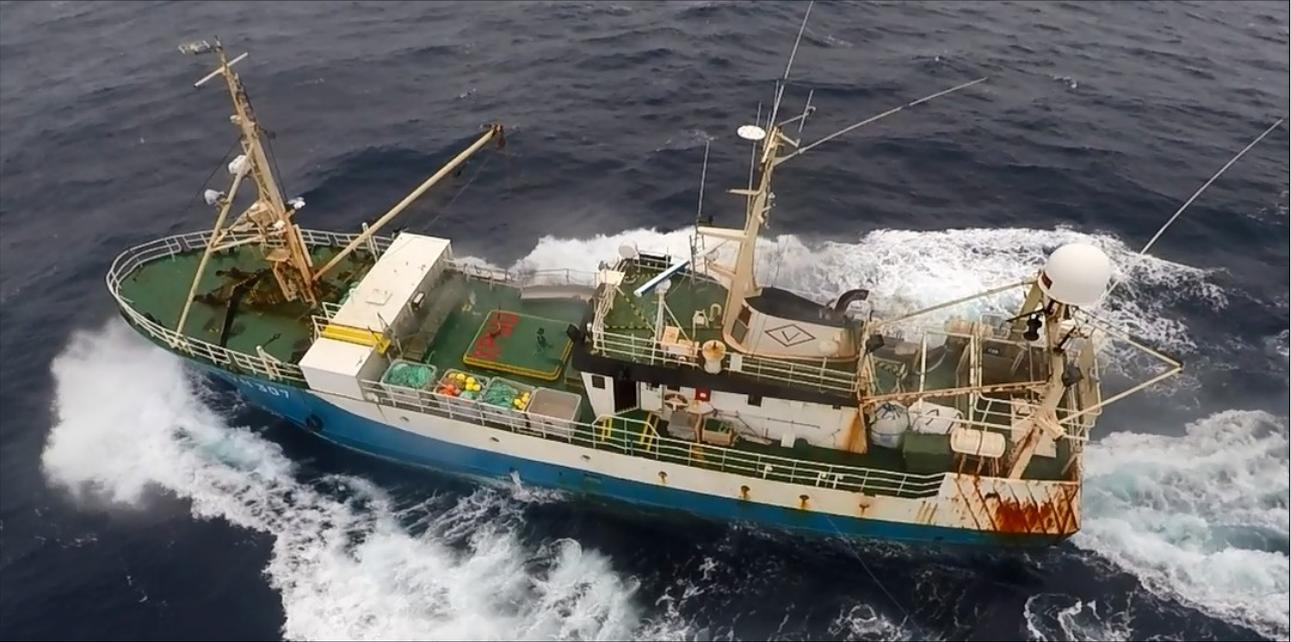
The pictures from the rescue helicopter at 1402 (figure 13) indicate that the fire was in its early stages when the crewmembers were evacuated because the ship did not show extensive heat damage on the steel plating and because the smoke was not dense. When the ocean patrol vessel VAEDDEREN arrived at the scene at 1715, approximately three hours after the crew had been

hoisted off VESTURLAND, the vessel was engulfed in flames. How the fire developed between 1400 and 1715 is unknown.

*Figure 13: Picture of ship at approximately 1400 after it had been evacuated*  
*Source: Atlantic Airways*
