# RIGI

Marine accident report on foundering

23 APRIL 2018

**MARINE ACCIDENT REPORT ON THE FOUNDERING  
OF RIGI ON 23 APRIL 2018**

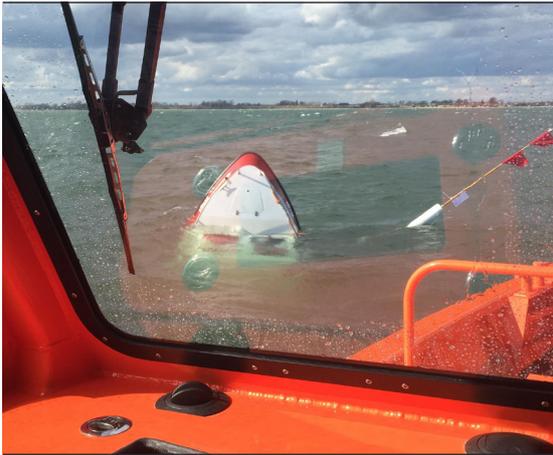
Figure 7: RIGI foundered in Faxø Bay  
Source: Klintholm Coastal Rescue Service

RIGI was flooded when two large waves came over the stern within a short timeframe, probably one or two minutes. The first wave flooded the deck area and flowed into the cabin, filling it to ankle level. The next wave flooded the boat entirely, which caused it to sink immediately by the port aft side first. Subsequent examination of the boat revealed no external damage to the boat, which could have contributed to the sudden flooding.

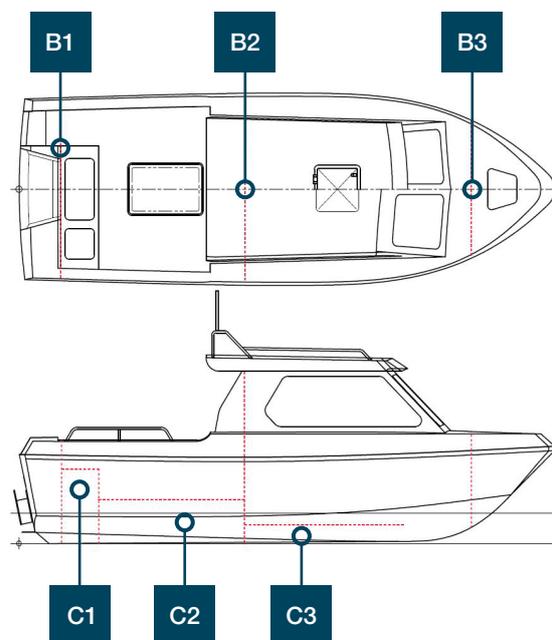
Figure 13: Sketch of compartments and bulkheads under deck  
Source: YARO/DMAIB

Below deck (fig. 13), RIGI consisted of what was essentially one single compartment, which extended from the transom, all the way to the bow of the boat. There were three transverse bulkheads: one at frame 2 (B1) that was the forward part of the transverse bench on the deck, one at frame 6 (B2) just below the sliding door between the cabin and the deck, and one in the foremost part (B3), which constituted the aft bulkhead of the anchor compartment.

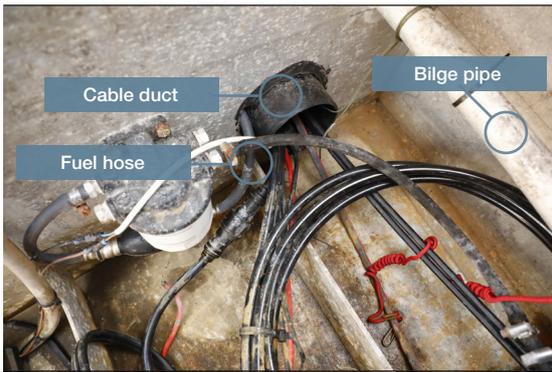
The bulkhead that separated the tank compartment from the area under the cabin (C3) had a large cut-out where the aluminum structure had been removed. Forwards of the cut-out, a plywood panel had been fitted as part of the cabin's wooden interior (fig. 15, next page).

Figure 14: Penetrations in bulkhead between tank compartment and aft storage/equipment compartment.  
Source: DMAIB

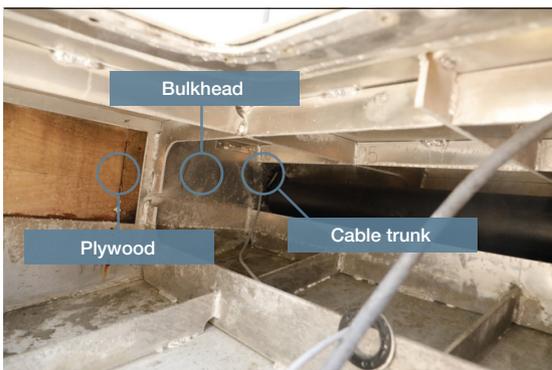
Figure 15: Penetrations in transverse bulkhead, frame 6 between cabin and tank compartment.  
Source: DMAIB

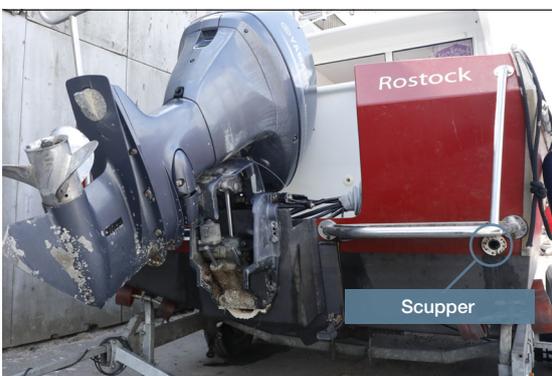
Figure 16: Self-bailing arrangement. Note the absence of non-return flaps on the scuppers outside.  
Source: DMAIB

The deck area aft of the cabin was designed to be partly self-bailing as it had bilge or drain holes in each corner of the aft end (fig. 16 and 17). The intended use of the self-bailing arrangement was that, when the boat passed at speed through the water, bilge water would be ejected through the drain holes, through a pipe in each side, and finally exit through scuppers with non-return flaps in the transom.

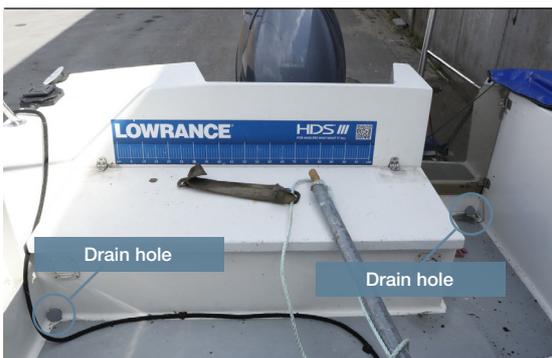
Figure 17: Self-bailing arrangement, plugged drain holes  
Source: DMAIB

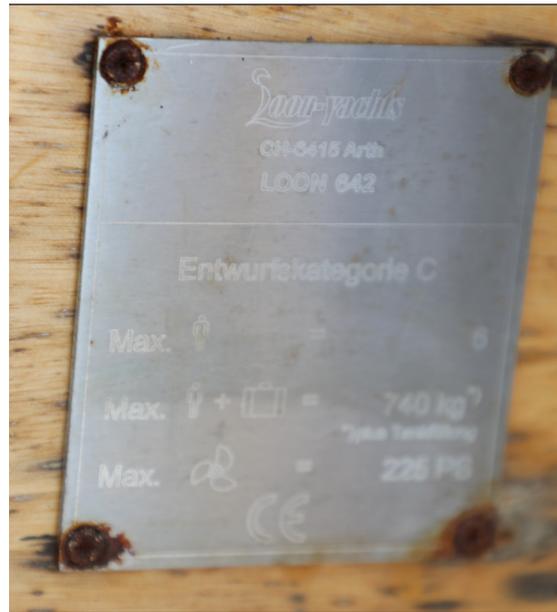
Manufacturer:	Loon-Yachts
Boat type:	Loon Fishing 642
Design category:	C
Max. allowed no. of persons:	6
Max. allowed load, incl. persons:	740 kg
Max. engine power:	225 HP

Figure 18: RIGI's CE-marking plate  
Source: DMAIB

To assess the payload that was likely on board RIGI when it foundered, DMAIB weighed all the items that were recovered and also those that were on board at the time. For persons, and items, which were not recovered, such as personal belongings, fishing gear etc., conservative estimates were made. DMAIB's calculations suggested that the load on board was likely in the region of 900 kg, some 50 kg more than the maximum allowed payload stated on the boat's CE-plate.
