Danish Maritime Accident
Investigation Board

MARINE ACCIDENT REPORT

SKAWLINK III and NORD GARDENIA
Fall overboard on 29 September 2016

This marine accident report is issued on 11 May 2017.

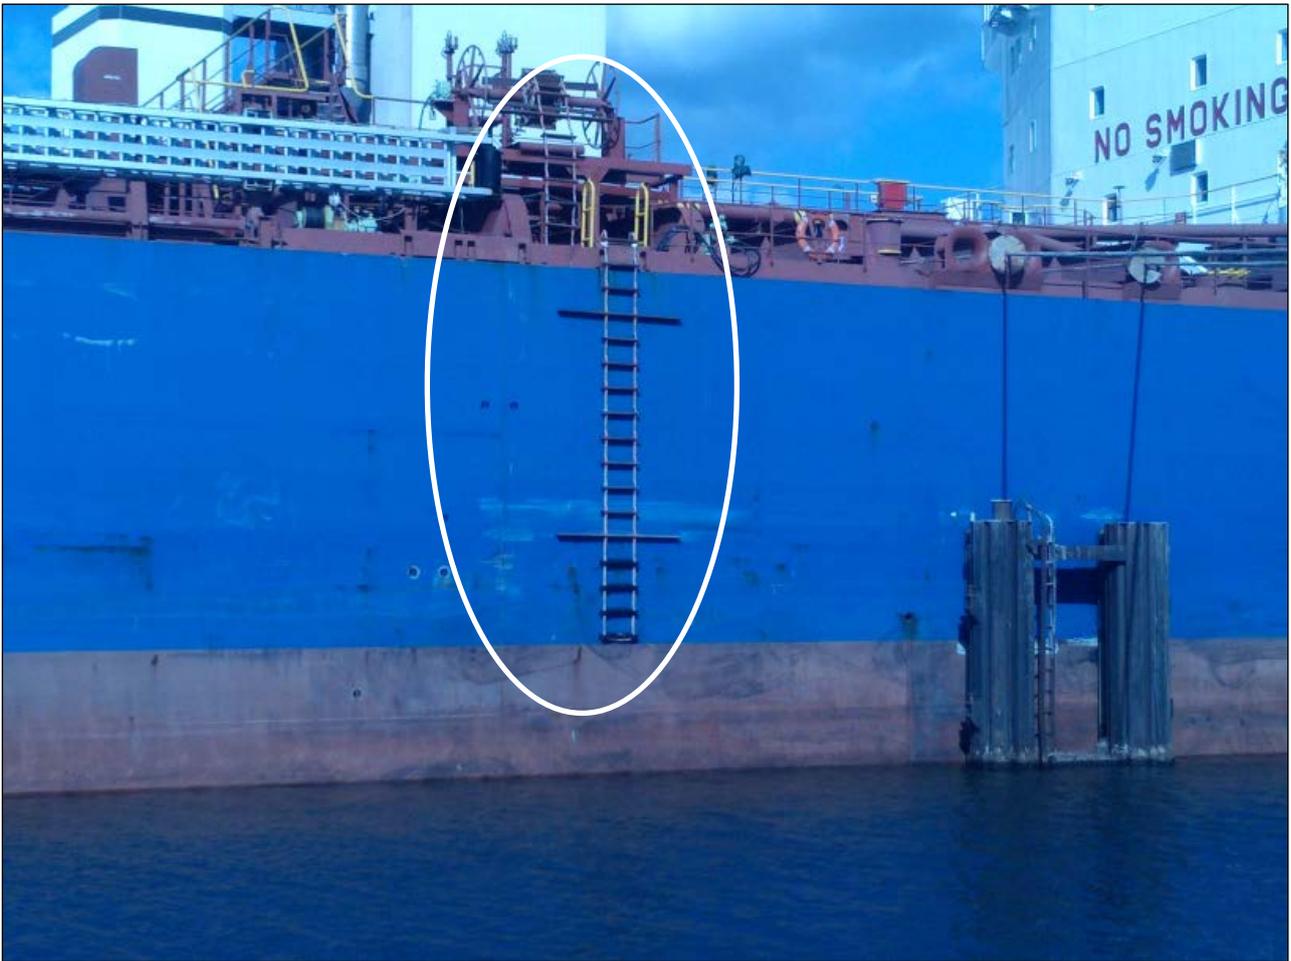
*Figure 4: NORD GARDENIA, pilot ladder arrangement on port side.
Source: Dampskibsselskabet Norden A/S*

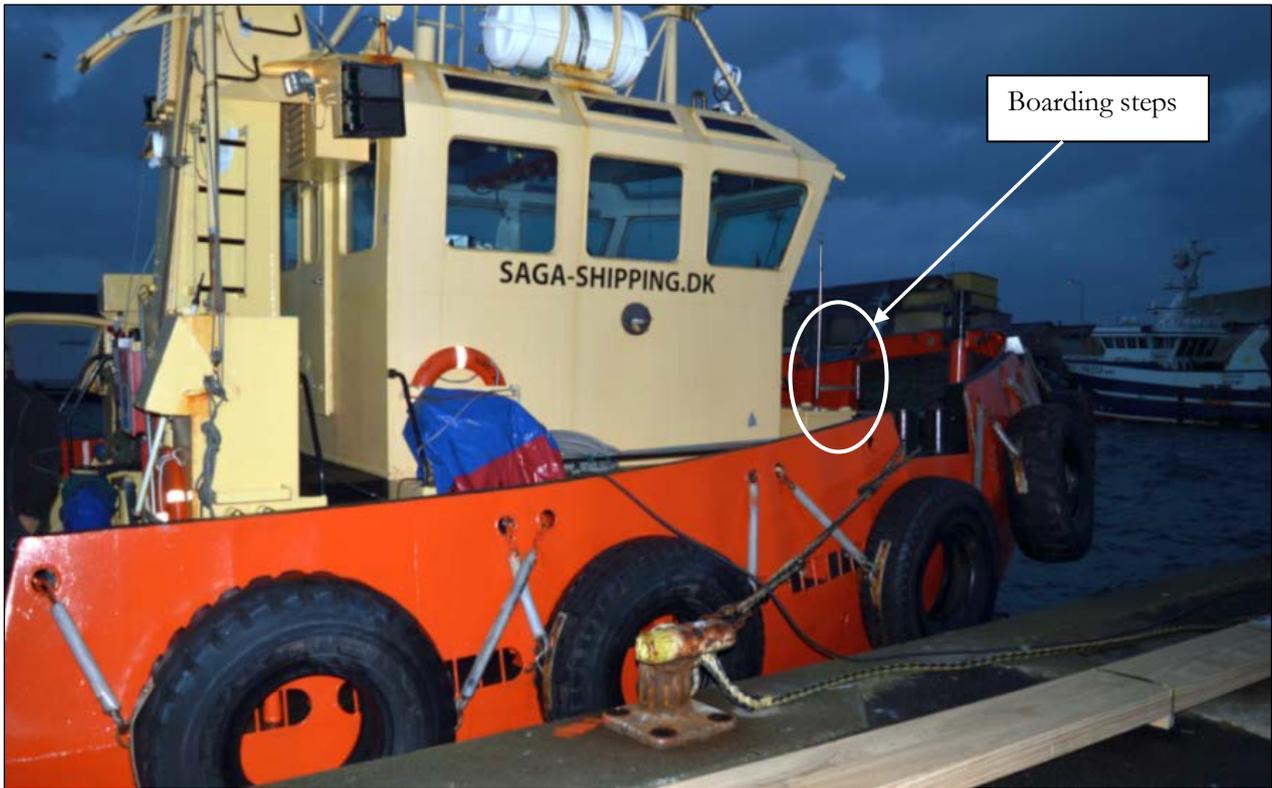
Figure 5: SKAWLINK III, starboard side.
Source: DMAIB

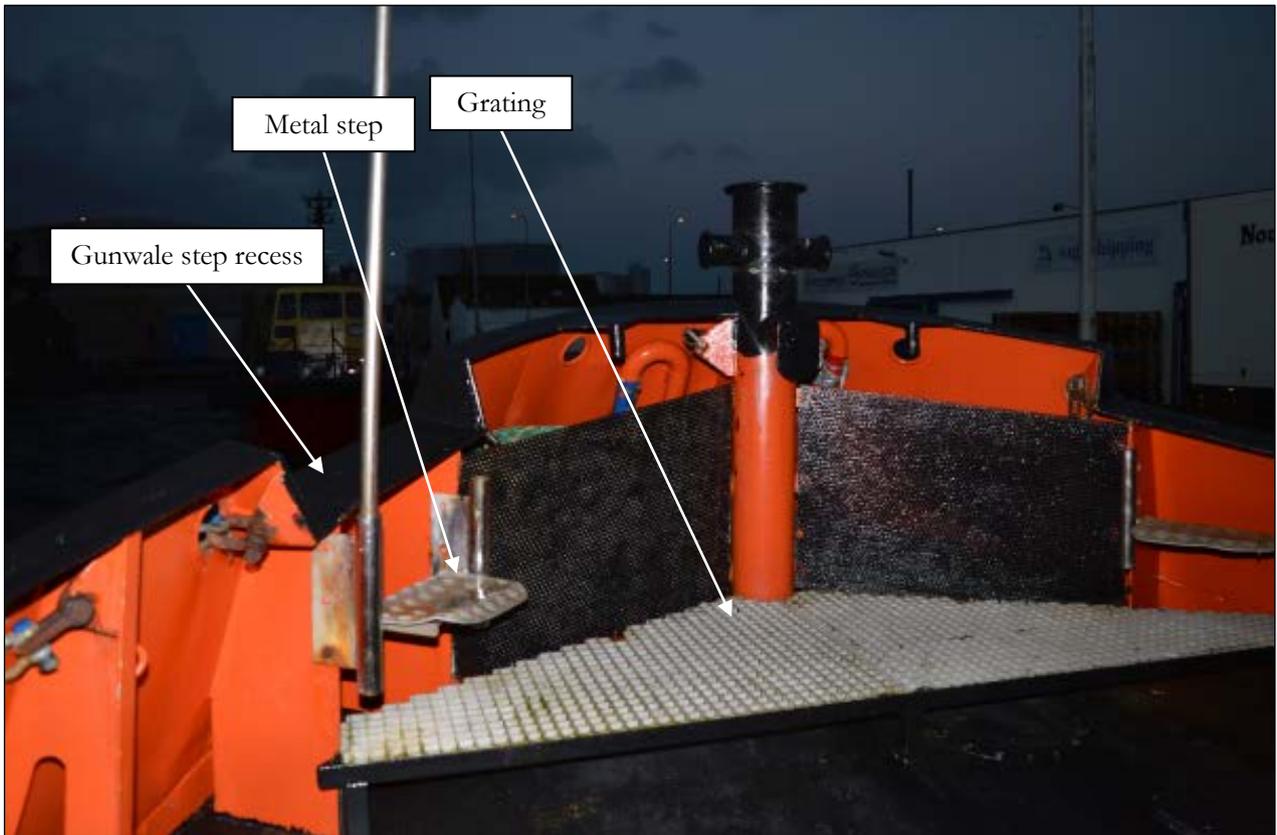
When the superintendent placed his foot on the top step on the gunwale, he slipped and fell down on the grating, landing hard on his chest and side. His colleague and the mate helped him up and asked him if he was OK. He replied that he was fine and immediately went on to climb the steps and grabbed hold of NORD GARDENIA's pilot ladder. The mate held on to the back of his life-jacket until he had a grip on the ladder. The moment the superintendent stepped from SKAWLINK III's gunwale towards the pilot ladder, the swell and waves caused SKAWLINK III to heave downwards and the superintendent did not get a proper footing on the ladder. For a brief moment, he was hanging by his arms only. He then lost his grip and fell into the water. On NORD GARDENIA's bridge, the time 0103 was noted.

The boarding area on the foremost part of the (figure 7) consisted of a triangular metal grating, approx. 25 cm above the deck, with a stainless steel step on each side, also approx. 25 cm high. The last step before stepping onto the pilot ladder was a recess in the gunwale. The width of the gunwale was approx. 20 cm and the recess was painted with non-skid paint. On the outboard side, a number of tyre fenders were mounted around the ship side. Due to the width of the fenders, there was a gap of approx. 30 cm. between the gunwale step and the pilot ladder on NORD GARDENIA, when the two ships were closest. A supporting metal sceptre of approx. 1.80 m height was mounted at the intermediate metal step. There was a bracket for mounting a second sceptre, but experience had showed that passengers preferred only one sceptre as that provided support without inhibiting their mobility.

Figure 7: SKAWLINK III, fore deck, grating and steps indicated
Source: DMAIB

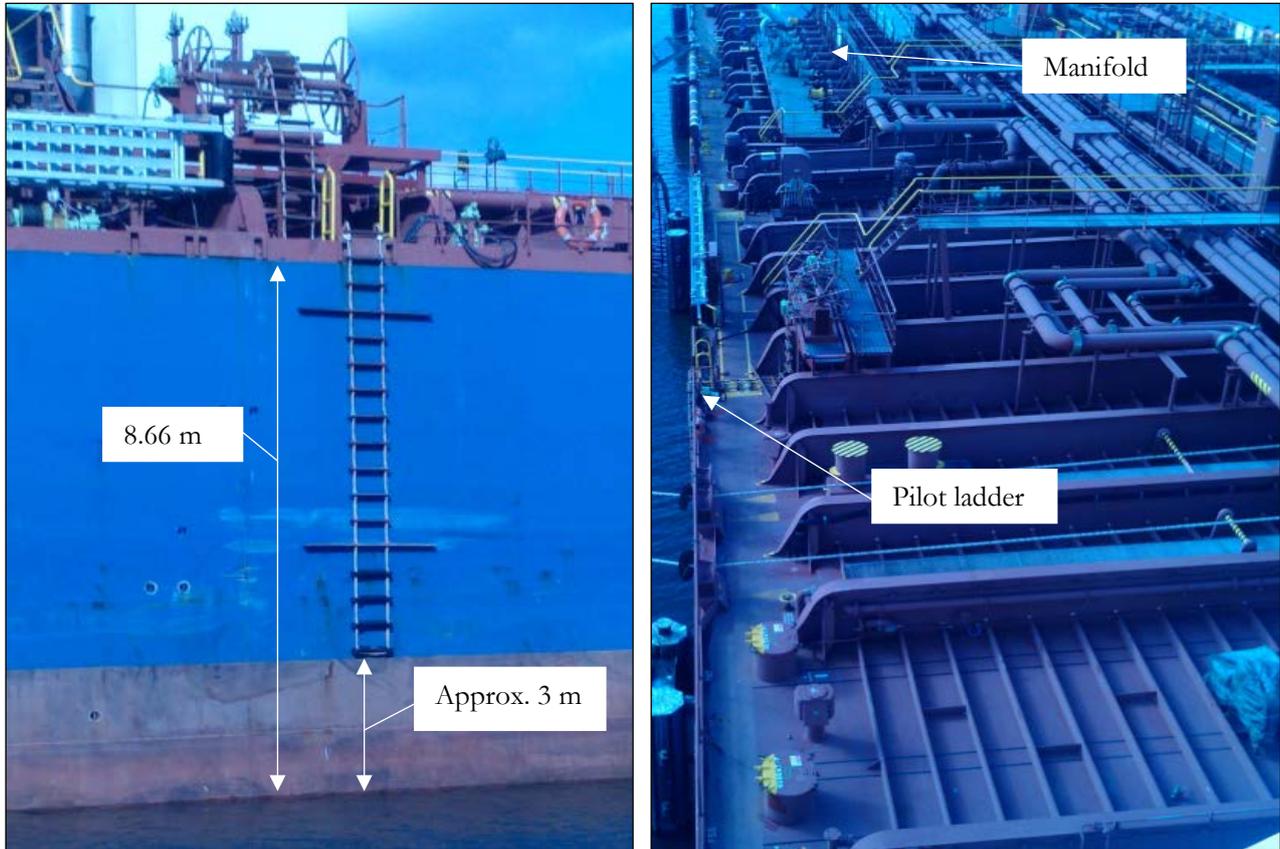
The ship's boarding arrangement, consisting of a hoistable accommodation ladder and a pilot ladder on each side, was placed aft of the manifold (figure 6). The arrangement used for personnel transfer complied with IMO's recommendation⁵, which prescribed the use of a combination of an accommodation ladder and a pilot ladder when the ship's freeboard exceeded 9 m, and a pilot ladder only if the freeboard was less than 9 m. The ship's pilot ladders were of an approved and certified type, and the ladder used on the day of the accident was intact and had been in use for approx. six months.

On the day of the accident, NORD GARDENIA's freeboard was calculated to be 8.66 m and therefore only the pilot ladder was used, rigged on the starboard side. As per agreement between the pilots and NORD GARDENIA's master, the lowest step of the pilot ladder was approx. 3 m above the waterline. In accordance with the ship's procedures, the chief officer and his team were stand-by at the ladder to supervise the transfer of the two superintendents. Figure 6 below shows a

similar arrangement on NORD GARDENIA, rigged on port side. The freeboard and the ladder's approximate height over the water on the day of the accident are indicated on the photo. When the accident happened, it was dark but the transfer area was well lit by flood lights, located on board NORD GARDENIA and, in addition, by a search light on SKAWLINK III.

Figure 6: NORD GARDENIA, pilot ladder arrangement. Left: View from port side.

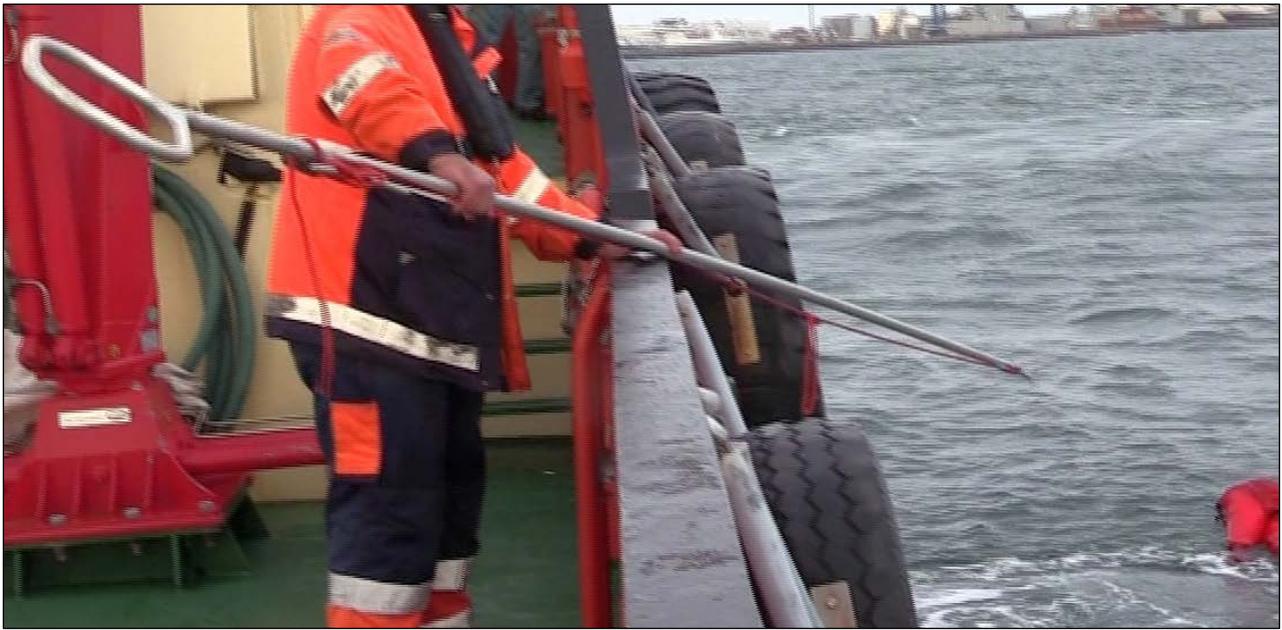
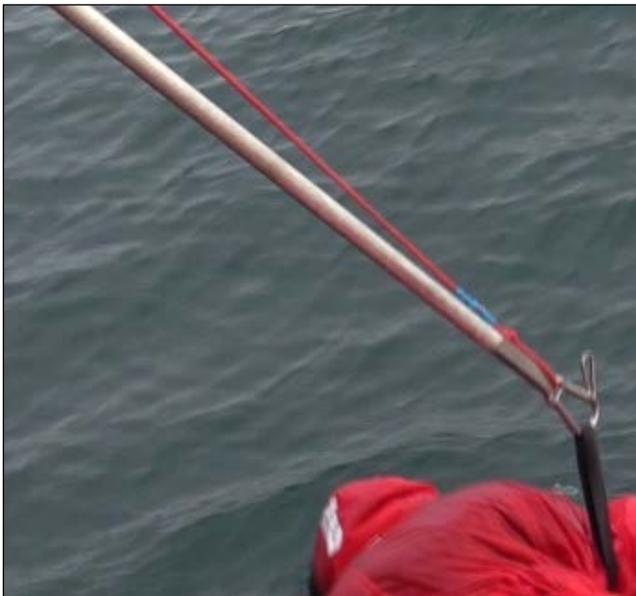
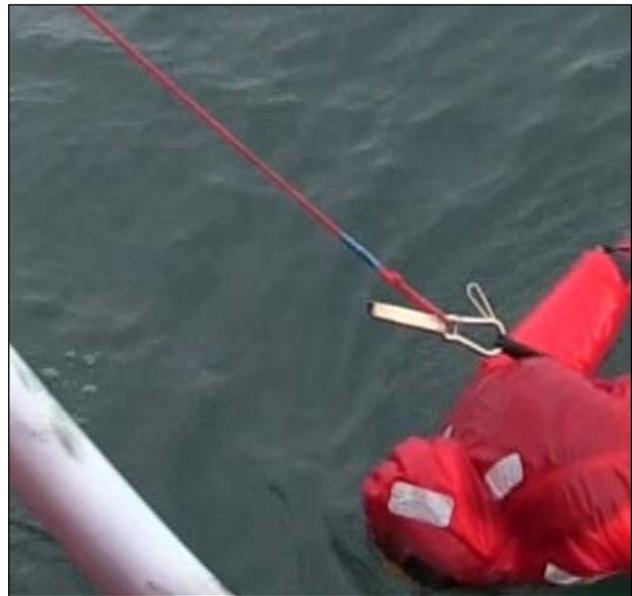
The contingency strategy for recovering a person from the water was that the mate would locate and observe the person in the water while the master manoeuvred the ship. When the person was within reach, the mate would get a hold of the person by means of either the boat hook or the rescue sling. Both crewmembers would then recover the person by hooking the line from the rescue gear to the ship’s boom and hoisting the person back on board.

Although not a part of the written procedures, it was common practice to hold man-over-board drills at least once a month. Typically these drills would include a 100 kg dummy being dropped overboard and recovered by means of the ships’ emergency equipment; rescue sling, boathooks and rescue boom or crane. Figure 8 below shows the principle of using the custom-made boathook to recover a person.

Figure 8: Demonstration of the use of the specialised boathook.

A heaving line is attached to a clamp at one end of the boathook and is fixed to a detachable karabiner at the other end. The length of the boathook allows the mate to attach the heaving line to the person in the water from a distance. The boathook is then withdrawn, leaving the karabiner and line attached to the person. The heaving line is then used to recover the person.
