Danish Maritime Accident
Investigation Board

MARINE ACCIDENT REPORT

SELANDIA SWAN
Fall overboard on 23 July 2015

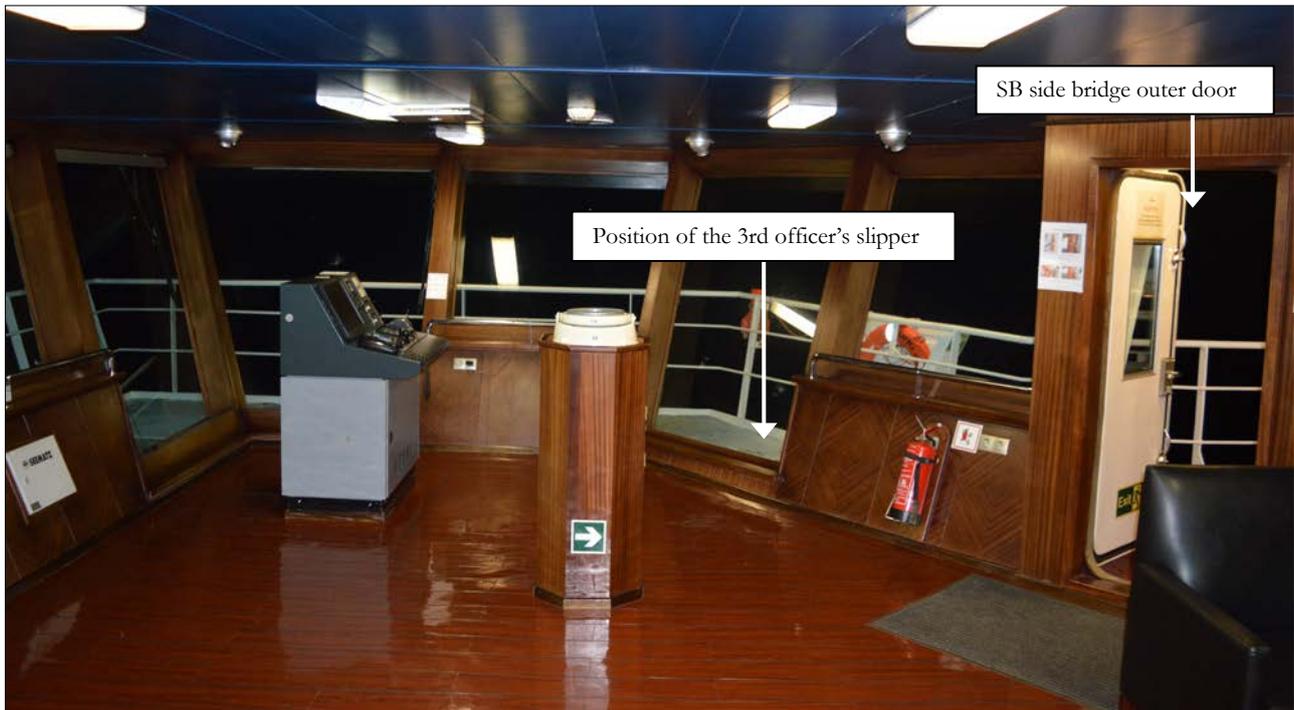
Figure 3: Picture of the starboard side bridge wing
Source: DMAIB

SELANDIA SWAN's navigation bridge had closed bridge wings with outer doors on each side facing aftwards. In the picture below (figure 3) the starboard side bridge wing can be seen from where the AB noticed the open outer door and a slipper lying on the grating. The aim of the investigation of the navigation bridge was to establish the time when the 3rd officer fell overboard and the causal circumstances of the accident.

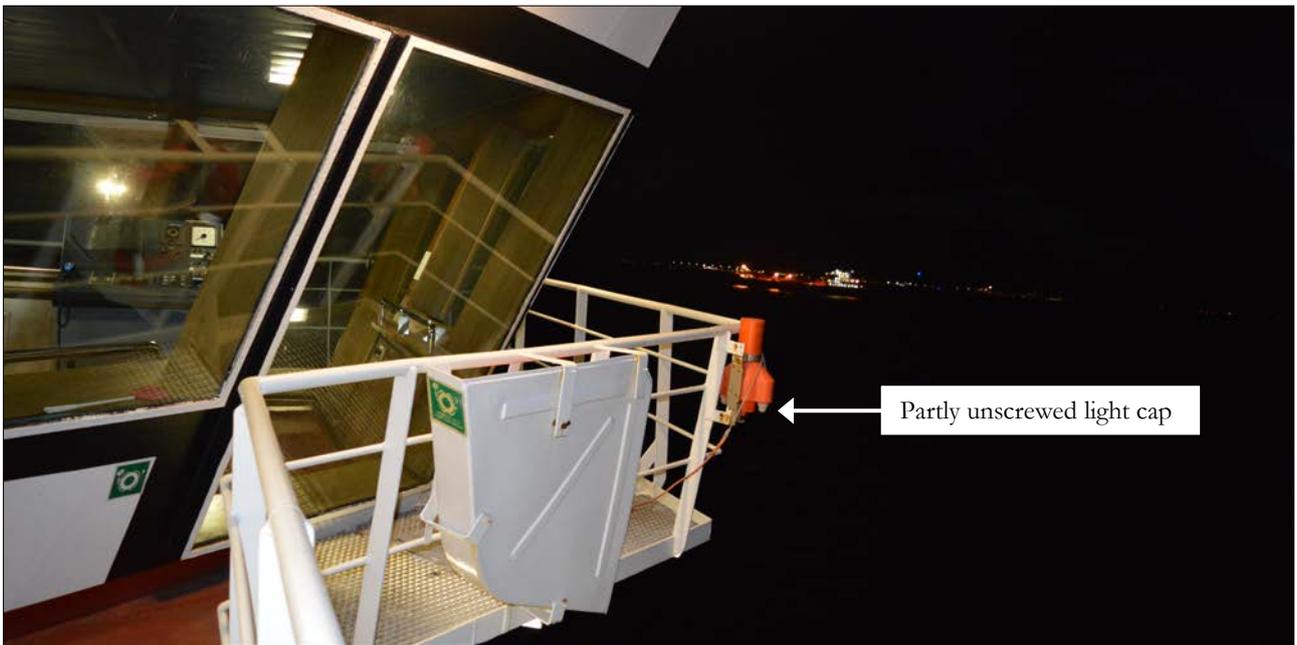
Figure 4: Picture of the starboard side lifebuoy
Source: DMAIB

An investigation of the navigation bridge indicated that the 3rd officer fell overboard while he was inspecting the buoy mounted on the outside of the starboard side bridge wing (figure 4).

This assumption was based on the fact that a slipper belonging to the 3rd officer was found by the starboard side lifebuoy, and there were indications that the 3rd officer was in the process of inspecting and dismantling the light caps from the lifebuoys (figure 4) on each side of the navigation bridge.

The slipper that was found on the grating by the starboard side lifebuoy was identified as belonging to the 3rd officer. The other slipper was not found.

The light cap on the starboard side lifebuoy was found to be partly unscrewed (figure 4).

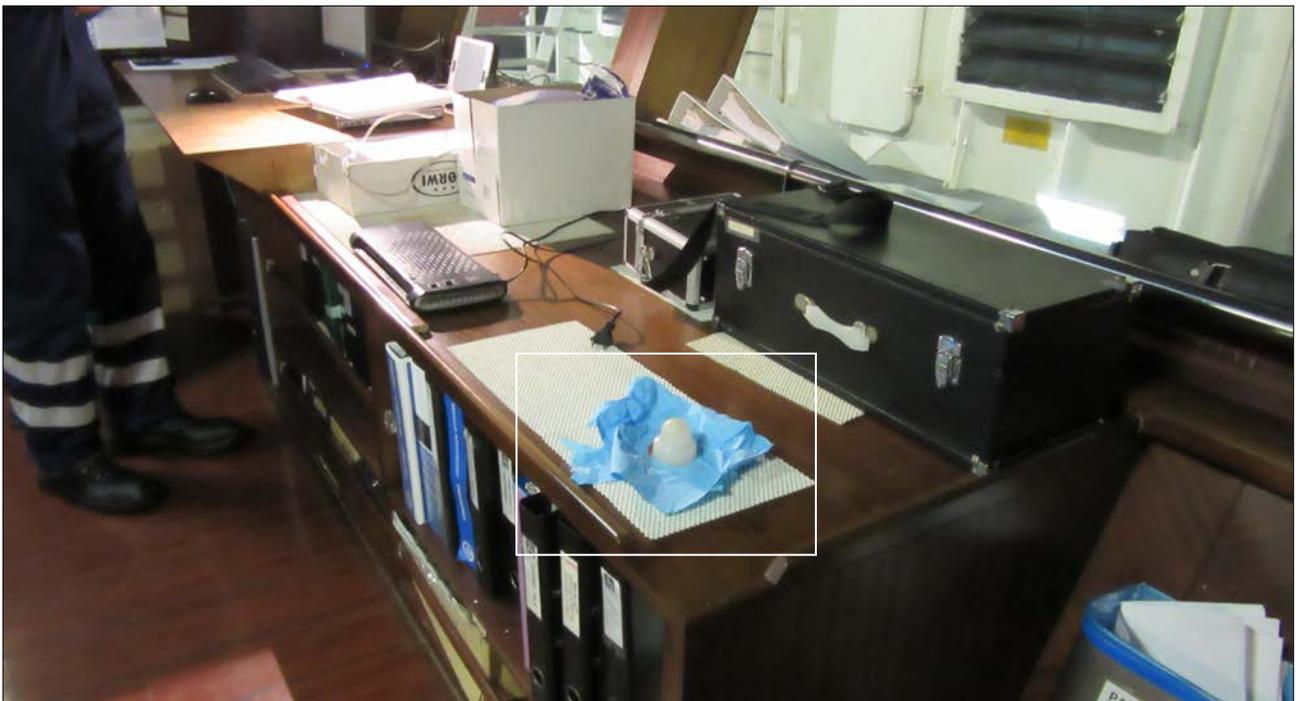
Figure 5: Picture of the light cap as it was found on the chart table
Source: DMAIB

One of the light caps and two O-rings from the port side lifebuoy were found on the chart table on the port side of the bridge (figure 5). The light bulb was found mounted on the smoke signal and showed no sign of being defective.

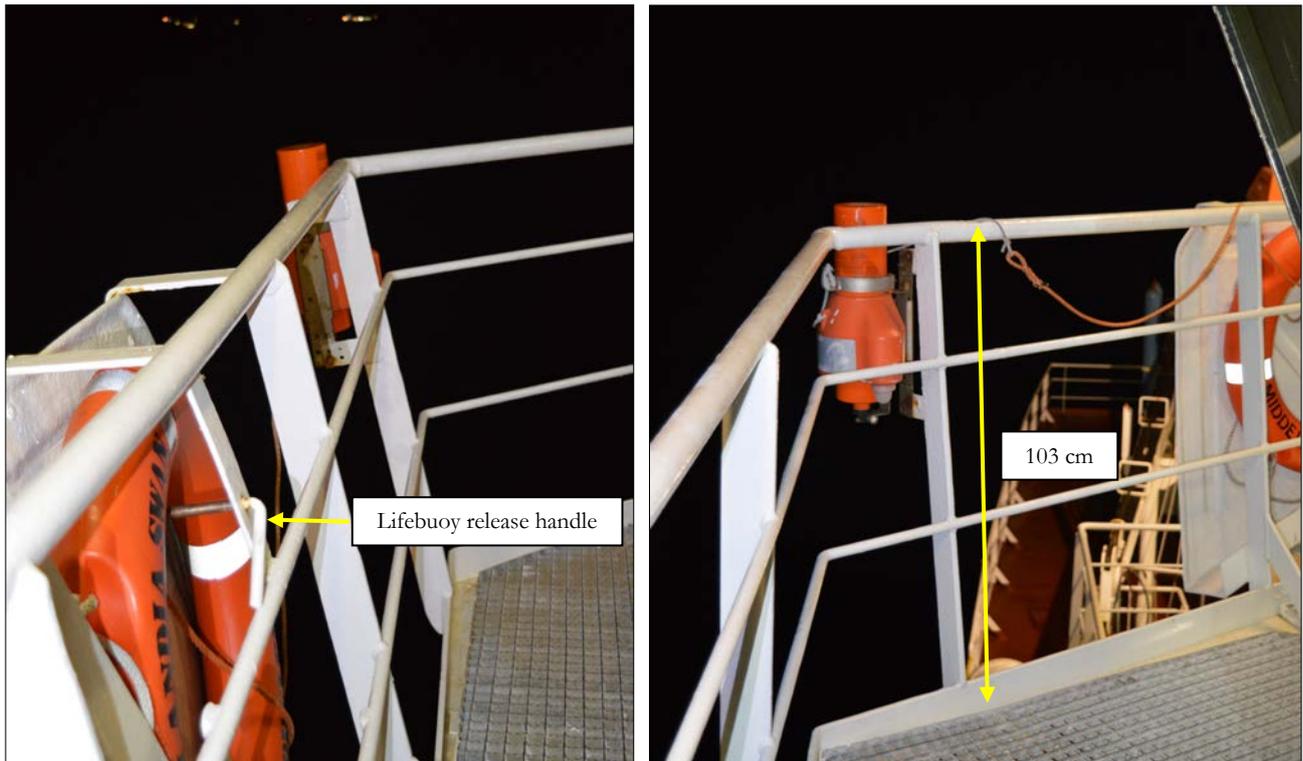
Figure 6: Overview of the workplace
Source: DMAIB

On the starboard side, where the 3rd officer's slipper was found, the guard rail was 103 cm in height with two intermediate bars with between 20 and 30 cm clear width. The buoy was mounted on a steel bracket by the passageway on the outside of the guard rail stanchion (figure 6), which made it inconvenient to access.

The only way to have a complete view of the lifebuoy was either to lean over the guard rail or to kneel on the grating to have a view between the intermediate bars. It would most likely be considered inexpedient to dismantle the smoke signal from the bracket, because it was difficult for one person to hold the device while removing the locking pin at a risk of dropping the smoke signal overboard.

The 3rd officer was 173 cm tall, which would make it difficult for him to lean over the guard rail without stepping up on the intermediate bar. It is therefore likely that the 3rd officer stepped on the intermediate bar and leaned over the guard rail in order to loosen the light cap with the purpose of inspecting the light. In that process he most likely fell overboard.

In order to release the lifebuoy, a handle is removed (figure 6) which holds the buoy in place. As the buoy is falling out of the holder, the weight of the buoy pulls the locking pin that holds the smoke signal in place. Both the buoy and the smoke signal are then released and fall into the sea.

The accident was therefore not a result of a lack of structural barriers, but rather due to the absence of clear instructions on how to go about inspecting the buoy. In the absence of instruction or guidance, he made a detailed inspection of the only item he could – namely the light. Neither the workplace nor the lifebuoy was designed for maintenance work. In order to carry out that inspection he had to climb the guard rail, thereby exposing himself to the risk of falling overboard. Presumably, he did not don a harness and fall arrester, because the risk of falling was not apparent to the 3rd officer as he was still behind the guard rail.

- The work descriptions in the maintenance systems will be revised so they are more specific in describing the work tasks during monthly and weekly inspections on components that require visible inspection.
- Two railing extensions have been mounted on the bridge wings thereby making the railing higher.
- The company has decided to limit the number of different types of lifebuoys.
