Danish Maritime Accident
Investigation Board

MARINE ACCIDENT REPORT

UMOE VENTUS
Fire on 23 December 2015

This marine accident report is issued on 19 September 2016.

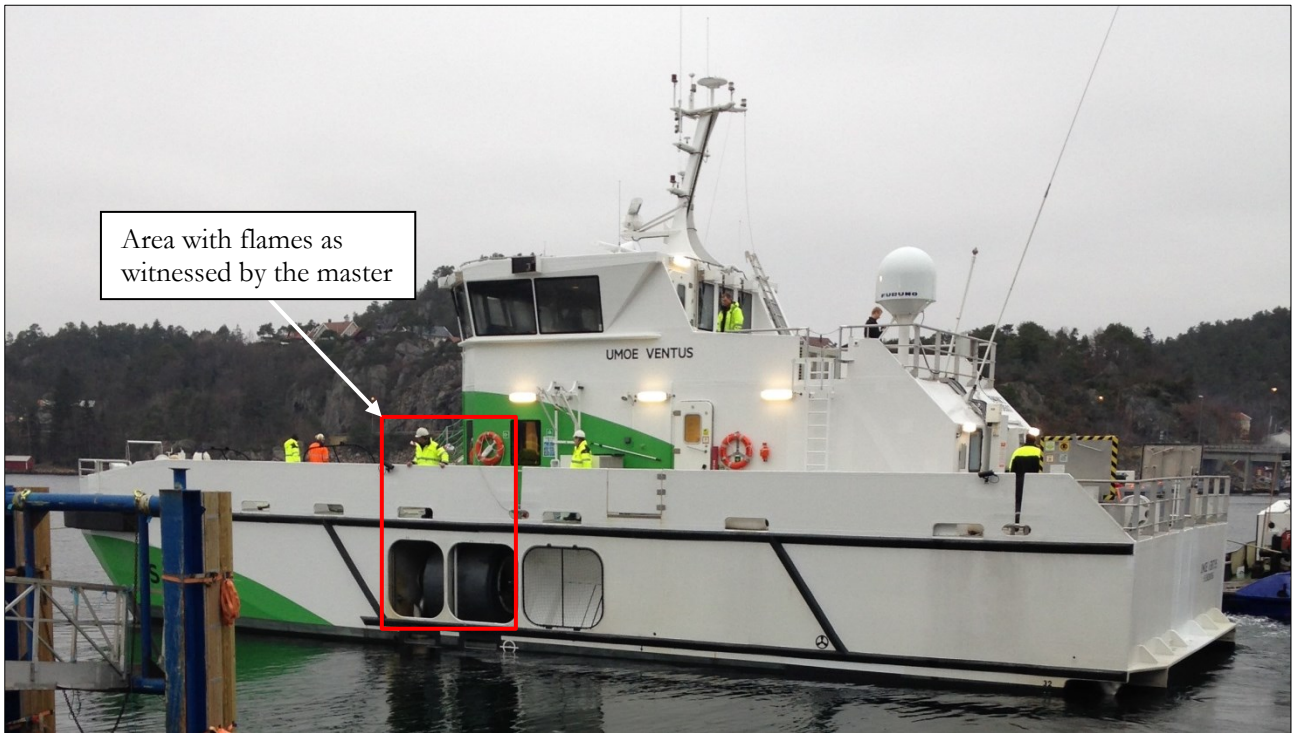
Figure 4: Port side of UMOE VENTUS.

Approximately ten minutes later as the master turned the ship to port and increased the propulsion power, a large cloud of black smoke from the port side engulfed the wheelhouse. The master immediately shut down the propulsion engines, looked out of the windows on the port side of the bridge and saw 1.5 metre high flames above the gunwale on the upper deck (figure 4). Shortly after the flames were observed, a fire detector alarm sounded from within the accommodation.

The crew had initially seen the flames coming from the fire on the port side from the area of the lift fan compartment (figure 4). The investigation of the wreck therefore focused on this section of the craft. The port side lift fan compartment was found completely destroyed by the fire. The starboard side lift fan compartment was structurally partially intact.

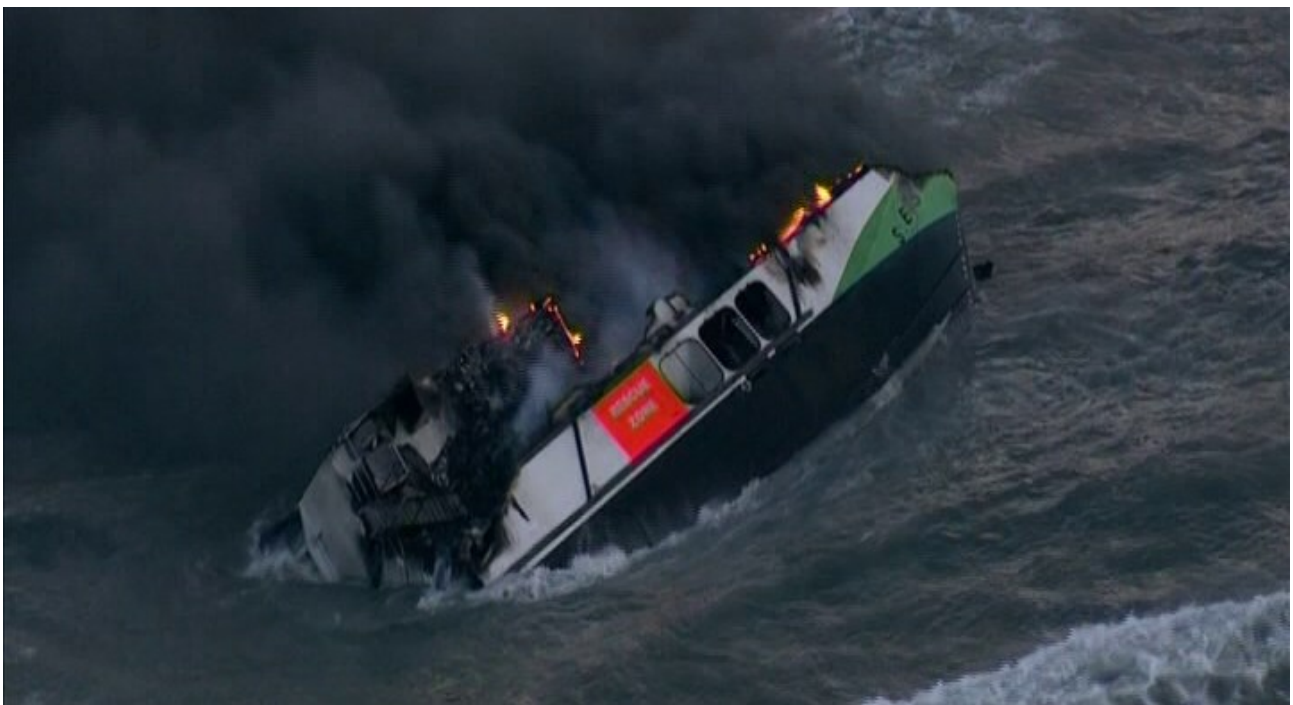
Figure 5: Starboard side of UMOE VENTUS shortly after the grounding
Source: TV2/Danmark A/S

The wreck was located approximately 60 metres from shore and it was therefore not possible for the shore-based fire services to extinguish the fire. The fire was extinguished when the structure of the craft had been damaged to the extent that all buoyancy was lost approximately 12 hours later, and it was almost submerged in the shallow water (figure 5).

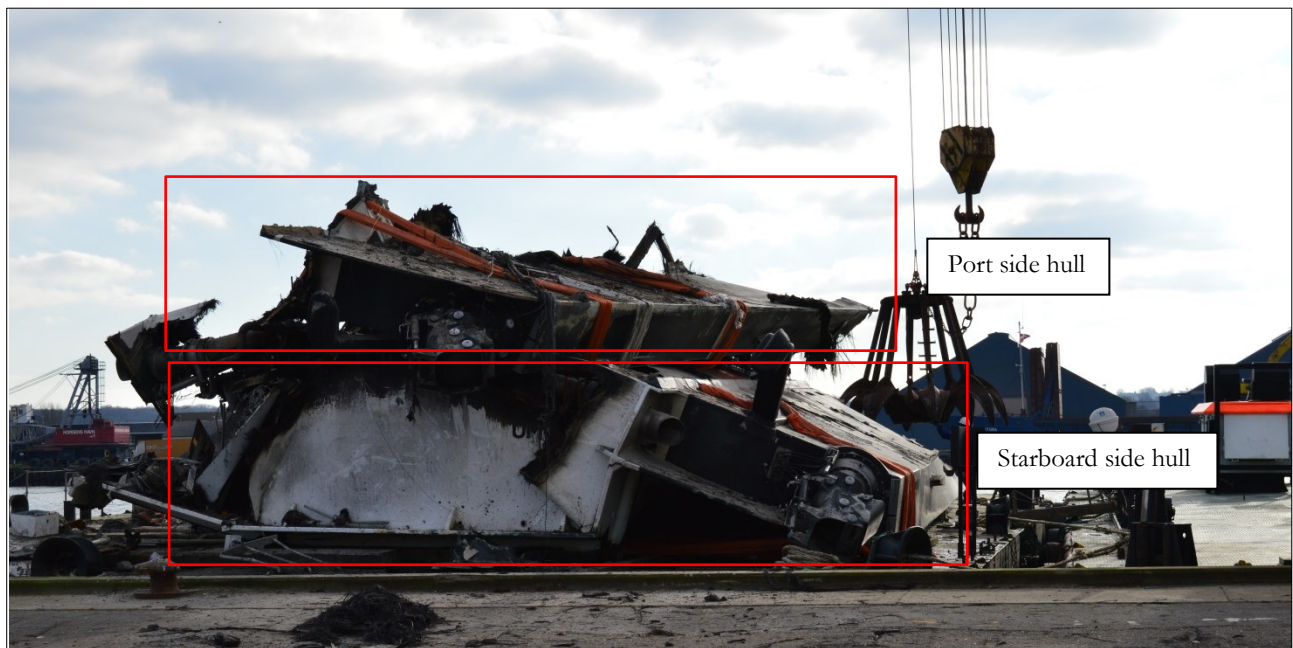
Figure 6: The two hulls of UMOE VENTUS on a barge after having been salvaged
Source: DMAIB

On 17 February 2016, the wreck of UMOE VENTUS was salvaged in several pieces. About half of the craft was salvaged as smaller pieces of debris. The wreck was brought to the port of Horsens, Denmark, on 23 February 2016 where an investigation of the wreck was conducted. It was apparent that the fire and the exposure to the sea had caused a complete structural breakdown of the craft. The fire had destroyed the accommodation, the main deck and most of the port side hull. The starboard side hull had also suffered a structural breakdown, but some sections of the bulwark were still complete. During the salvage, the remains of the port side hull were placed on top of the starboard side hull (figure 6).

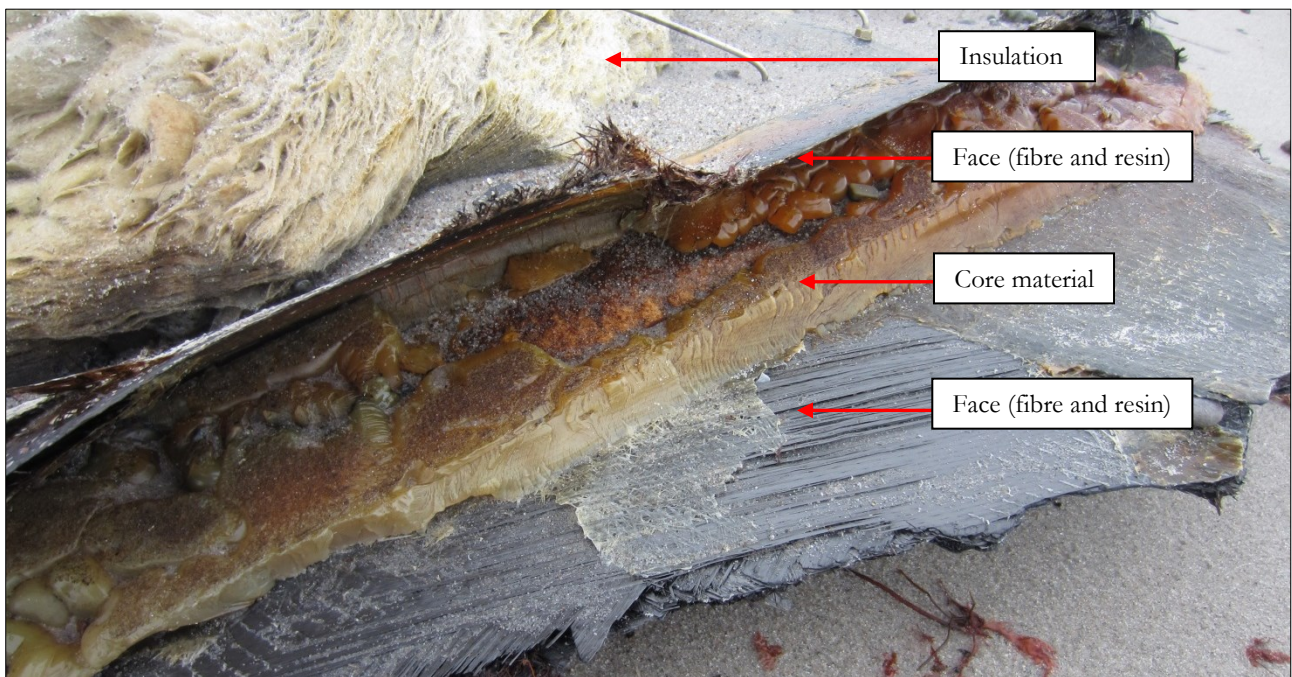
Figure 10: Section of bulkhead from the wreck of UMOE VENTUS found on the beach north of Bagenkop
Source: DMAIB

Figure 10 below is a photo of a bulkhead from the wreck of UMOE VENTUS. The photo shows the sandwich construction with the face and core material. On the upper part of the photo the remains of the fire resistant insulation can be seen.

The photo shows that the core material has been exposed to heat and is partly melted, thereby deteriorating the structural strength and integrity of the sandwich construction.

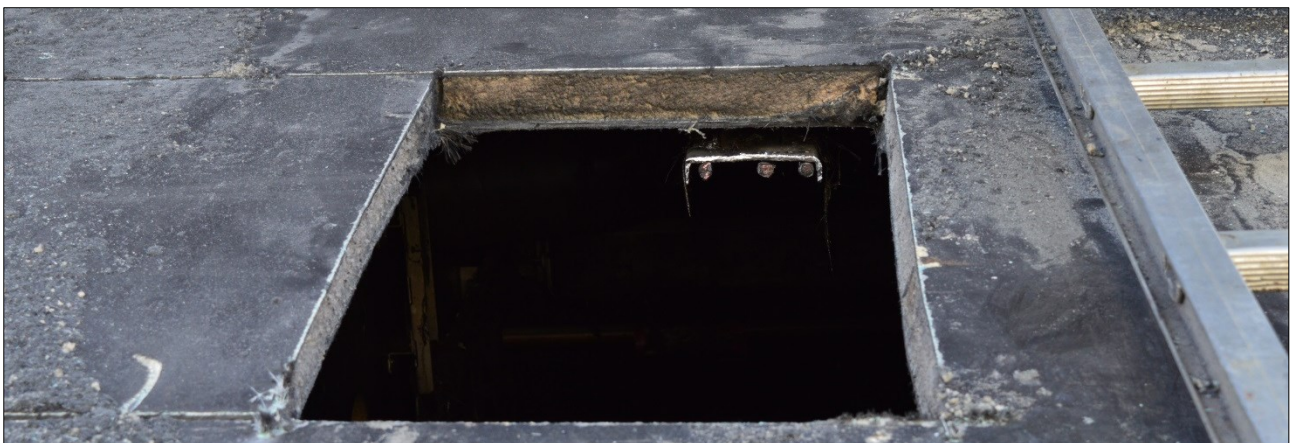
Figure 15: Core of bulwark from the wreck of UMOE VENTUS

The sandwich composites used in UMOE VENTUS consisted of the foam cored type with a range of different foam core densities and fibre reinforced polymer face sheet configurations at different locations in the vessel, as shown in figure 14 (cellular or balsa) and as seen in the picture below (figure 15) from the wreck of UMOE VENTUS.

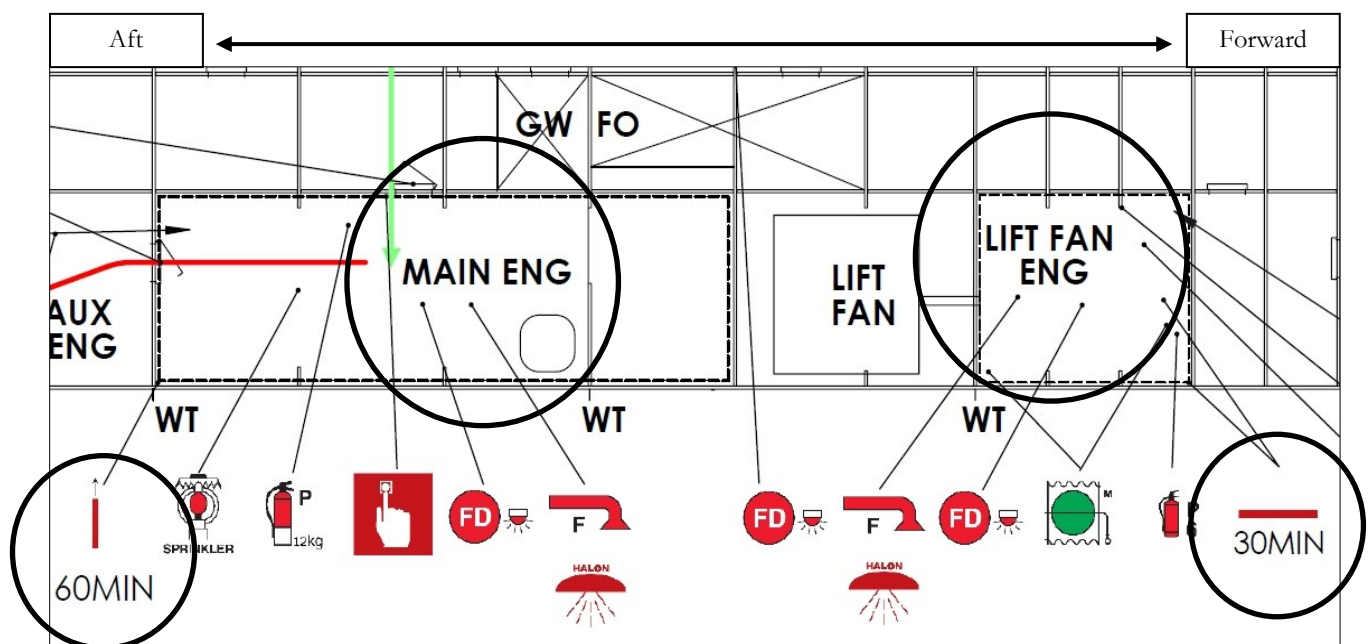
Figure 16: Extract from fire and safety plan UMOE VENTUS

Several compartments in the craft were fitted with structural fire protection, i.e. some of the bulkheads and decks were insulated to ensure that energy (heat) from the fire could be contained for a certain period of time. The lift fan engine compartment was insulated to an A30² standard and the propulsion engine compartment was insulated to an A60 standard, as it can be seen on the below extract from the craft's fire and safety plan (figure 16). The semi-open lift fan compartment was not fitted with any structural fire protection.

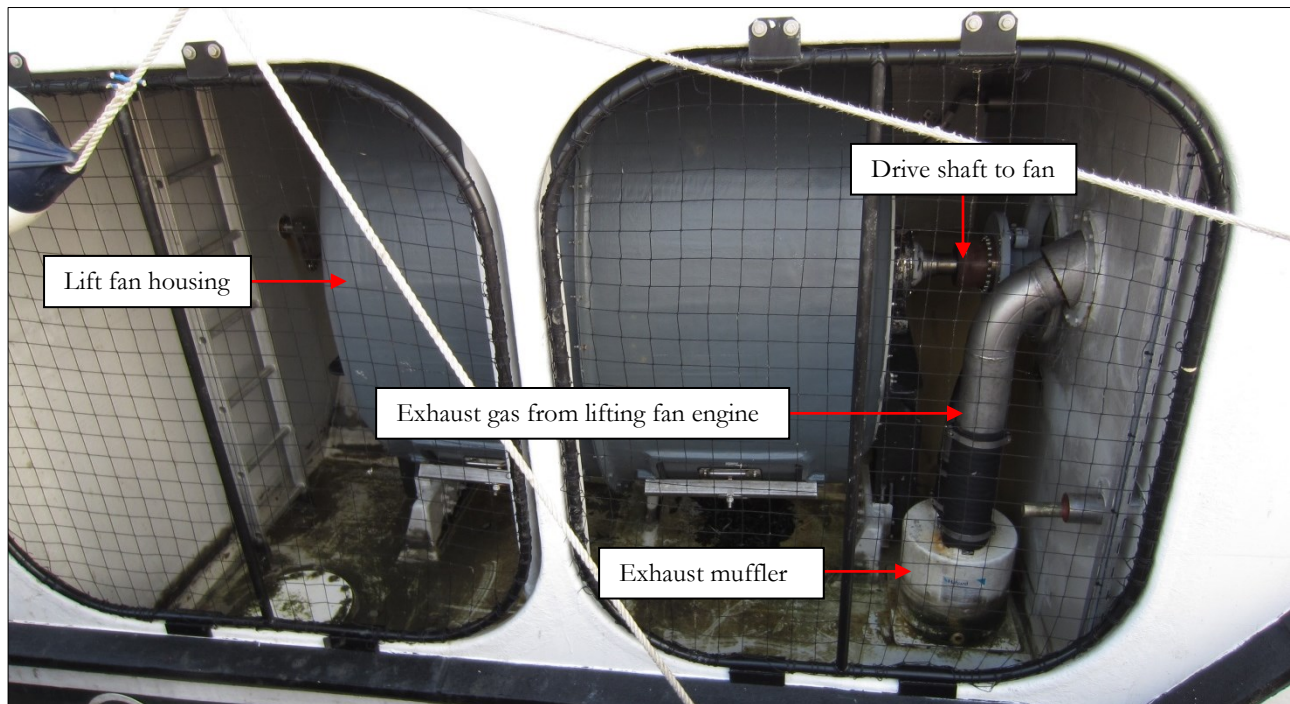
Figure 17: Picture of starboard side lifting fan compartment on UMOE VENTUS
Source: Private photo

It is unlikely that the fire started within one of the adjacent engine compartments and burned for a prolonged period, while all the fire detectors in the rooms malfunctioned, and broke out through the bulkhead without the crew noticing. It is, however, more likely that the fire originated from the lift fan compartment itself, which was not equipped with a fire detection system.

In figure 17 below is a photo of the starboard side lift fan compartment, which was similar to the port side compartment. Inside the compartment there were four components: the lift fan

There were indications that the fire originated from the exhaust gas system because there were several alarms on the cooling water system while the craft was arriving in Bagenkop and upon departure from Bagenkop.

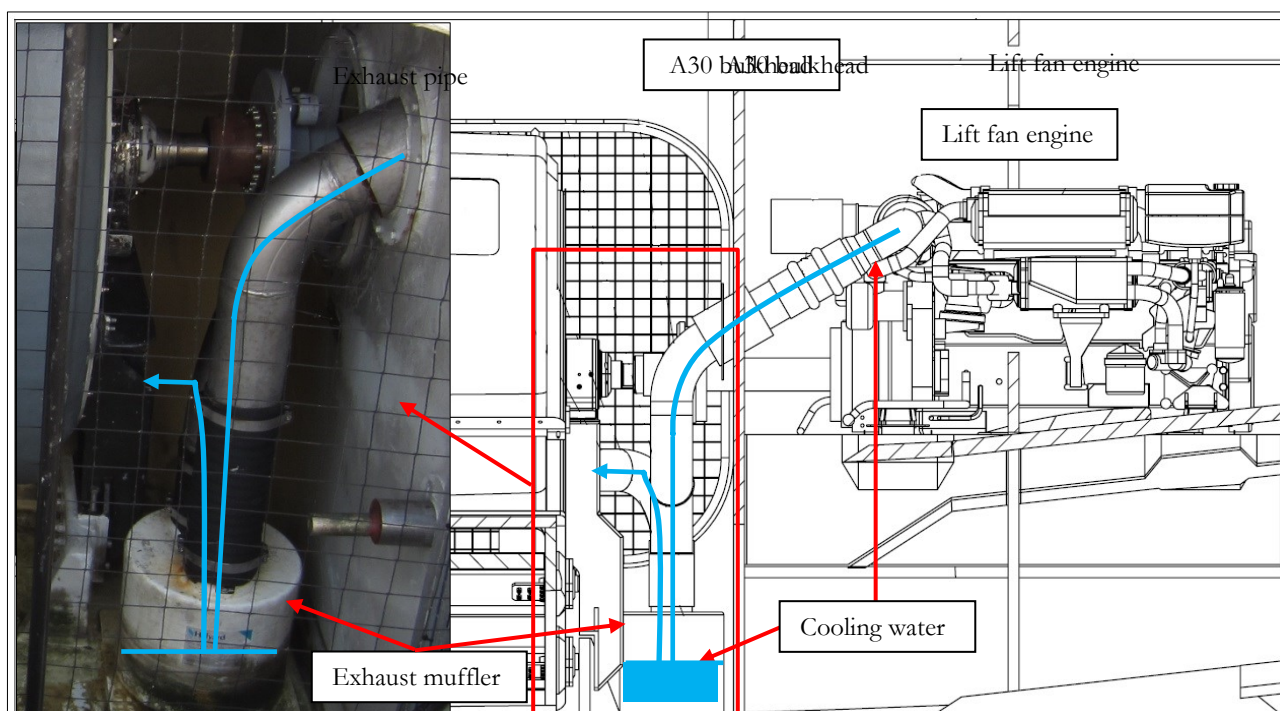
Figure 18: Picture of identical starboard side lifting fan compartment on UMOE VENTUS
Source: Mandal Shipyard, private photo and DMAIB

Figure 18 below shows the layout of the lift fan engine exhaust system. On the right hand side of the layout is the engine, in the centre an A30 bulkhead and on the left is a picture of the exhaust pipe and the exhaust muffler.

During normal operation, the lift fan engine⁴ had an approximate exhaust temperature of 520 °C. The exhaust pipe from the engine was injected with seawater (blue line) from the outlet of the lift fan engine heat exchanger. The exhaust gas and cooling water mixed and flowed down into the exhaust muffler (a lift-type silencer) in which the sound was reduced. From the exhaust muffler approximately 0.4 m³/s of exhaust gas was discharged and mixed with approximately 40 m³/s ambient air and directed into the pressurized cushion.

It has not been possible to determine with certainty what caused the drop in pressure on the seawater cooling system because the fire caused extensive damage to the ship structure and equipment that was spread out on the seabed. The condition of the valves and strainers could not give reliable information about the state of the system at the time of the accident. An investigation of the main seawater pumps did not indicate any significant wear or malfunction that would cause a significant drop in the seawater pressure on the main cooling water system.

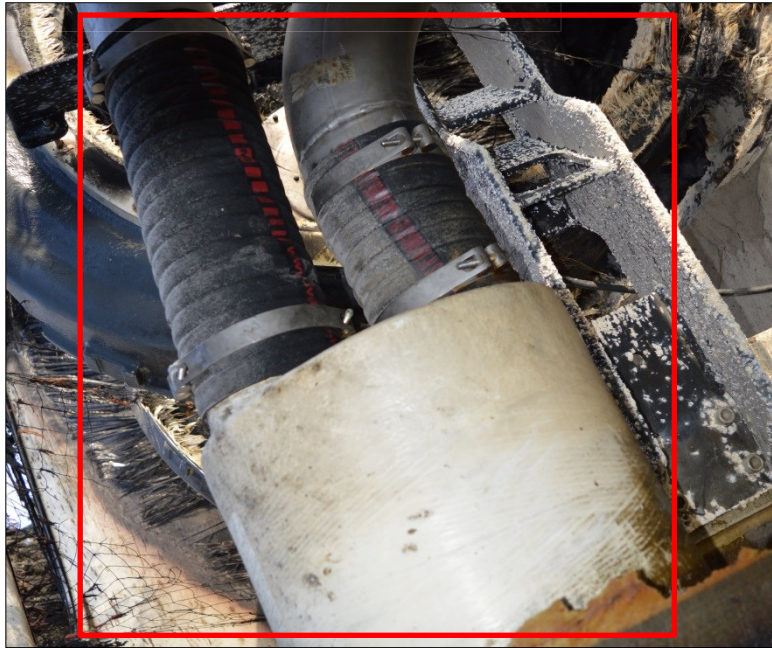
Figure 19: Picture of starboard side exhaust muffler found on the salvaged wreck
Source: DMAIB

The port side lift fan engine cooling water impeller pump would not be able to run for a prolonged period without a water flow before malfunctioning – causing insufficient cooling of the lift fan engine and the exhaust. An investigation into the starboard side lift fan engine showed that it did not experience a loss of cooling water as the exhaust muffler was found to be intact (figure 19).

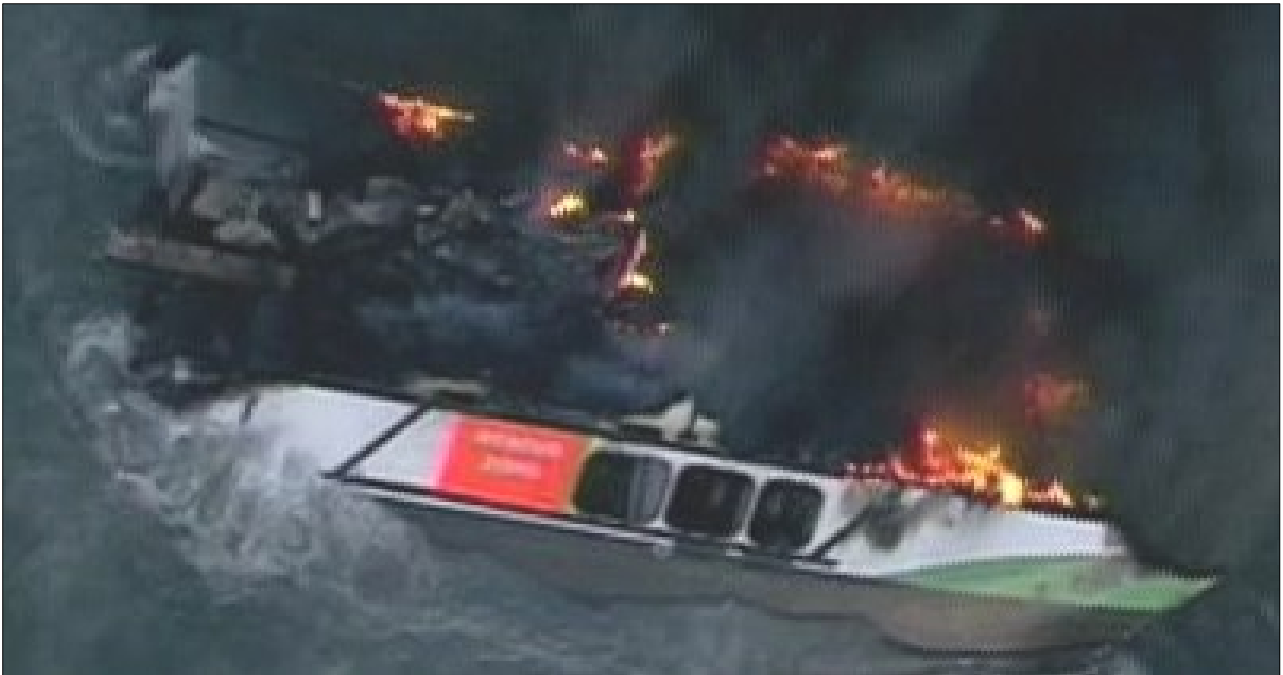
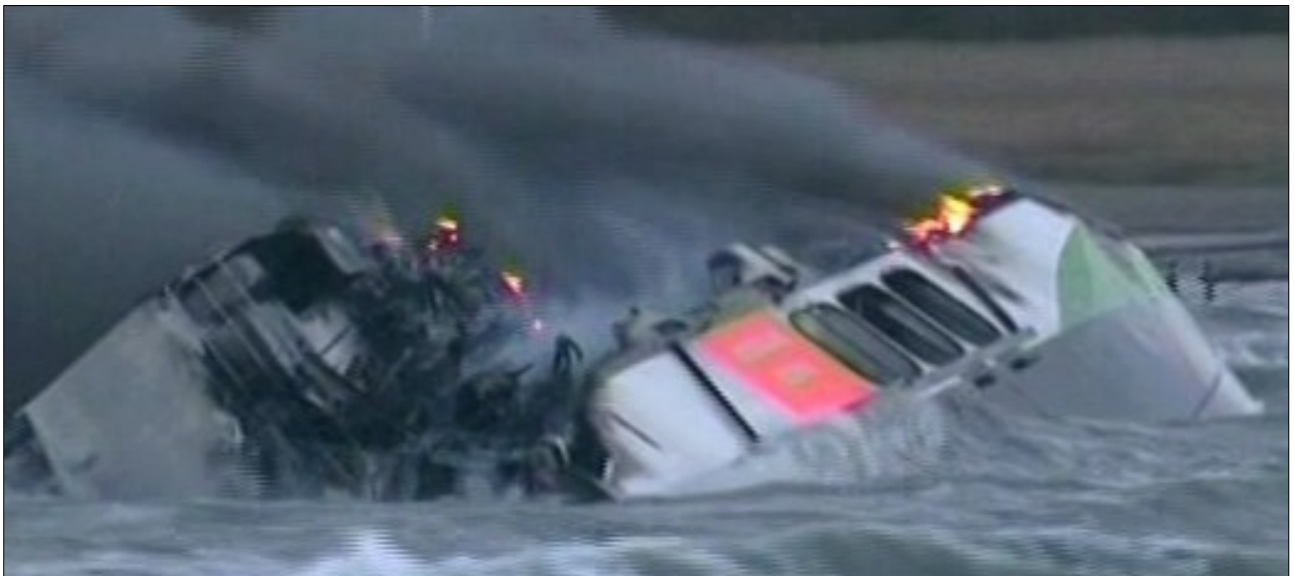
Figures 20 and 21 are aerial photos after UMOE VENTUS had grounded – approximately 3 hours after the fire was discovered by the crew.

From both photos it can be seen that the starboard side outer hull was almost intact. The entire accommodation was destroyed and the centre deck structure between the two hulls had collapsed inwards.

Presumably, the fire spread not only outwards and upwards, but also inwards to the diesel oil tank, which fuelled the fire in the deck area between the hulls and upwards through the passenger salon in the accommodation. The fire in the central deck area weakened the structure to the extent that the craft's two hulls collapsed inwards (figure 21). As the deck area was submerged in the sea, the fire was extinguished except in the two hulls (figure 20).

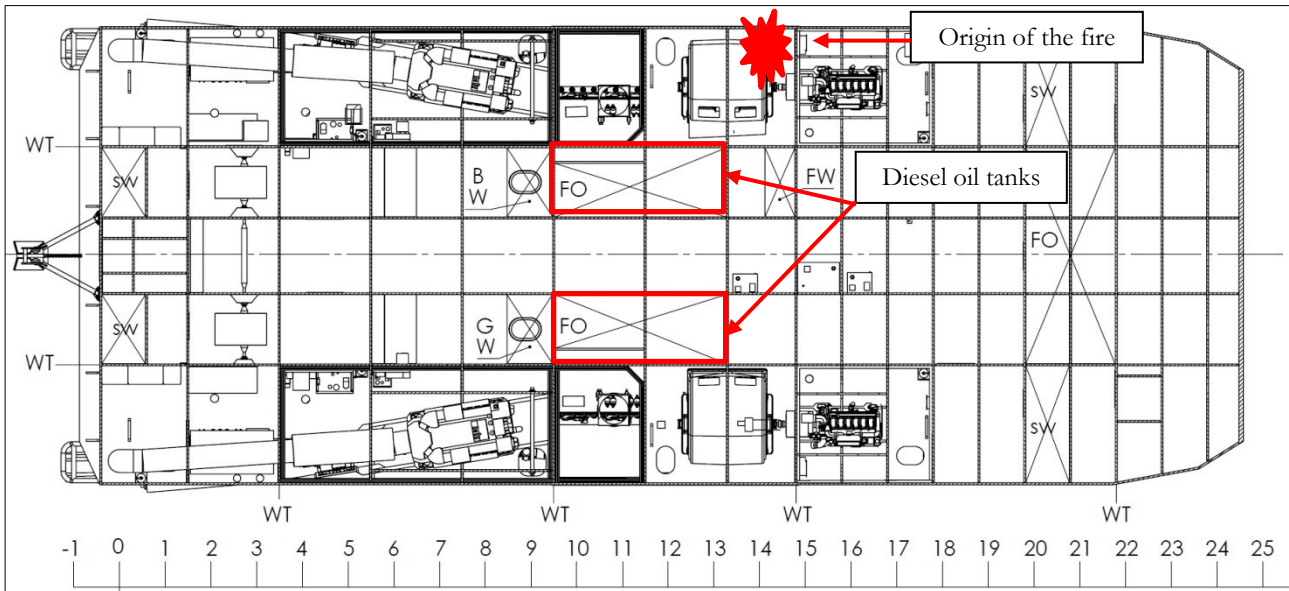
Figure 22: Extract from general arrangement plan UMOE VENTUS
Source: DMAIB and Valling Ship Management

Figure 22 is a general arrangement drawing of UMOE VENTUS seen from above. Two of the craft's three diesel oil tanks were located below the passenger lounge and can be seen just next to the port side lift fan compartment where the fire originated. The diesel oil tanks had been completely destroyed by the fire. The part of the diesel oil tank which was not facing the engine room was protected neither by structural (e.g. insulation) nor by functional (e.g. sprinklers) fire protection. It had been made of the same material as the lift fan compartment and accommodation. There was approximately 5,000 litres of diesel oil on board.
