Danish Maritime Accident
Investigation Board

MARINE ACCIDENT REPORT

DIVER MASTER
Foundering on 4 August 2014

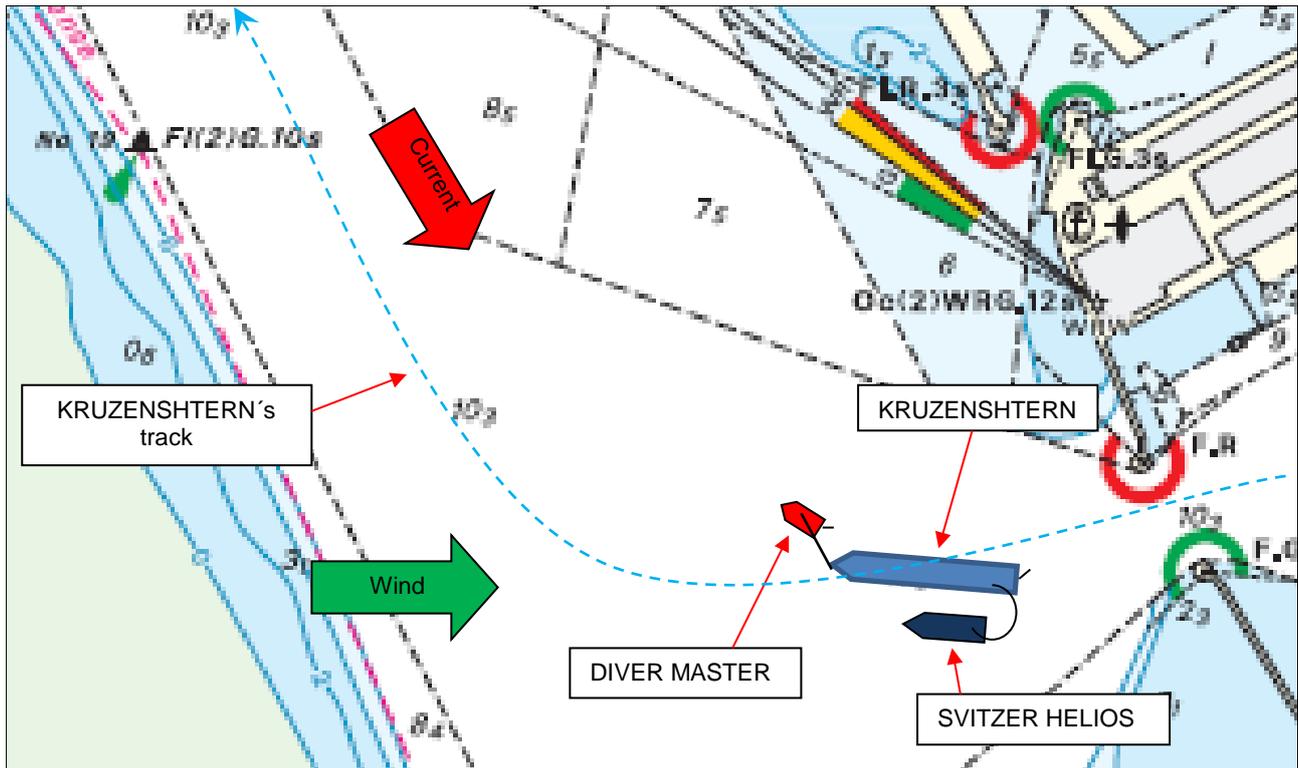
When DIVER MASTER reached the one o'clock position ordered by the pilot, the master quickly became aware that the tug did not behave as he expected (figure 8). KRUZENSHTERN continued on a westerly course at a speed of approx. five knots. The master of DIVER MASTER informed the pilot on board KRUZENSHTERN that he was losing control over the tug as he was now being dragged by KRUZENSHTERN and that the towline needed to be disengaged. The pilot ordered KRUZENSHTERN's engines stopped, and SVITZER HELIOS was released from the stern in order to assist DIVER MASTER.

Figure 8: Situation at 1745 with DIVER MASTER in a one o'clock position
Source: DMAIB

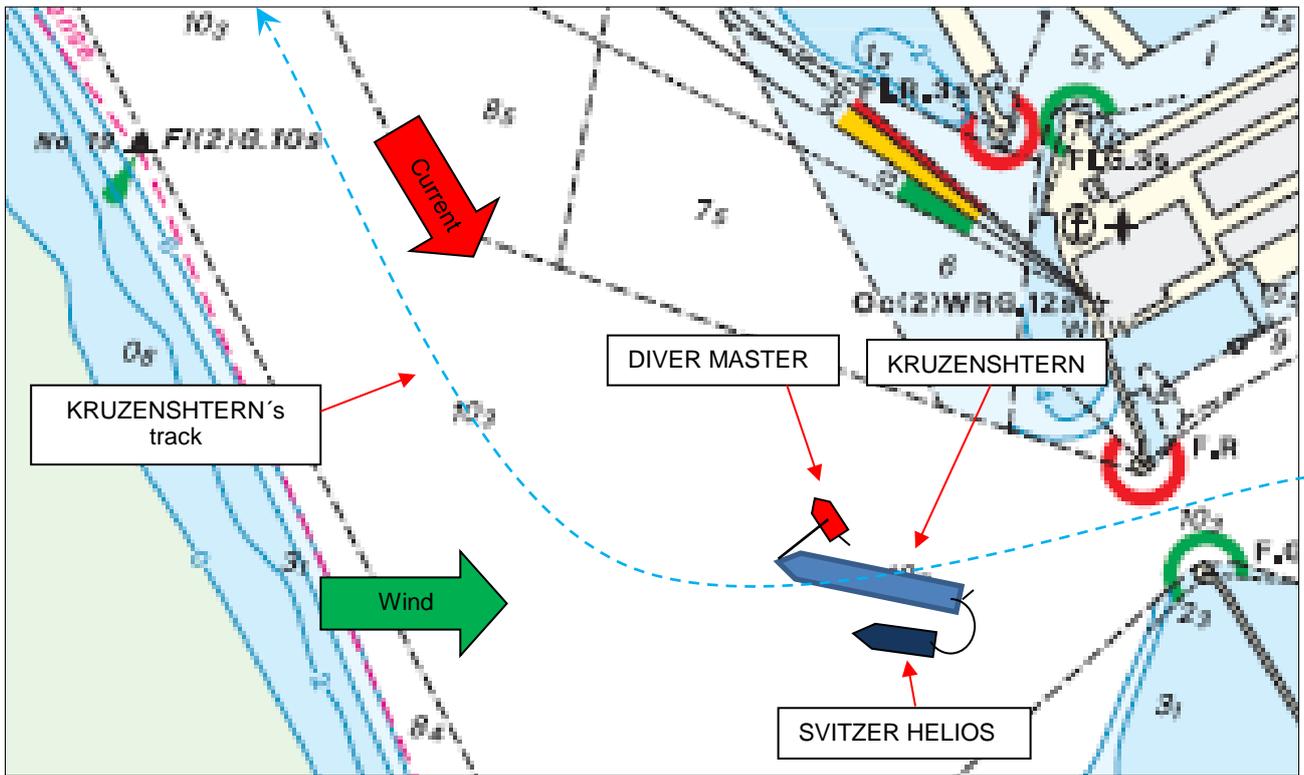
The mate on DIVER MASTER was on deck and attempted to release the towline from the towing hook, but the hook did not disengage. DIVER MASTER was dragged in a half circular motion and, at the same time, turning starboard and heeling to port. The towline assumed an athwart ship's position and ultimately DIVER MASTER swung its stern into KRUZENSHTERN's starboard side, leaving the port side of DIVER MASTER in the sailing direction of KRUZENSHTERN (figures 9, 10 & 11). DIVER MASTER heeled further to its port side and capsized, while being dragged along the side of KRUZENSHTERN (figure 12).

Figure 9: Situation approx. 20 seconds later than shown on figure 8 with DIVER MASTER in a continuing starboard turn while the mate attempted to release the towing line
 Source: DMAIB

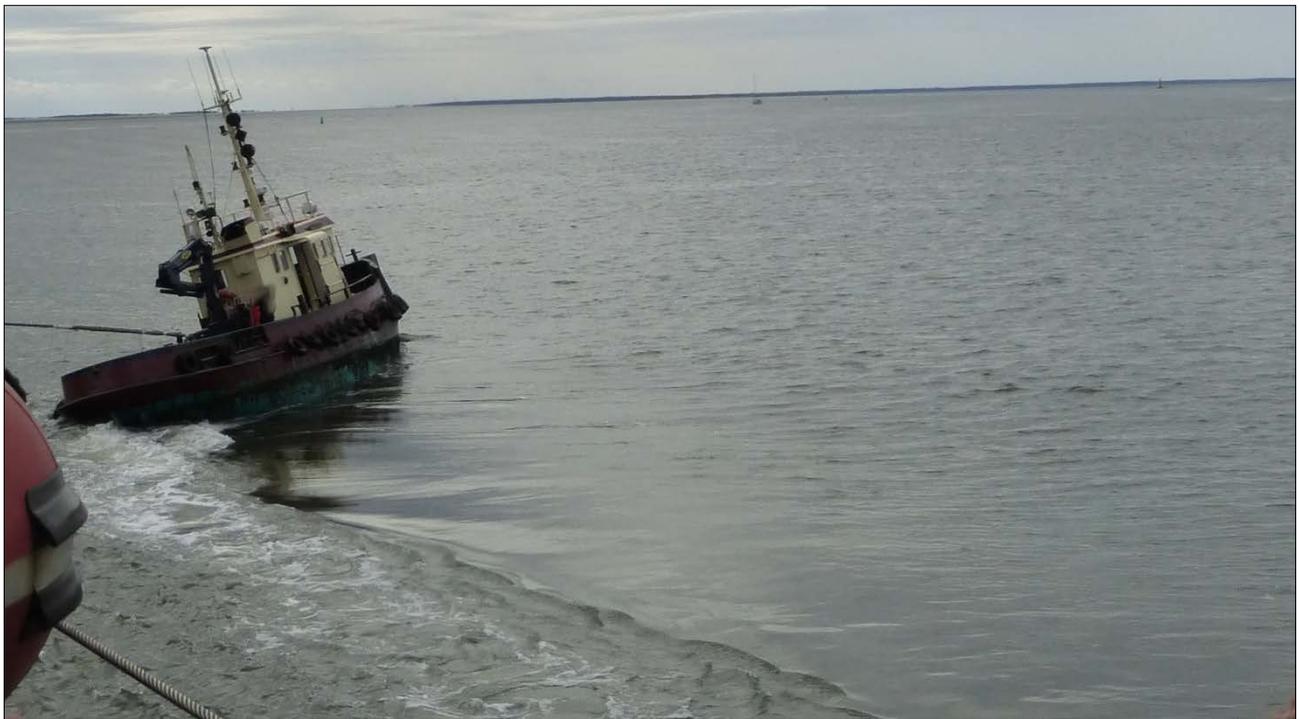
Figure 10: DIVER MASTER heeling over and turning starboard
 Source: DMAIB

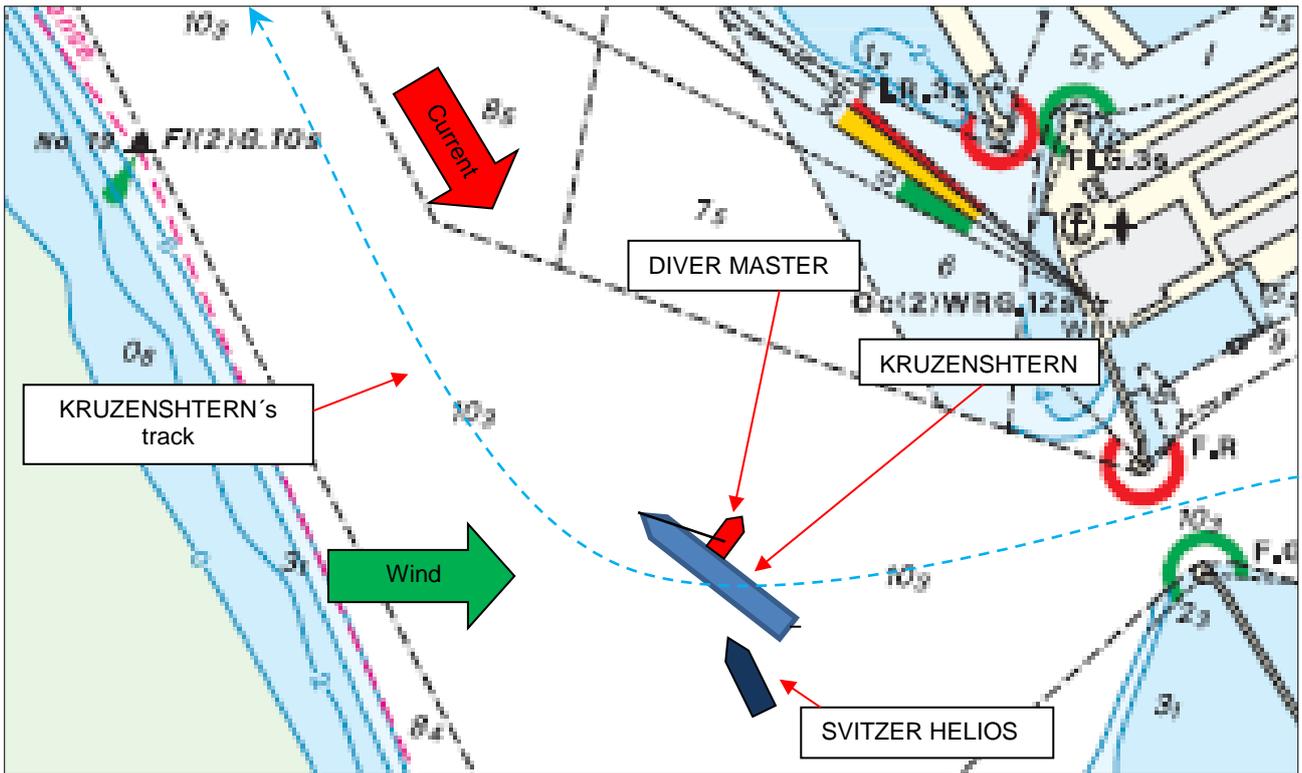
Figure 11: Situation approx. 20 seconds later than shown on figure 8 with DIVER MASTER hitting the side of KRUZENSHTERN with its stern end
 Source: DMAIB

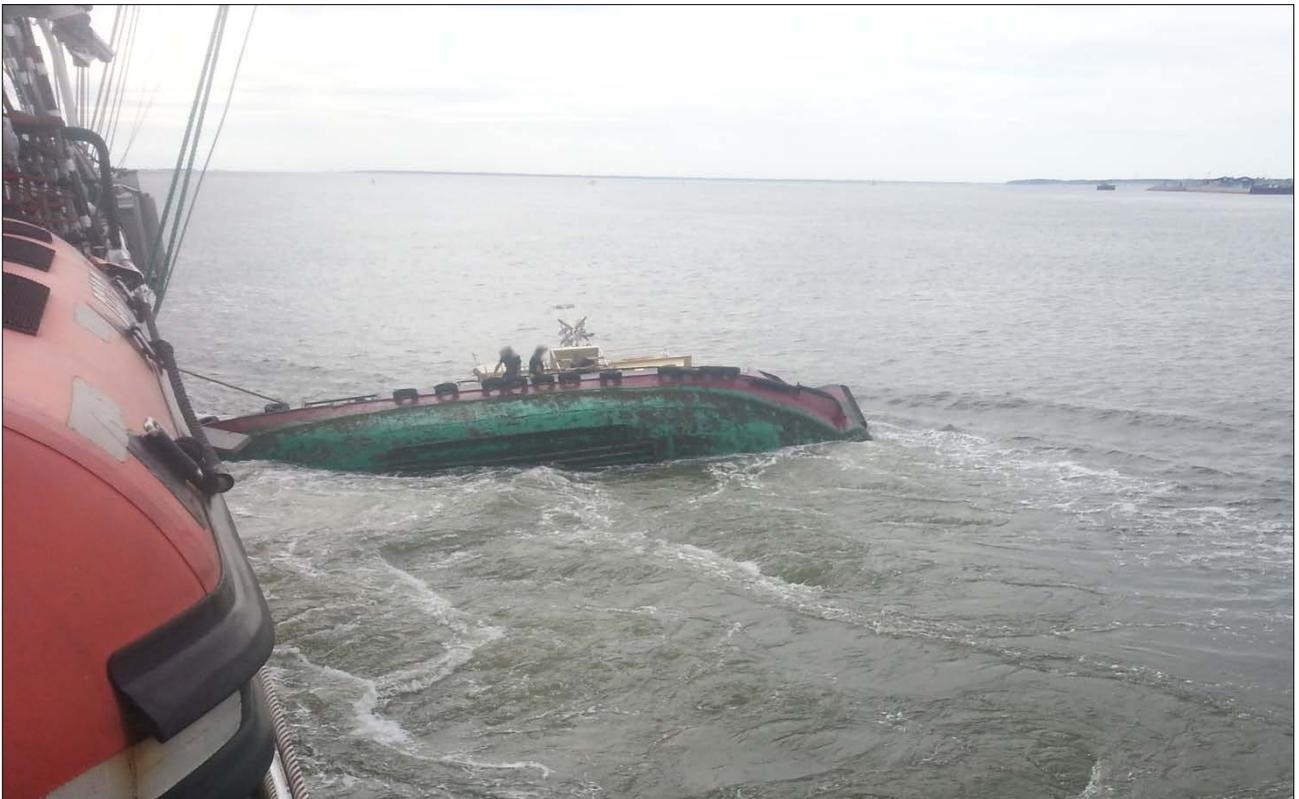
Figure 12: DIVER MASTER capsized and dragged by the side of KRUZENSHTERN
 Source: KRUZENSHTERN

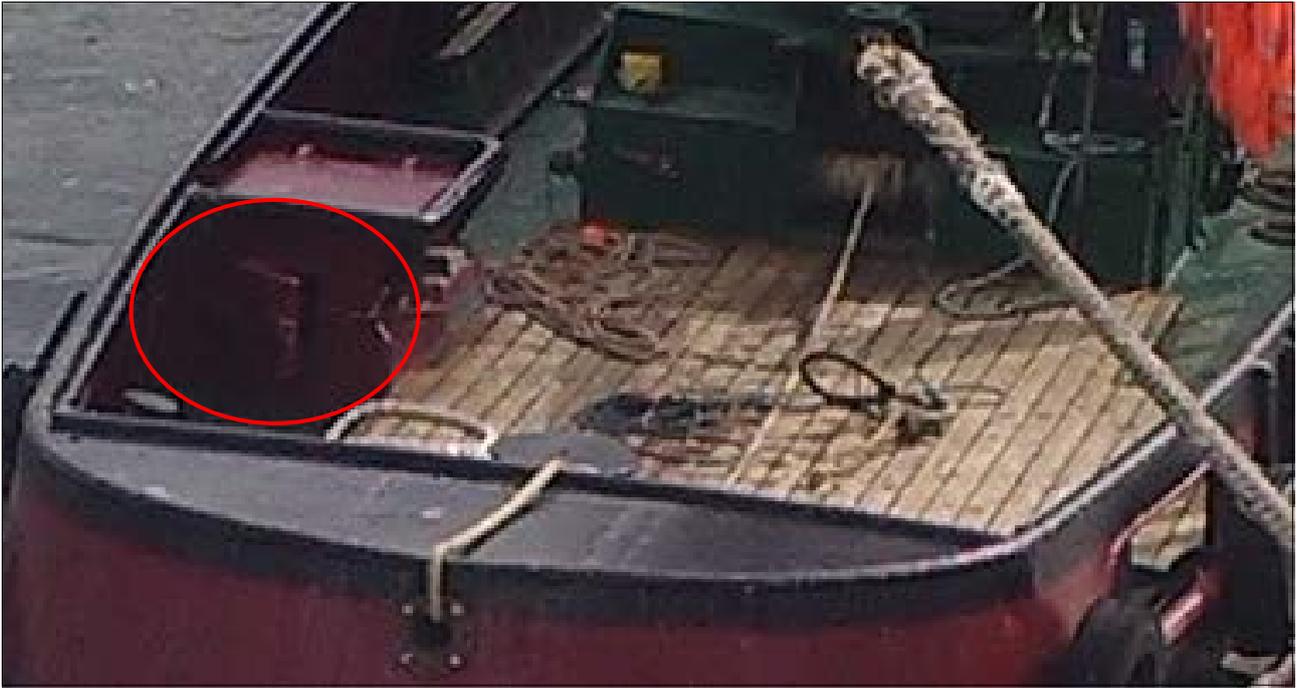
DIVER MASTER had the wheelhouse placed forward of the working deck, where the towing equipment was situated. Entrance to the wheelhouse was via a door on the starboard side of the main deck. There was no door on the port side. In the forward end of the wheelhouse, there was a stairway down to the lower deck where the accommodation and engine room were located. This stairway had an emergency exit leading to the forecastle. A watertight door connected the accommodation in the forward end with the engine room. Aft of the engine room there was a stores room likewise connected to the engine room with a watertight door. From the stores room there was a hatch for stores, also serving as an emergency exit, leading to the port side of the aft main deck. On the main deck level, the hatch coaming had a smaller hatch incorporated on the aft side (figure 16). The smaller hatch was open during the accident as seen in figure 17.

Figure 17: DIVER MASTER aft deck with open hatch encircled during the towing of KRUZENSHTERN
Source: KRUZENSHTERN

DIVER MASTER had a low freeboard and therefore the deck edge was quickly immersed when the ship heeled excessively, causing an immediate loss of stability⁸. Water entered the hull through the open small hatch in the port side of the aft deck, and possibly other openings, causing a further significant reduction in the tug's stability. The entering water quickly flooded the stores room and the engine room, likely through the door between the stores room and the engine room.

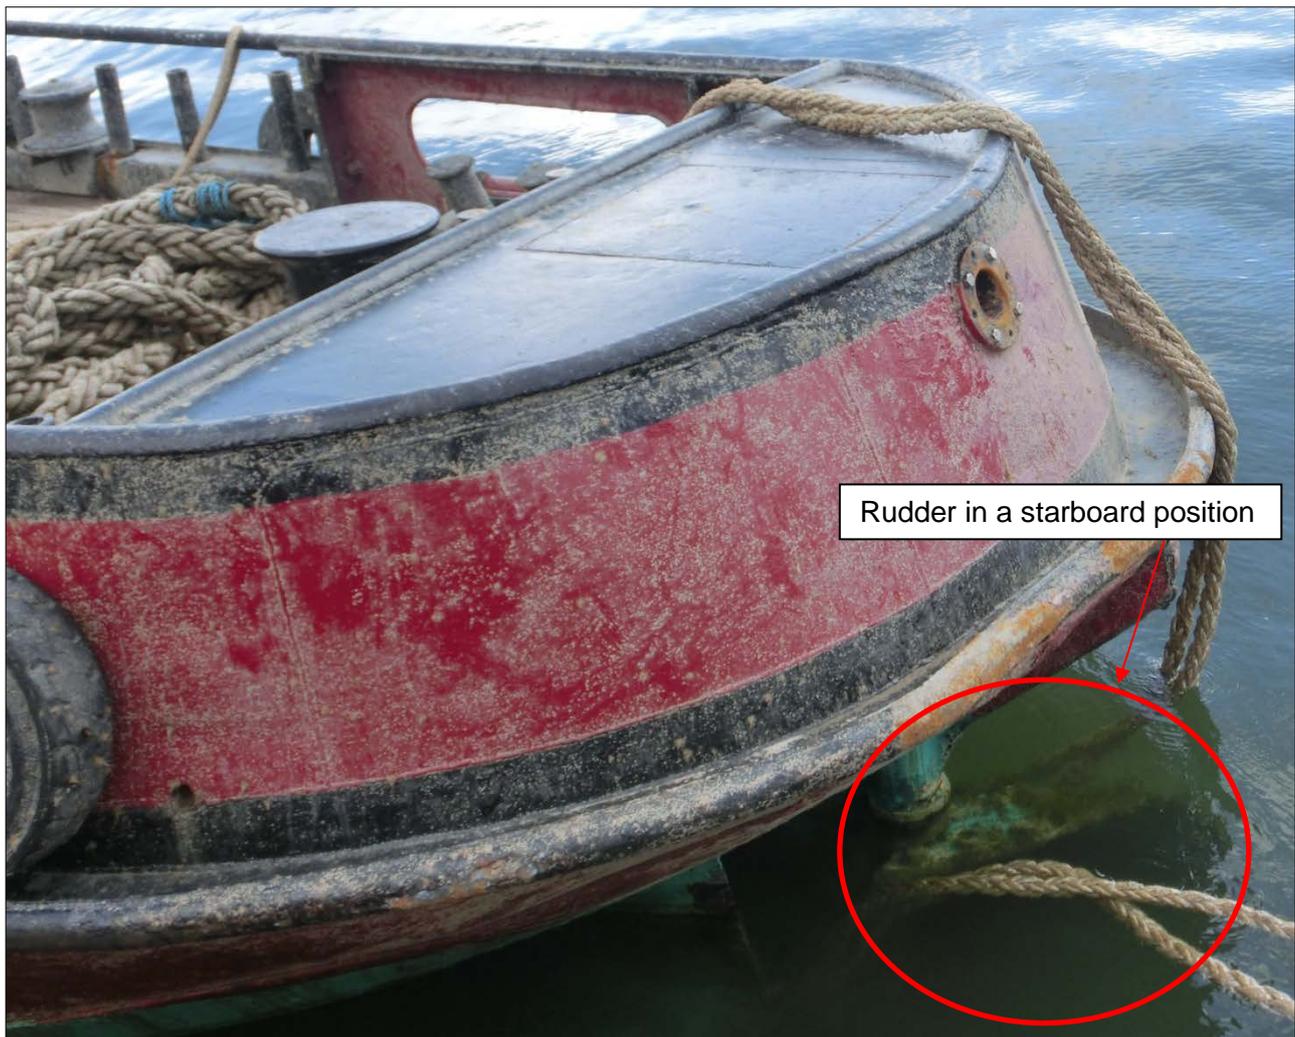
On 17 August 2014, DIVER MASTER was raised from the seabed and brought alongside in the Port of Esbjerg. The rudder position of DIVER MASTER indicated that the ship had been in a starboard turn when the accident occurred (figure 19).

Figure 19: Stern end of DIVER MASTER after the salvage
Source: DMAIB

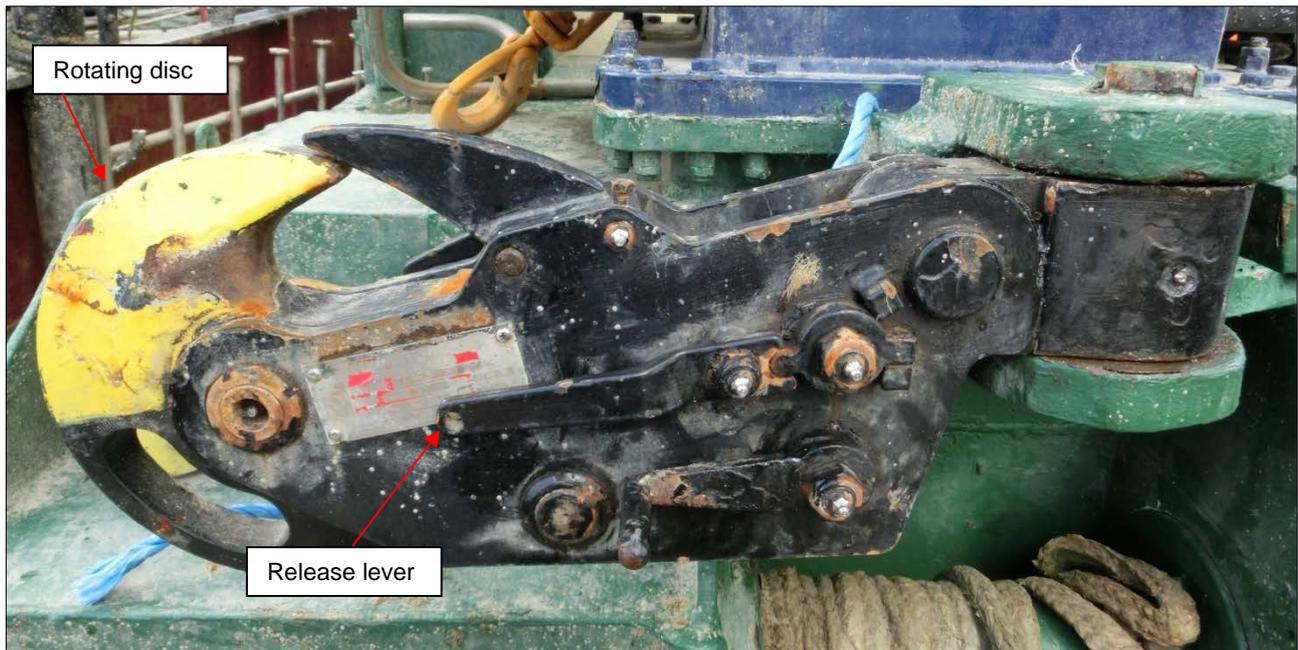
DIVER MASTER was equipped with a quick-release disc-type towing hook (figure 20). This had been fitted to the ship in 2007 when the ship was transferred to the Danish flag, replacing an existing and older towing hook. The towing hook had been tested and certified by the manufacturer to a test load of 14 tons. It had a corresponding safe working load of 7 tons. The towing hook was designed to be easy to operate, even at full safe working load, as release should be possible with a manual effort of less than a force equal to 15 kg².

Figure 20: Towing hook on DIVER MASTER. Picture taken after the salvage
Source: DMAIB

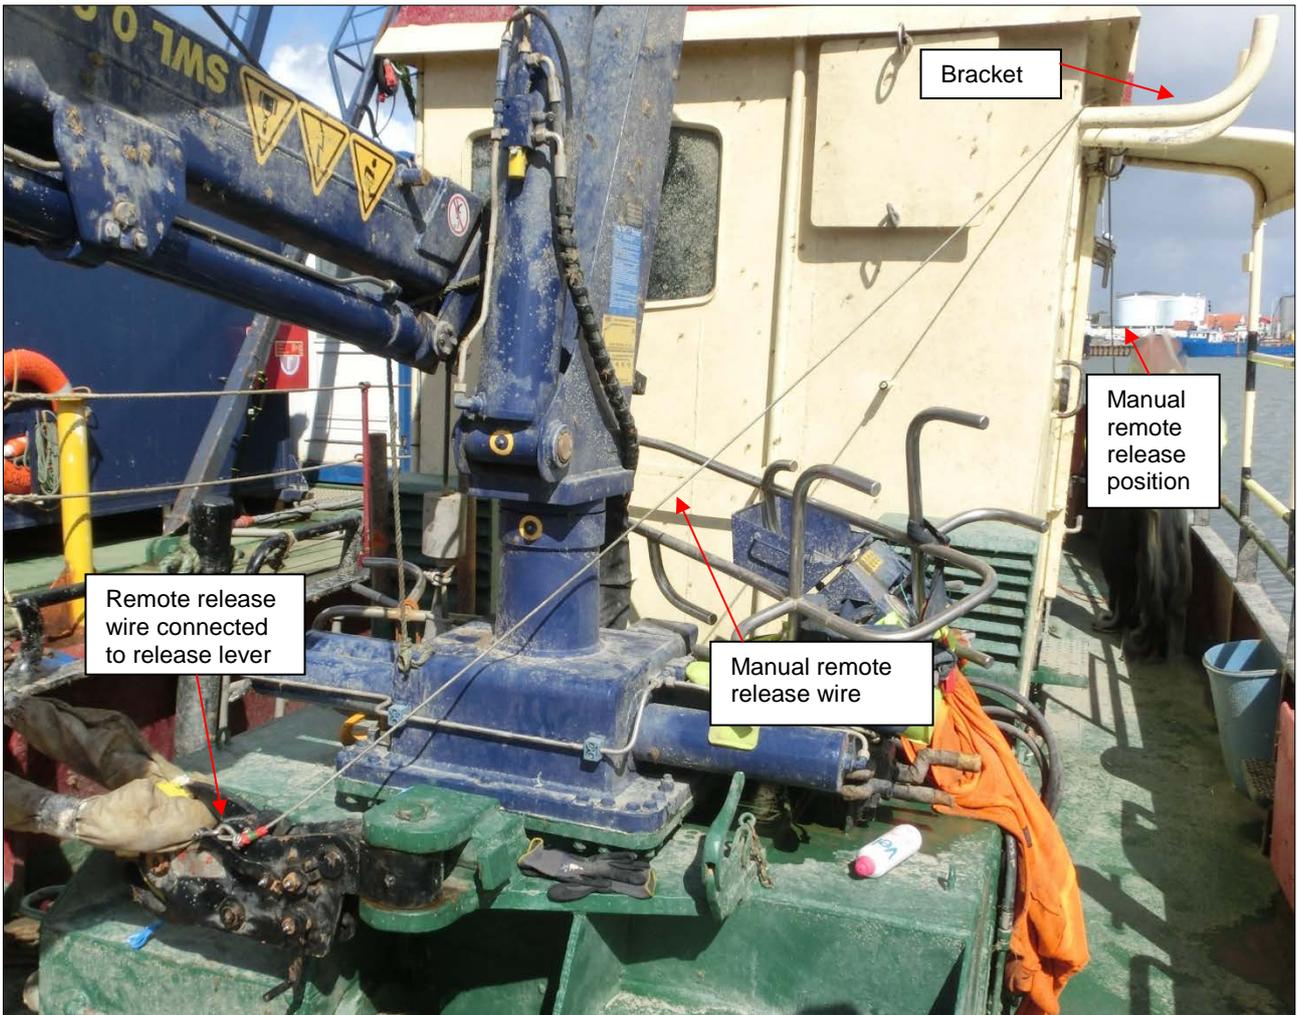
The towing hook had a lever for release once the towline had been fastened in it. The release lever could be fitted with a wire for remote manual release of the hook. A specially designed, small fairlead was available as an option for guiding the manual release wire to the wheelhouse³ of a ship. Such a feature was not fitted on board DIVER MASTER due to technical difficulties in guiding the wire to the wheelhouse. The normal procedure on board DIVER MASTER was instead to lead the wire to a bracket mounted on the starboard side of the wheelhouse (figure 21). At the time of the accident, the wire had not been fitted on the bracket and therefore attempts were made to release it from a different position on deck, further aft, as the wire had not been led to the bracket at that time.

Figure 21: Manual remote release wire arrangement on board DIVER MASTER. Reconstruction made after salvage
Source: DMAIB

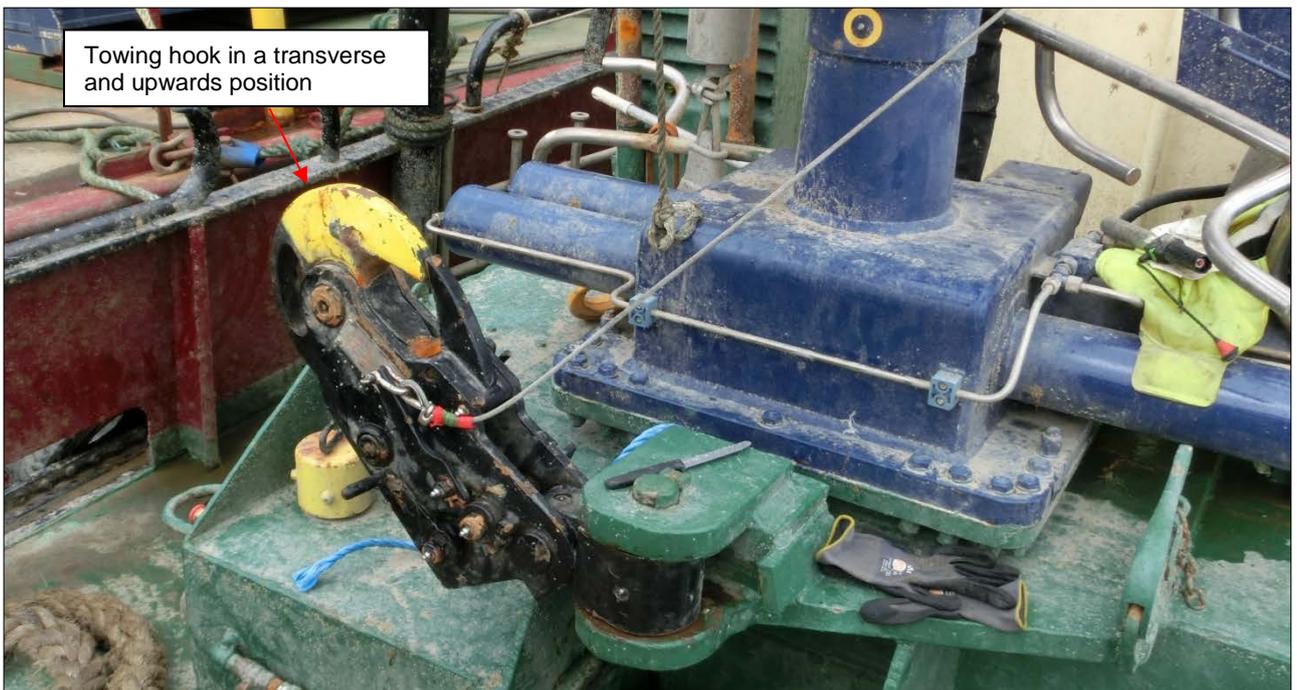
During the accident, the towing hook had moved to a transverse and upwards position as illustrated in figure 22 as a result of the tension from the towline.

Figure 22: Towing hook in odd position on board DIVER MASTER. Reconstruction made after salvage
Source: DMAIB

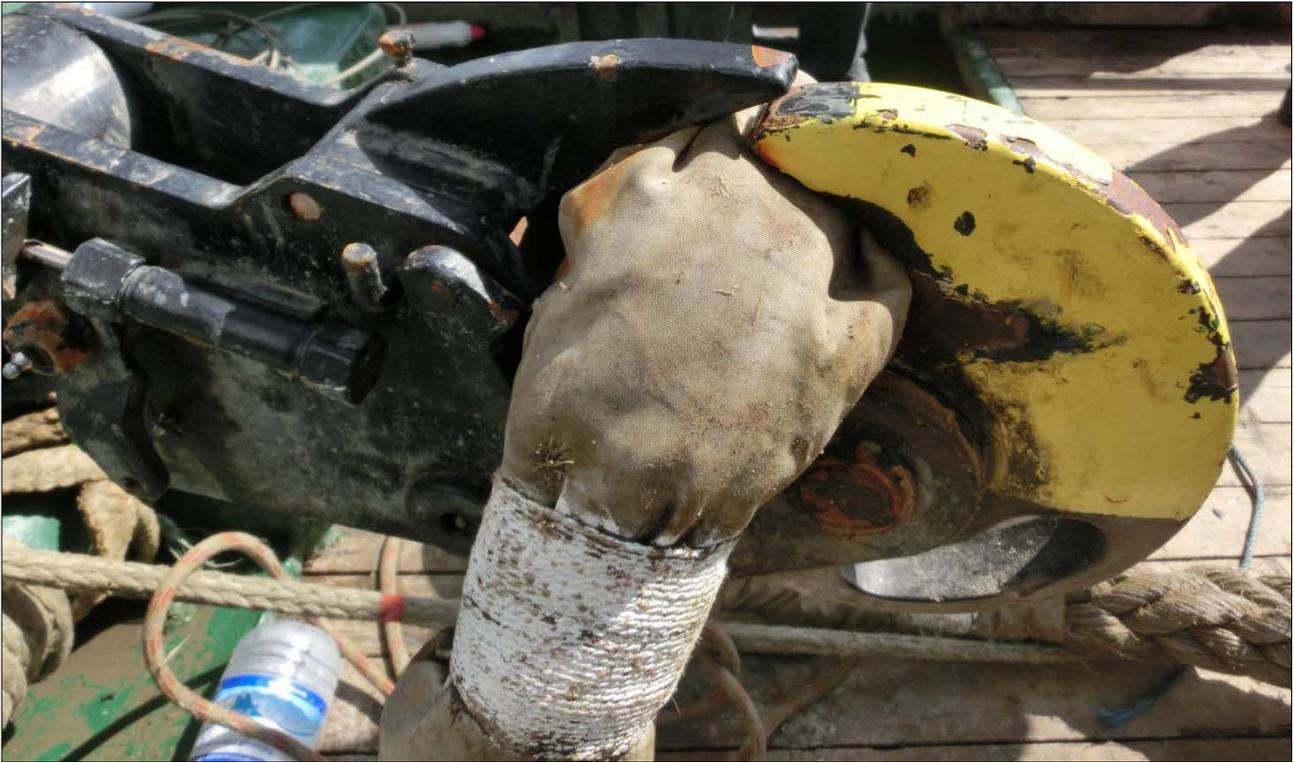
The towline supplied by KRUZENSHTERN had dimensions barely fitting those of the towing hook as illustrated in figure 23. The release function was tested by the DMAIB with the towline from KRUZENSHTERN, after the salvage. The test showed that release of the hook could be problematic even without tension from the towline as the disc was not able to rotate freely with the towline fitted.

Figure 23: Towing hook with towline from KRUZENSHTERN. Reconstruction made after salvage
Source: DMAIB

The towing hook quick-release function did not work as expected. It is likely that the hook did not release due to a combination of the larger dimensions of the towline supplied by KRUZENSHTERN and the immense tension it induced on the hook. The latter is likely to have been well above the towing hook's nominal working and testing parameters.

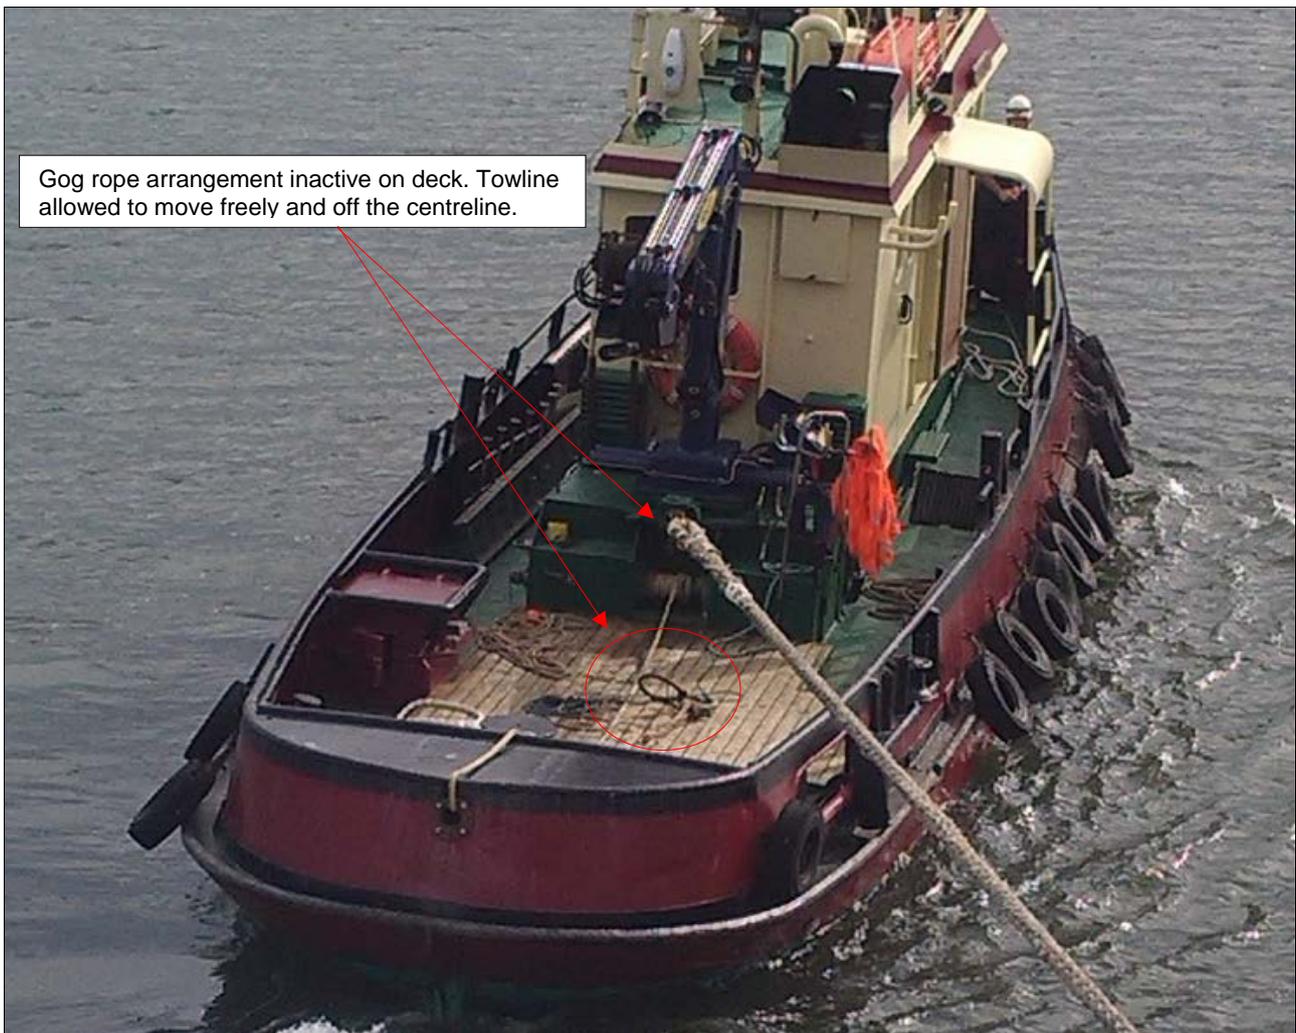
During the towing of KRUZENSHTERN, the gog rope arrangement was not in use on board DIVER MASTER (figure 29). The DMAIB has been informed that it could be considered as normal practice not to use the gog rope arrangement during this kind of towing operation, when acting as a forward tug without the need to move astern.

Figure 29: DIVER MASTER aft deck when towing KRUZENSHTERN towards the port entrance
Source: DMAIB

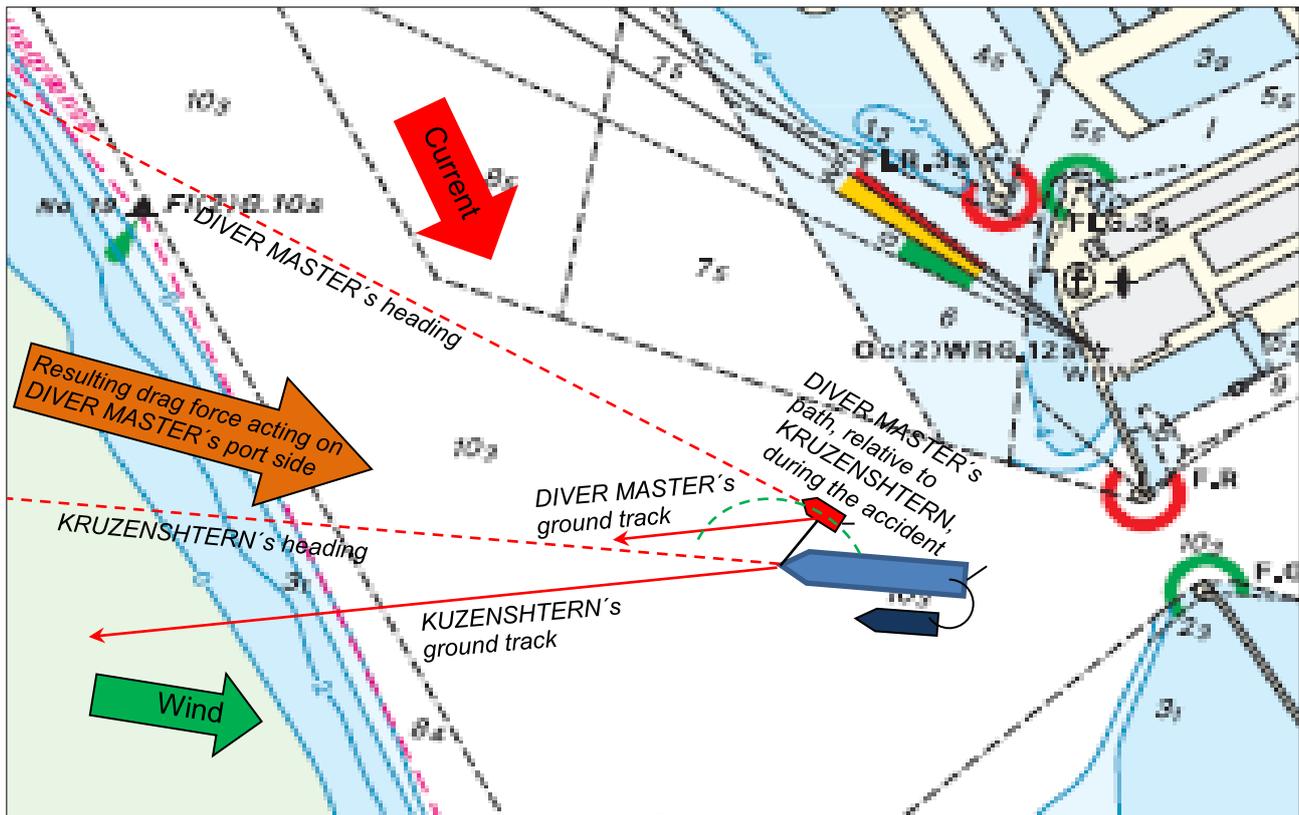
The accident occurred when DIVER MASTER assisted KRUZENSHTERN, as a forward tug boat, during departure from the Port of Esbjerg. KRUZENSHTERN was moving at the speed necessary for manoeuvring in the waters' strong current, and DIVER MASTER was overtaken when manoeuvring to the starboard side of KRUZENSHTERN as this continued ahead. In this situation, the engine power generated on board to control DIVER MASTER became ineffective, and the tug lost its manoeuvrability as it became subject to the dragging force of the water flow acting on the underwater hull (figure 32). In this situation, DIVER MASTER did not manage to realign with the towline and tow.

Figure 32: Situation showing DIVER MASTER being overtaken by its own tow
Source: DMAIB
