# MARINE ACCIDENT REPORT

**SCORPIUS**  
Occupational accident on 8 May 2014

**This marine accident report is issued on 10 December 2014**

**Case number: 2014011309**

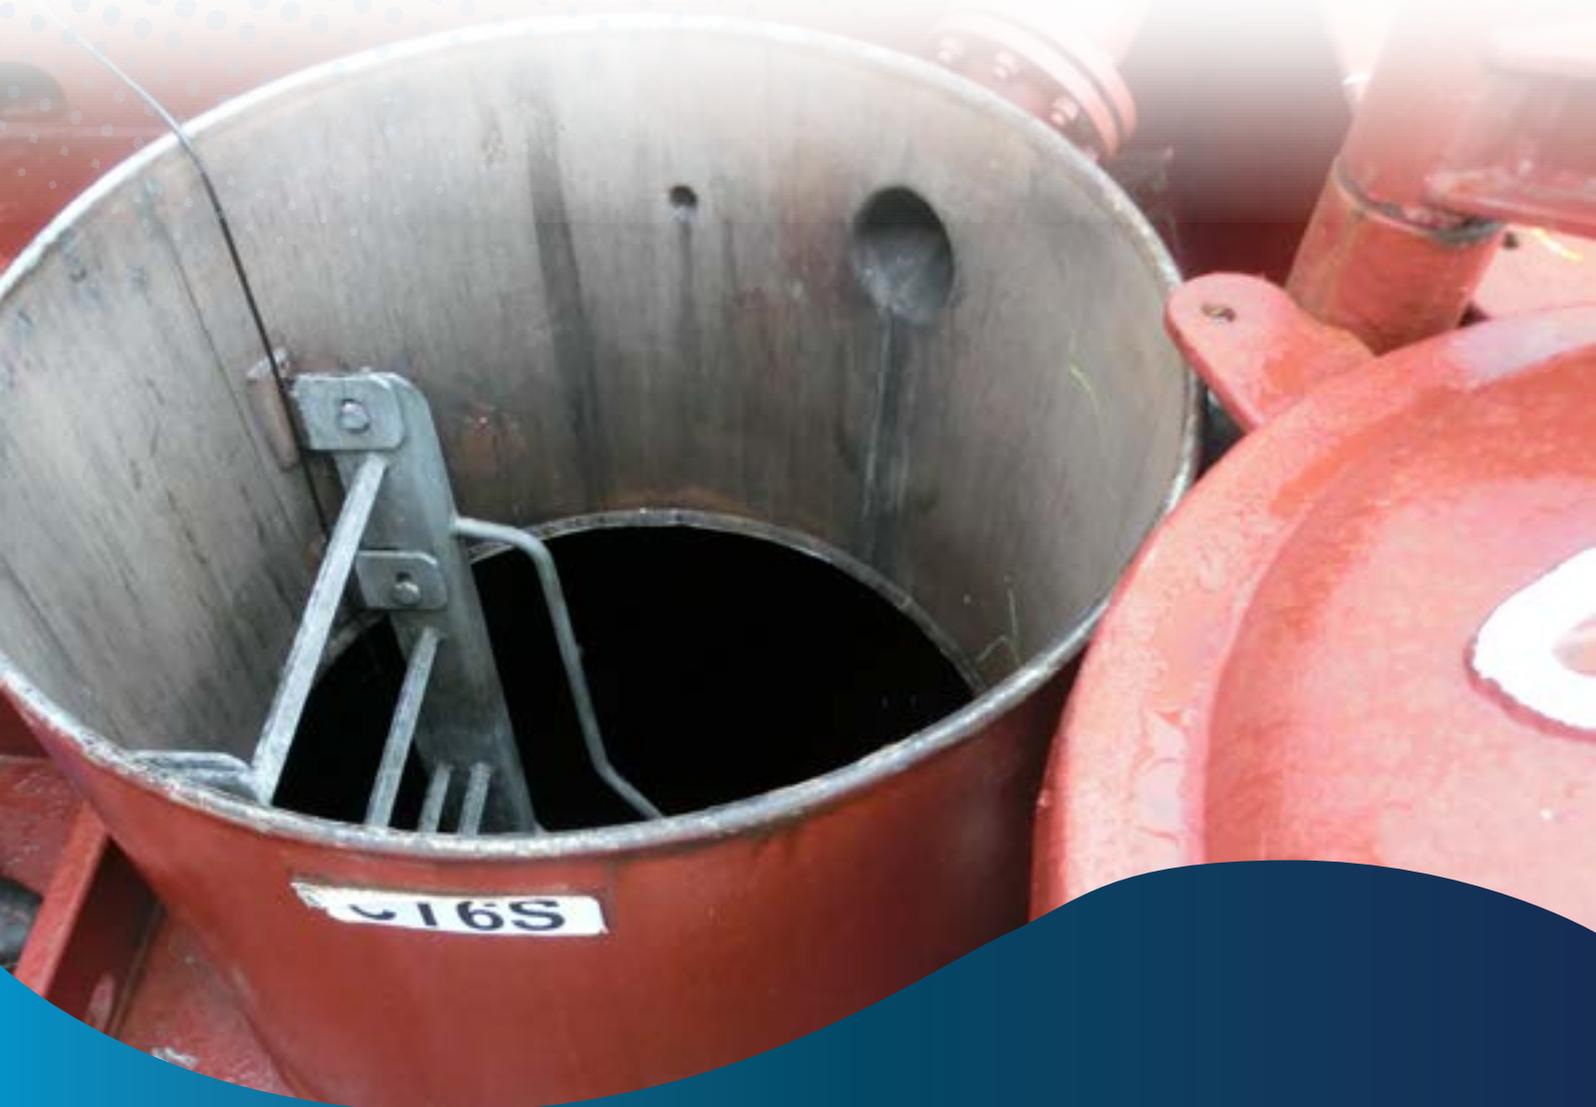
**Front page:** Hatch at cargo tank CT6S on board SCORPIUS. **Source:** DMAIB.

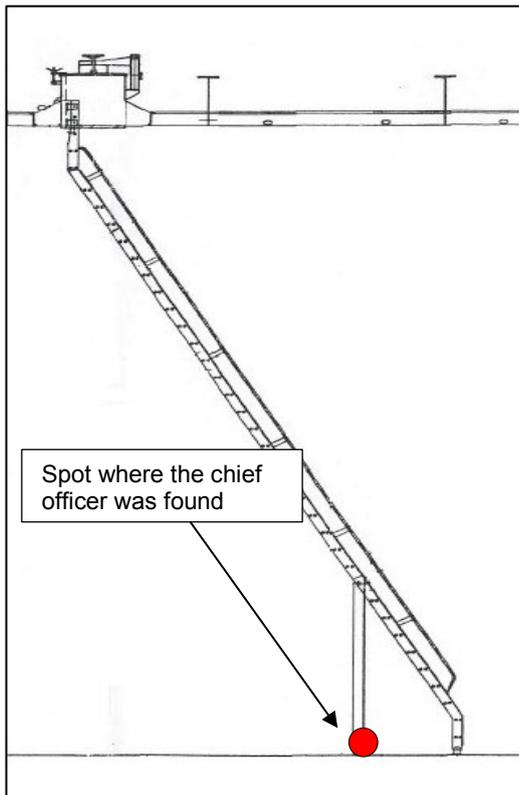
The chief officer was found approx. one metre away from the foot of ladder on the port side (figure 5). The heating coils at the bottom of the tank, in the area where the chief officer was found, were significantly bent (figure 6). The bent heating coils and the nature of the chief officer's injuries suggest that he struck the bottom of the tank with great force. It is most likely that the chief officer fell from the uppermost part of the ladder, tumbled down some of the ladder's steps, and fell over the left side handrails. The post mortem examination has established that the chief officer was killed by the impact of the fall.

Figure 5: Scene of the accident, view  
Source: DMAIB

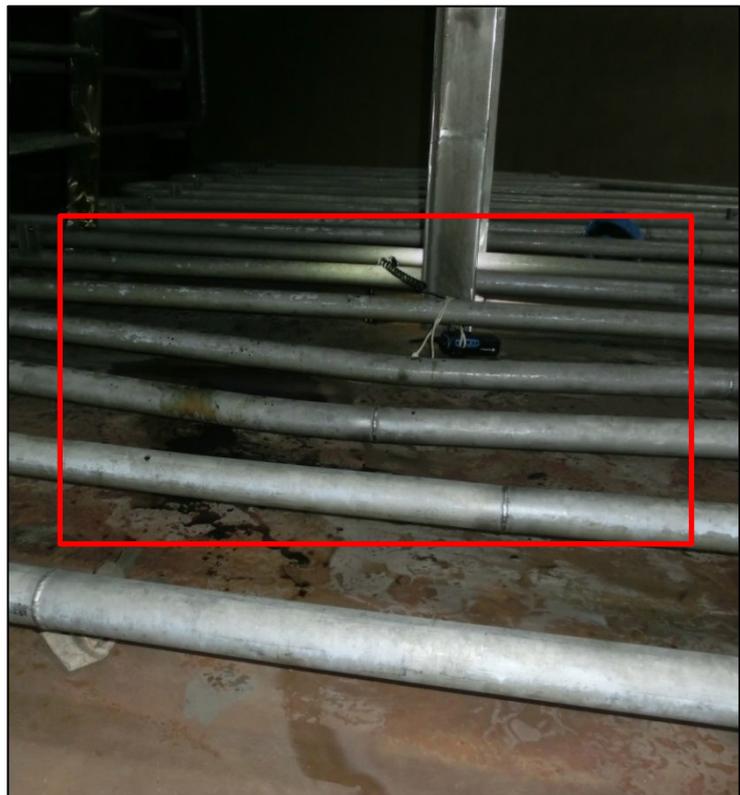
Figure 6: Bent heating coils beside the ladder viewed from port side.”  
Source: DMAIB

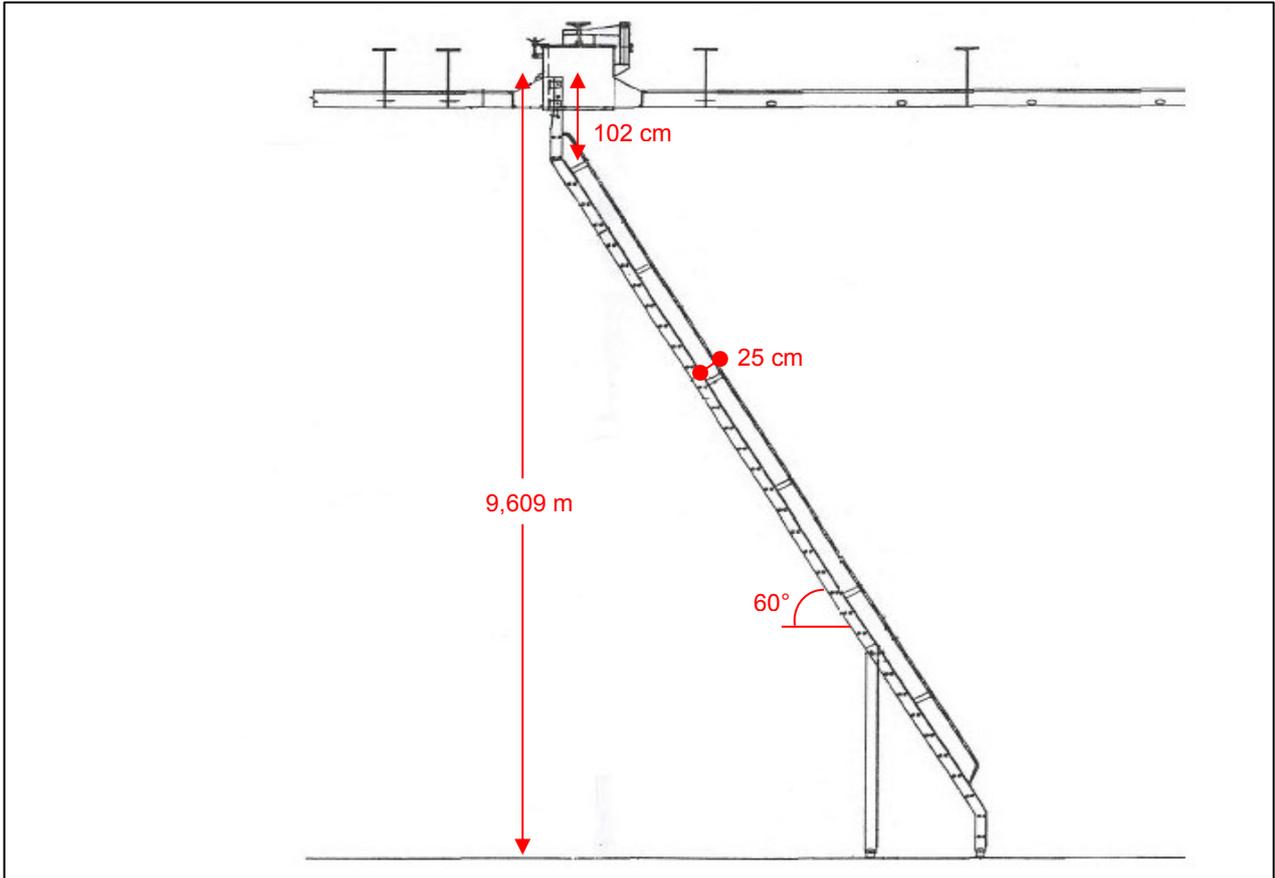
Cargo tank CT6S was accessed through a hatch on the tank deck and by means of a permanent stainless steel ladder of 9.6 metres height. The ladder was vertical for one metre at the top, and then the inclination changed to approx. 60 degrees in relation to the horizontal plane surface (figure 6 and 7). For the last two steps of the ladder, the inclination changed to vertical again. The inclined part of the ladder was fitted with a handrail placed approx. 25 cm above the stringers, measured at a right angle of the stringers. The vertical top of the ladder was not fitted with handrails or back braces.

Between the stringers, the width was 40 cm, and each step consisted of two square bars of 22 mm by 22 mm in section fitted to form a horizontal tread with the edges of the bars pointing upwards. The distance between each tread was 25 cm.

Figure 6: Drawing of tank access ladder on board SCORPIUS  
Source: DMAIB/Sirius AB

The inclination of the tank access ladders on board SCORPIUS was not constant, but consisted of an inclined main part and two short vertical parts. As the inclination of the main part of the ladder was below 70 degrees and had been approved by the class without any arrangements for fall preventive equipment, it is likely that the construction of the ladder had been perceived as complying to the prescriptions in the Danish Maritime Authority's Notice B rule 7.3, meaning that a fall arrestor was not needed. If so, the vertical part at the top of the ladder was not taken in to consideration.

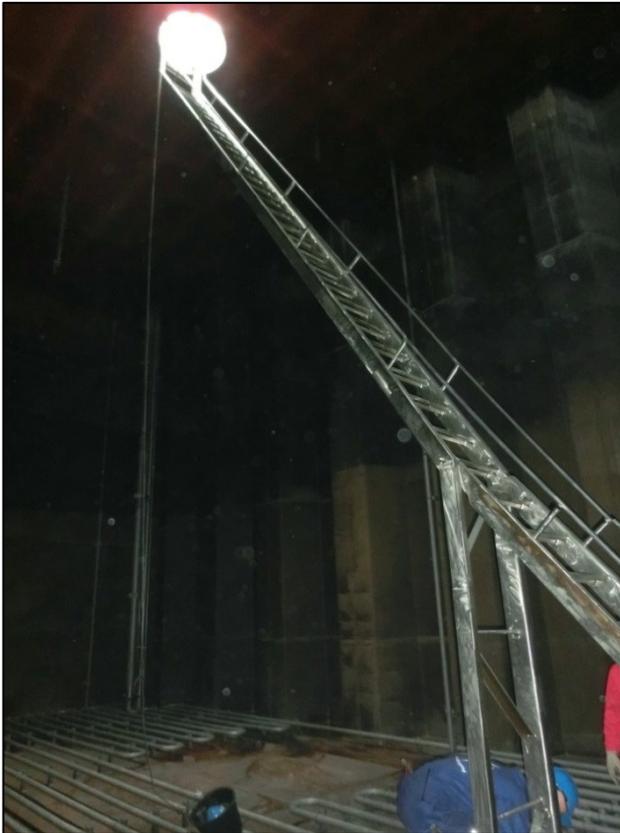
Figure 7: Tank access ladder in CT6S  
Source: DMAIB

The cargo tank ladder on SCORPIUS contained hazardous elements of risk in its design. The risk of falls that sprung from the design was not countered by effective fall protective measures, because the ladder was not perceived as being unsafe. Therefore, a simple slip from the top of the ladder could lead to a fatal accident.

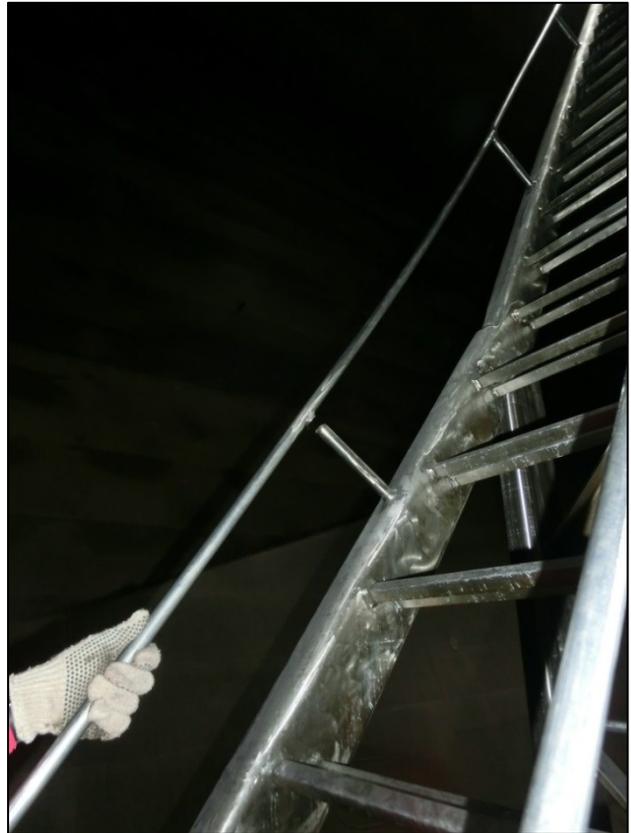
Approx. 2 metres from the bottom, the handrails were found detached from their fittings on both sides of the stringers. The damage on the handrails may have occurred during the evacuation of the chief officer (figure 8).

Figure 8: Broken handrail  
Source: DMAIB

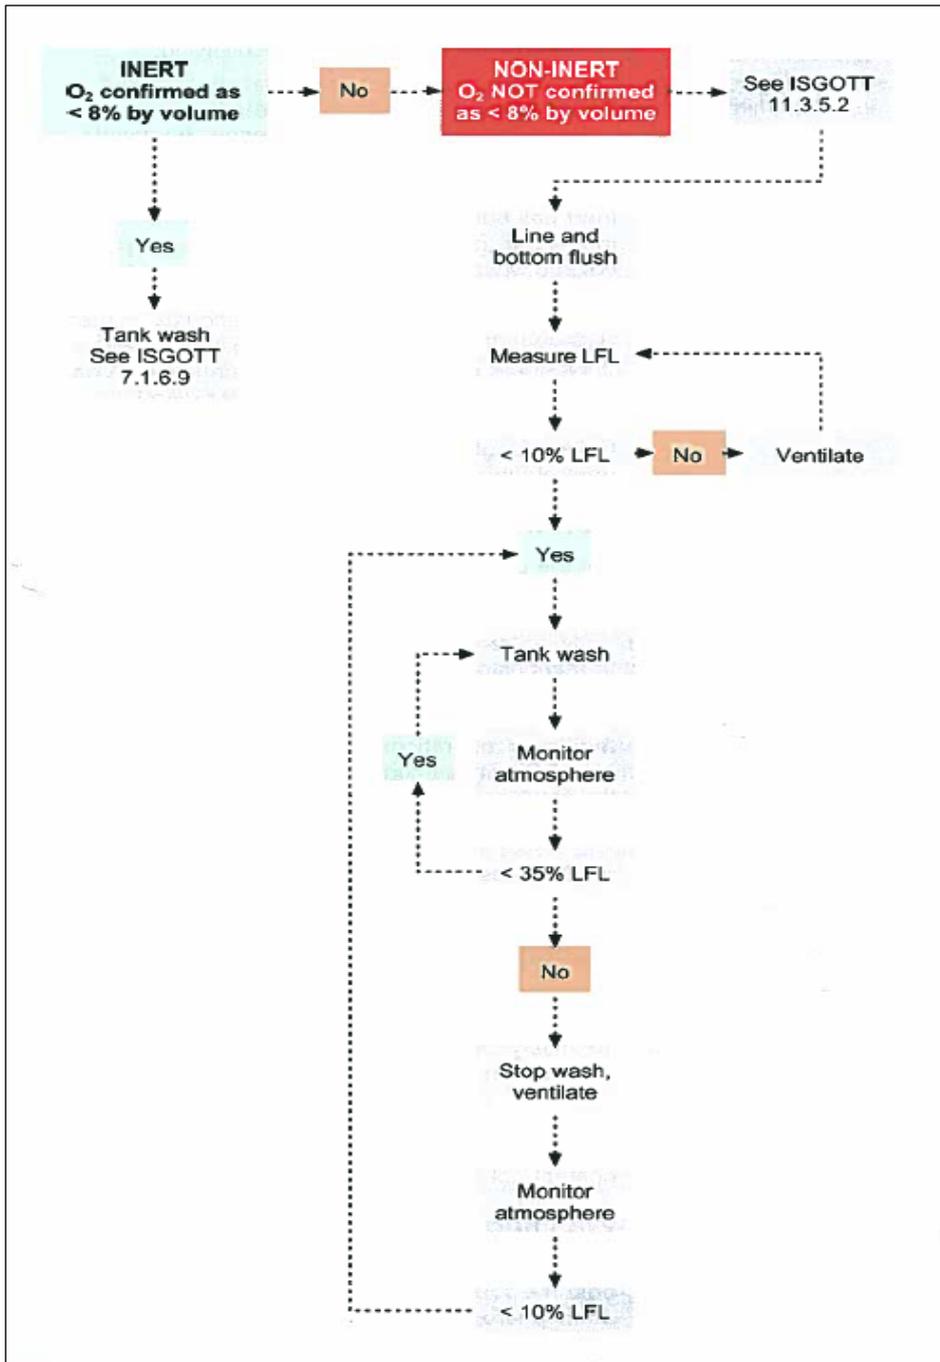
The ISGOTT flow chart, which the crew was instructed to use, referred only to prevention of explosion and advised the crew on how to prevent this hazard by ongoing atmosphere testing and by stopping and starting the tank wash accordingly. It did not help the crew in planning the cleaning operation ahead or ensuring the quality of the tank cleaning. Furthermore, the ISGOTT flow chart was closed circuited and, hence, not useful in an operational situation; if the flow chart guideline was actually followed, the tank cleaning would be unending.

Figure 9: ISGOTT tank cleaning flow chart  
Source: ISGOTT
