Danish Maritime Accident  
Investigation Board

# MARINE ACCIDENT REPORT

**BRITANNIA SEAWAYS**  
**Fire on 16 November 2013**

**Case number: 2013024446**

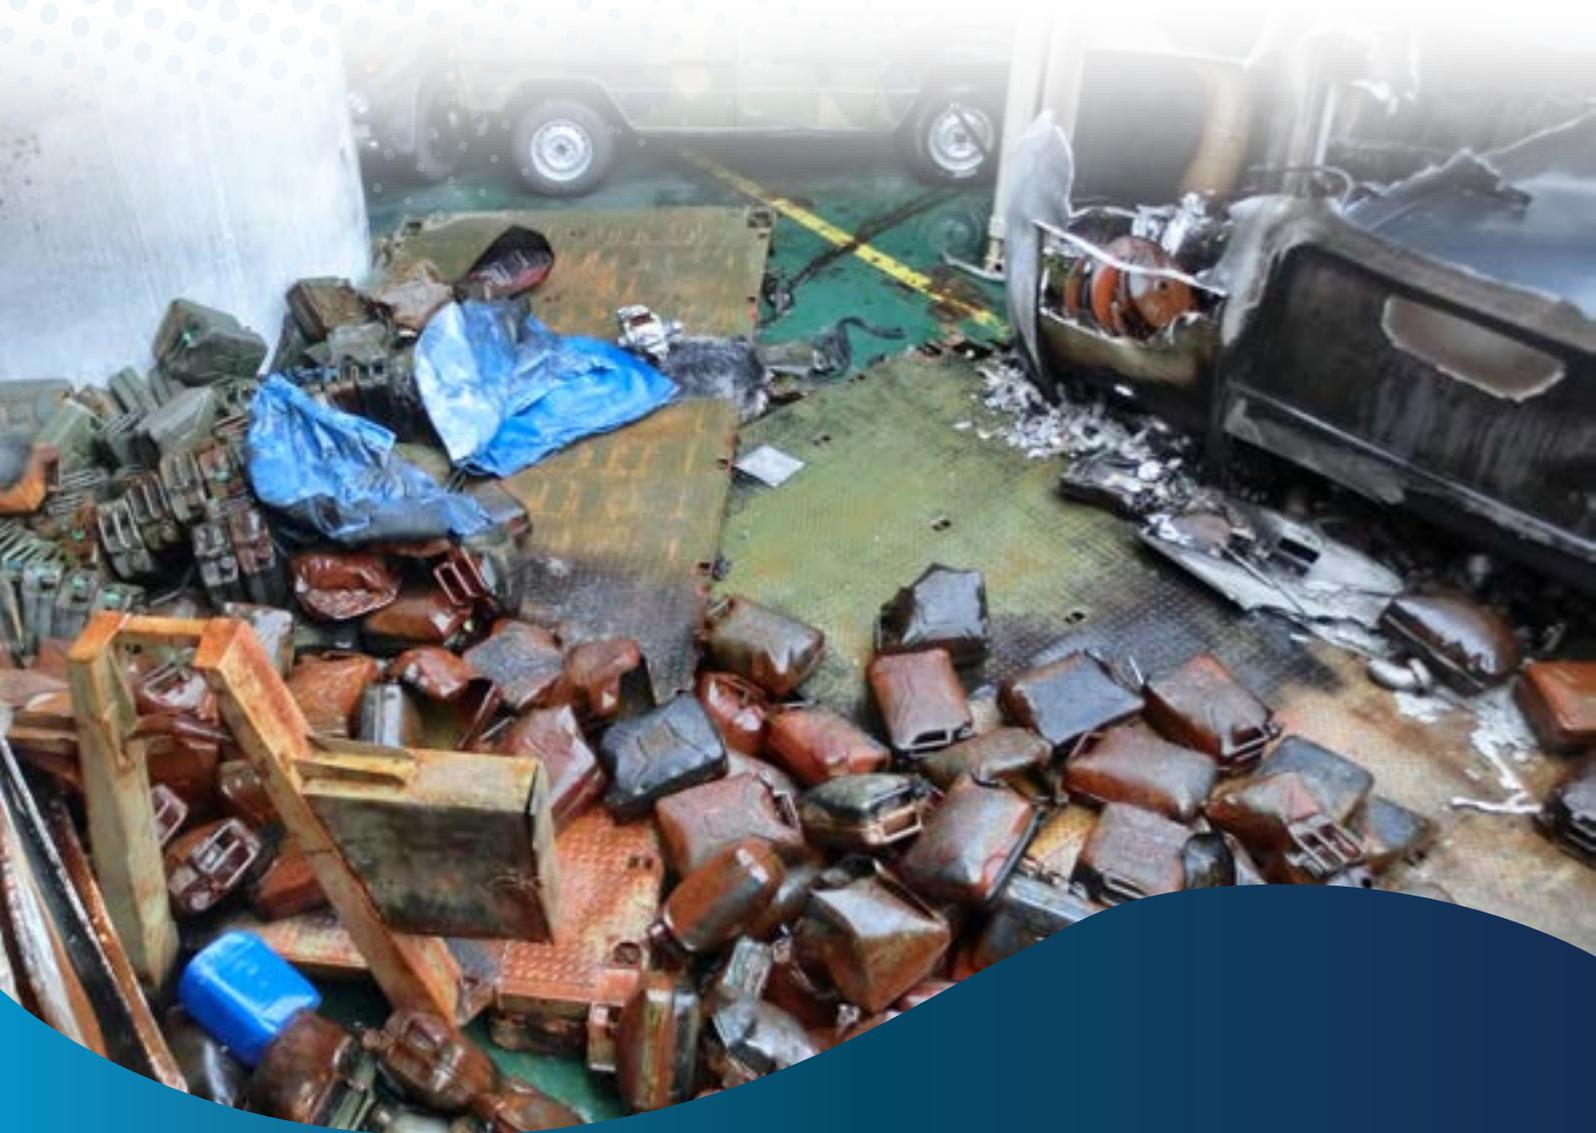
**Front page:** Deck area after fire. Source: DMAIB

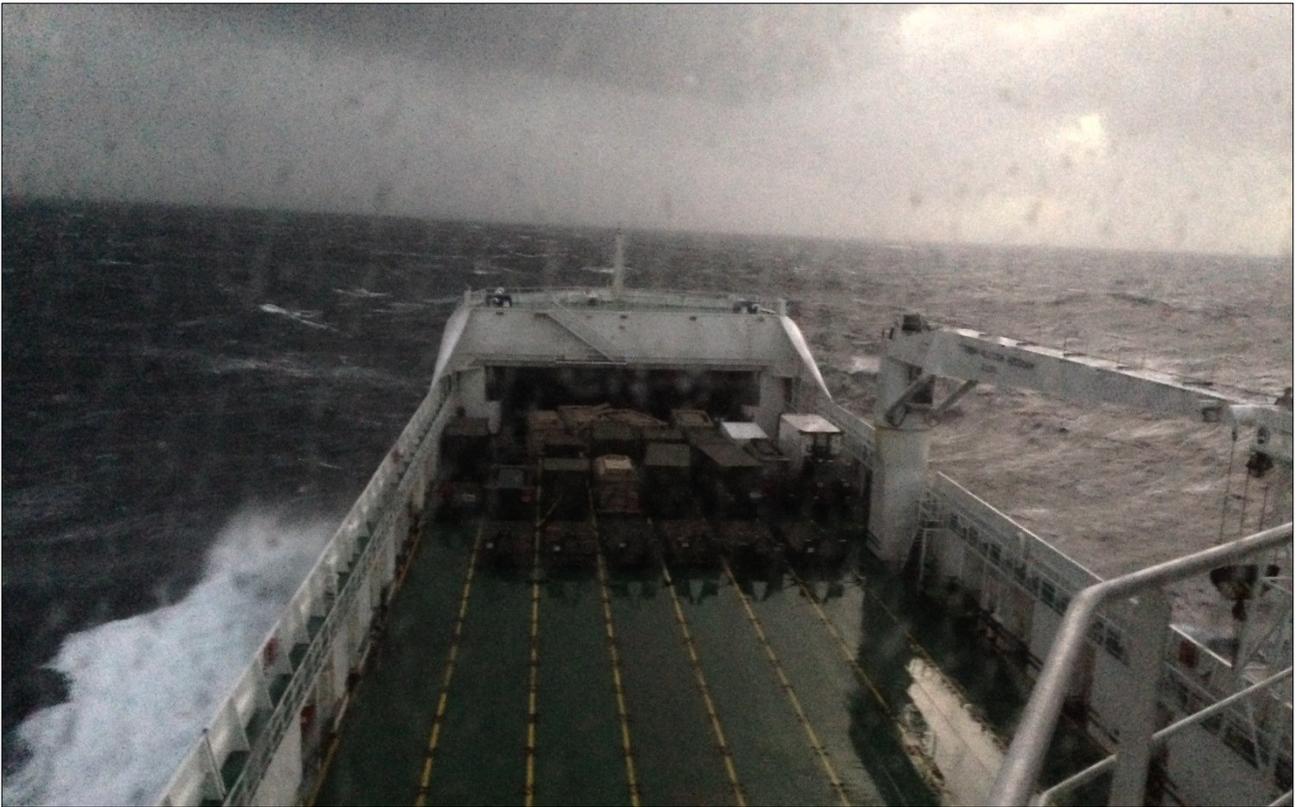
*Figure 4: Containers on forward part of weather deck, having shifted as a result of the ship's movements*  
Source: DFDS

It was observed from the bridge that two jerrycans were lying on the deck between the flatrack and the tank container that had initially shifted. The jerrycans had loosened from their lashings, obviously because they had been hit by the tank container. At 1630 hours, the chief engineer reported to the master that there was a smell of fuel from the deck areas. There was not much wonder at where the smell came from. The jerrycans were probably damaged and leaking, but it did not cause any serious concern, because at that time the ship was slamming so hard in the heavy seas and large amounts of sea water were washing over the bow. It was therefore believed that the fuel from the jerrycans would be diluted, thus creating no hazard to the safety of the ship.

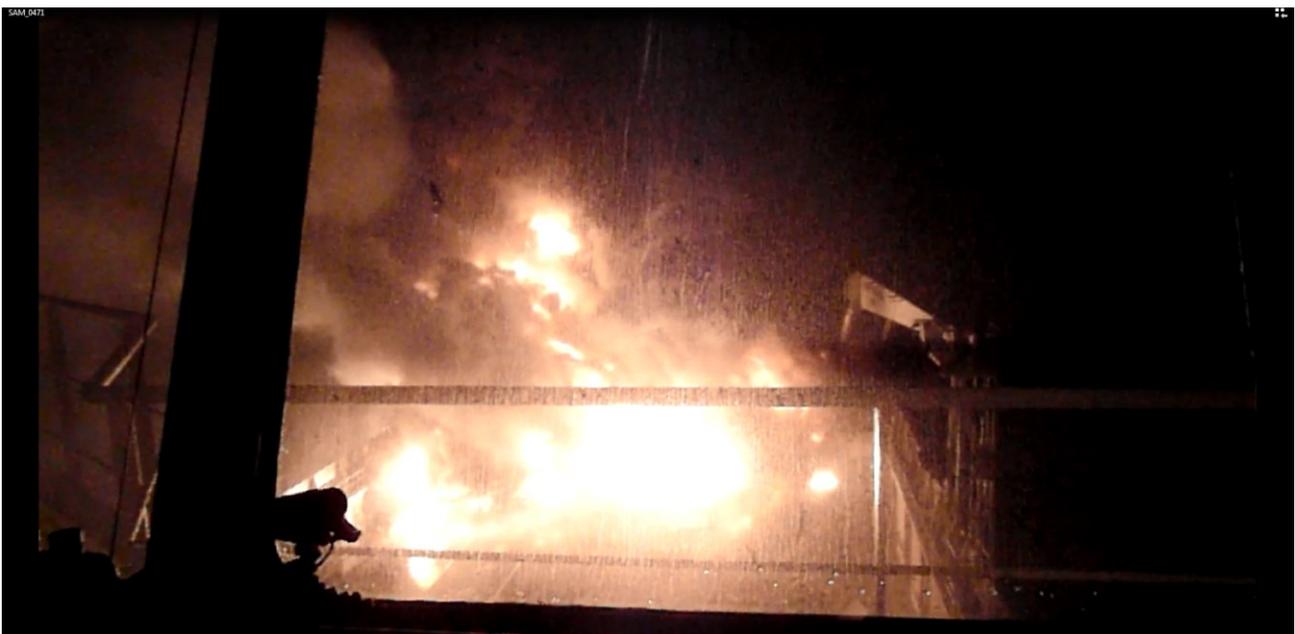
As the containers slid across the deck, steel against steel, they created powerful sparks that instantly ignited leaking fuel from the jerrycans and created high flames. Within a few seconds, some jerrycans exploded and fuelled the fire. The scenario was also observed from the drivers' mess room by the military personnel.

Figure 5: The fire, at an early stage, snapshot from a video recorded from the bridge  
Source: DFDS

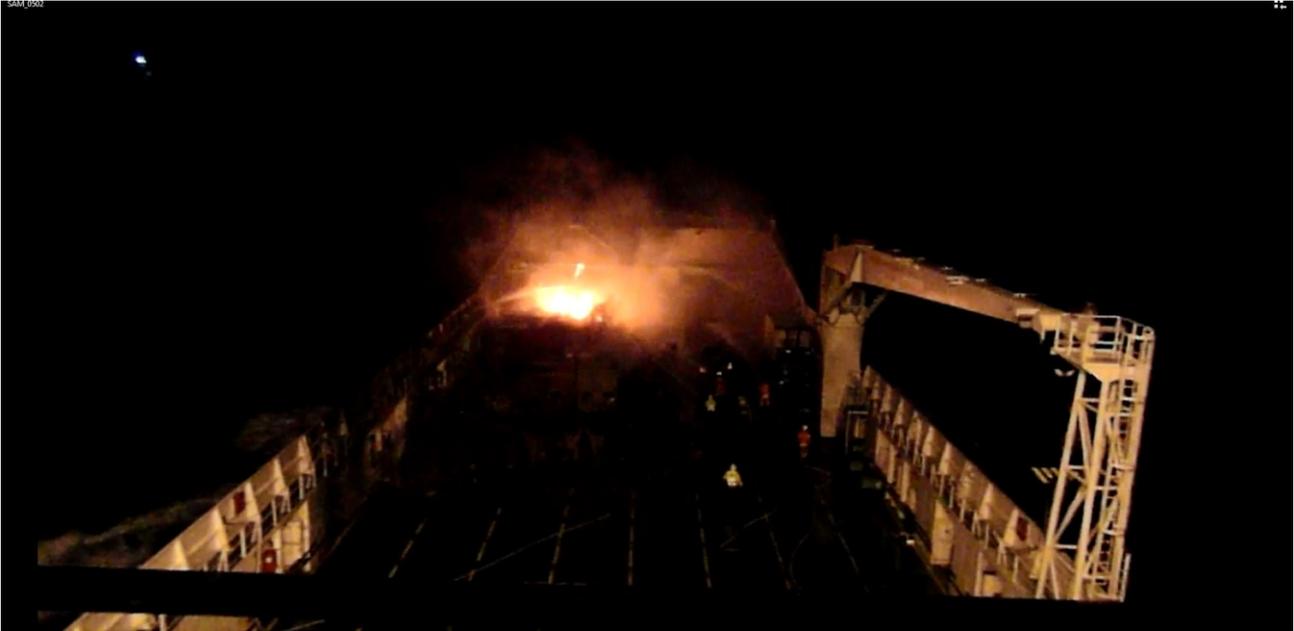
Heat radiation from the fire hindered the firefighters in getting close to the immense fire. Furthermore, the heat caused the web lashings on all other cargo units on the weather deck to burn or melt, whereafter all units could slide across the deck and create damage and leakage to fuel containers and jerrycans, thereby enhancing the fire. The sprinkler system in the section below the accommodation was started, and the window sprinklers on the wheelhouse windows were started because the fire rapidly developed and the flames became up to 30 metres high, and the heat radiation from the flames could be felt inside the wheelhouse.

*Figure 6: The fire, at a later stage, snapshot from a video recorded from the bridge*  
Source: DFDS

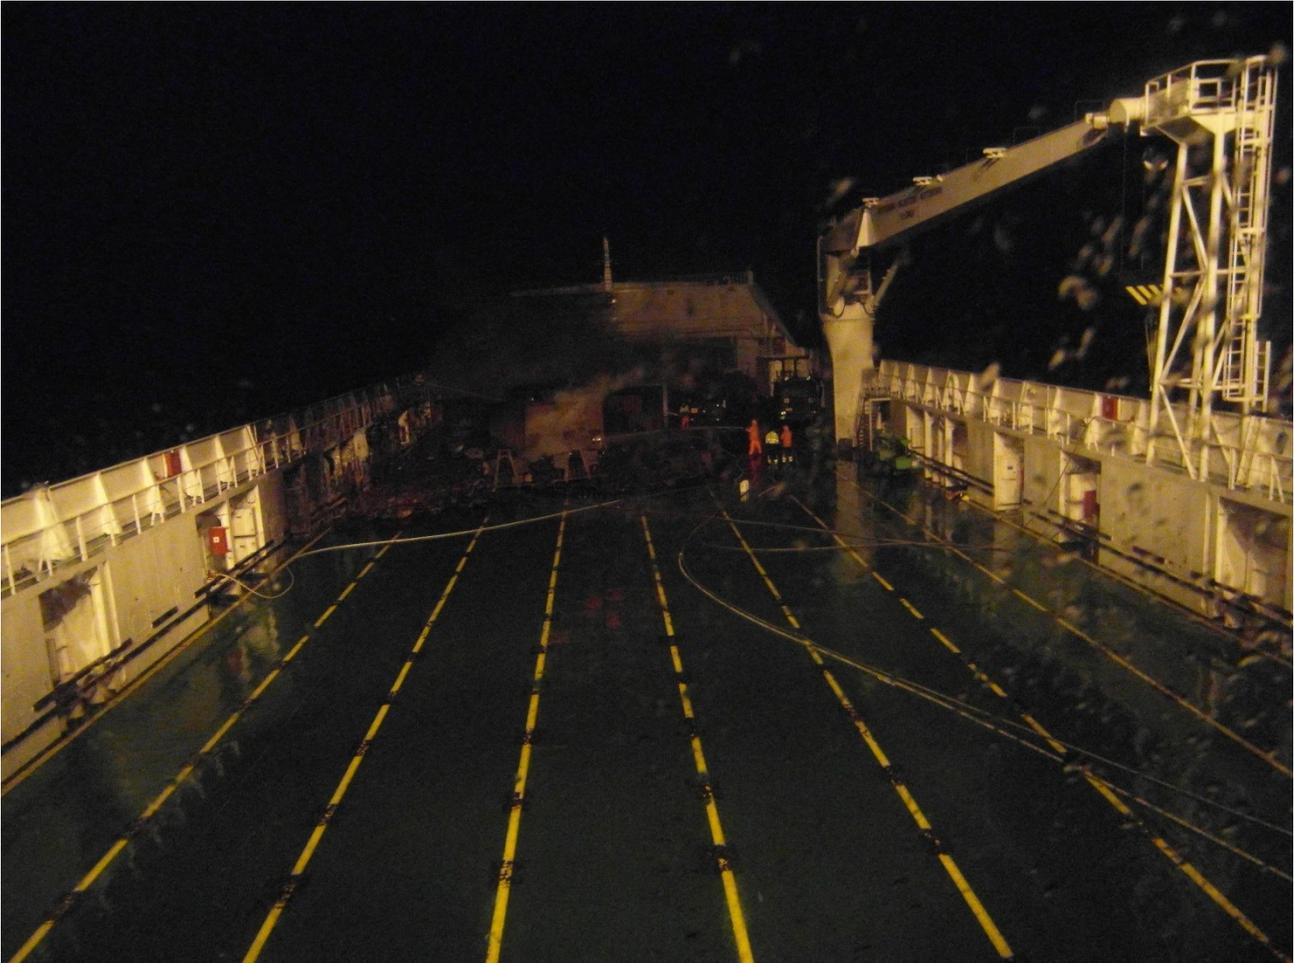
*Figure 7: The fire, at a late stage, almost extinguished, snapshot from a video recorded from the bridge  
Source: DFDS*

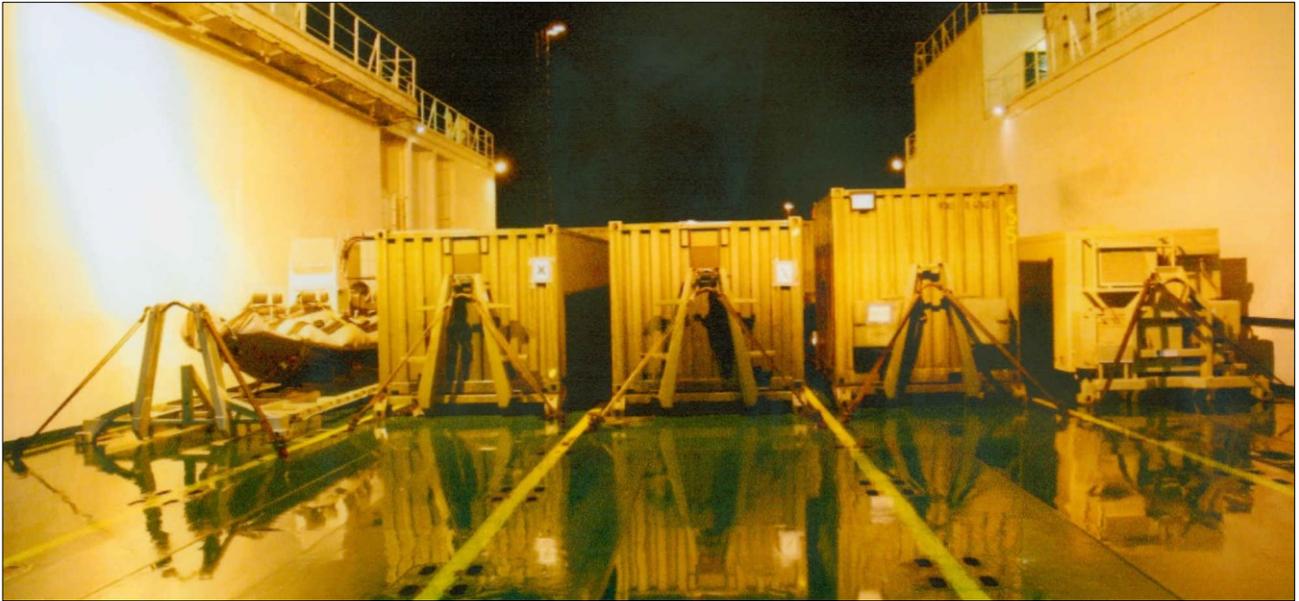
The master realized that, even though he had never before experienced stowage of jerrycans in that way, the jerrycans seemed well secured by web-lashing straps on the flatracks. Because the cargo consisted of various types of vehicles and flatracks with various types of containers etc., the securing of the cargo was not uniform.

Some flatracks were placed on anti-slide mats of rubber material and some were not.

Figure 10: Examples of securing of cargo on aft part of the weather deck  
Source: Norwegian military police

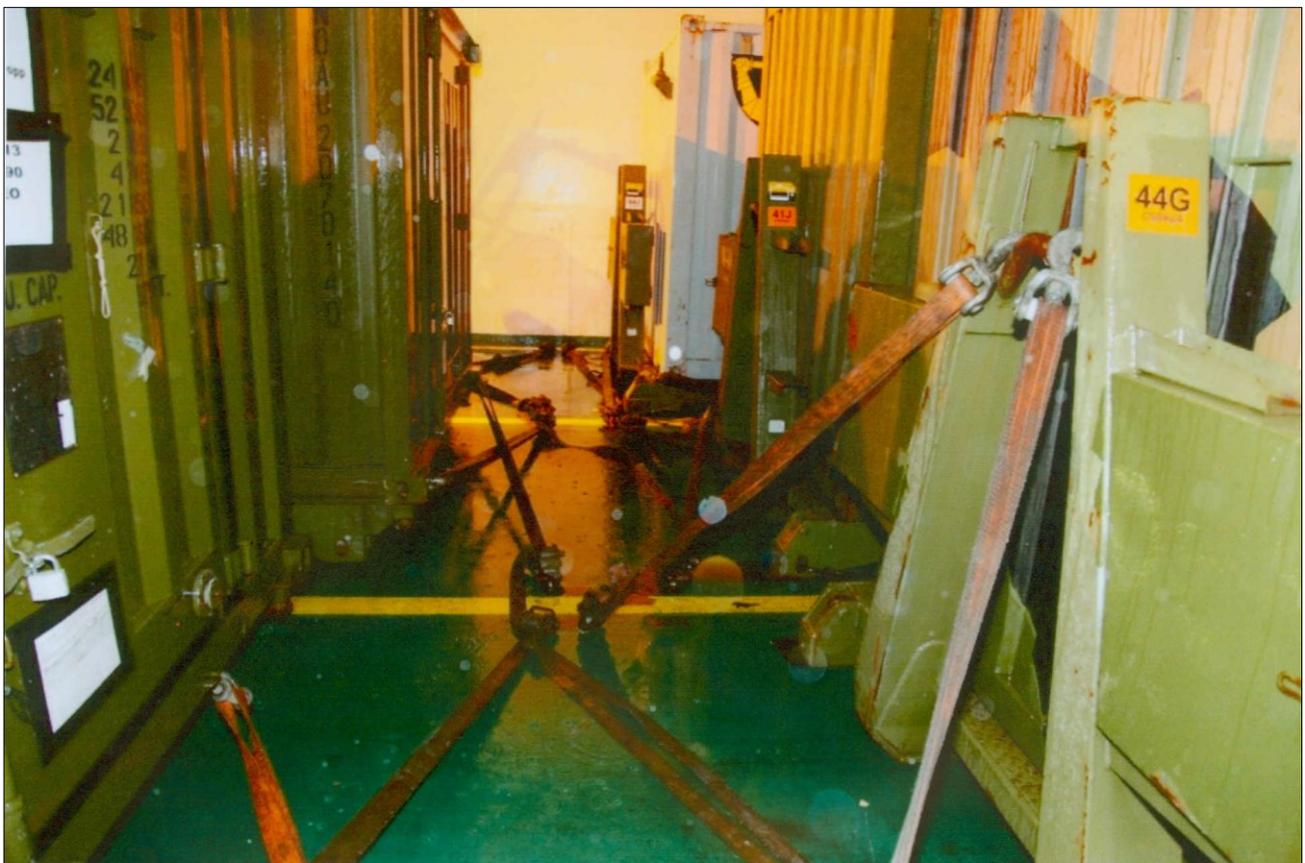
Figure 11: Examples of securing of cargo on aft part of the weather deck  
Source: Norwegian military police
