Danish Maritime Accident
Investigation Board

SUMMARY REPORT

EUGEN MÆRSK
Fire on 18 June 2013

This marine accident report is issued on 10 April 2014.

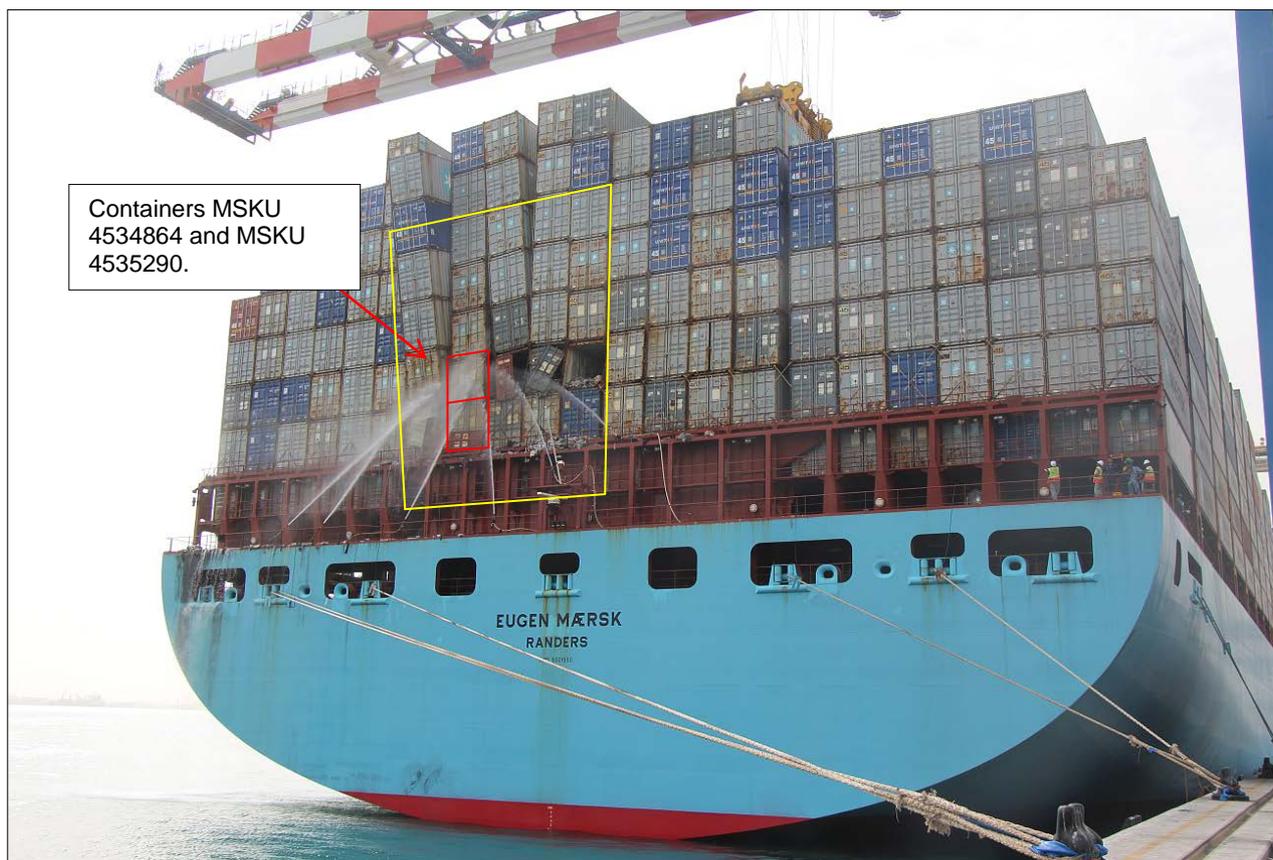
Two days prior to the fire, as the vessel sailed through rough weather, the lashings of at least two containers on bay 90 came loose. A twistlock was found broken and the corner castings of some containers were found cracked and damaged. A container stack on bay 90 was observed as it was swaying approximately 1.5 metres from side to side. The crew re-established missing lashing rods and re-tightened the loose lashings but the effect was not satisfactory as the container stack was still moving too much. Extra chain lashings were established and the ship's course and speed were adjusted to reduce movements.

Figure 4: View of bay 90 seen from aft. Containers where fire originated marked in red. Area most affected by fire/firefighting marked in yellow.

The location of the origin of fire was inside containers MSKU 4534864 at pos. 900886 and MSKU 4535290 at pos. 900884 (figure 4).

- 1) The fire started as a result of friction heat created by the collapse of the container stacks. This ignited the contents of the containers and the fire developed from there.
- 2) The fire was initiated at an early stage, perhaps even before the containers were loaded on board. After having slowly smouldered for a long time, the collapse of the containers created a sudden burst of oxygen which made the fire flare up and develop.

In both scenarios the collapse of containers is considered a major contributing factor to the fire.

The DMAIB's investigation has revealed nothing to significantly support one of the analyses of the direct cause of fire in favour of the other. However, the collapse of container stacks contributed to the fire starting or developing. The reason for the collapse of containers leading up to the fire was most likely a combination of multiple factors, including the structural integrity of the containers, the weather conditions, the stack weights, the lashings and dynamic forces acting on the ship.

Following this and other similar incidents, the company has equipped vessels with specially designed tools/fittings that ease fixing of fire hoses and nozzles. Compared to either holding the hoses manually or improvising fixtures, these devices are considered by crews to be quite an improvement for prolonged firefighting operations and anti-piracy measures alike.
