Danish Maritime Accident
Investigation Board

MARINE ACCIDENT REPORT

ATAIR J
Mooring accident on 3 October 2013

This marine accident report is issued on 3 July 2014.

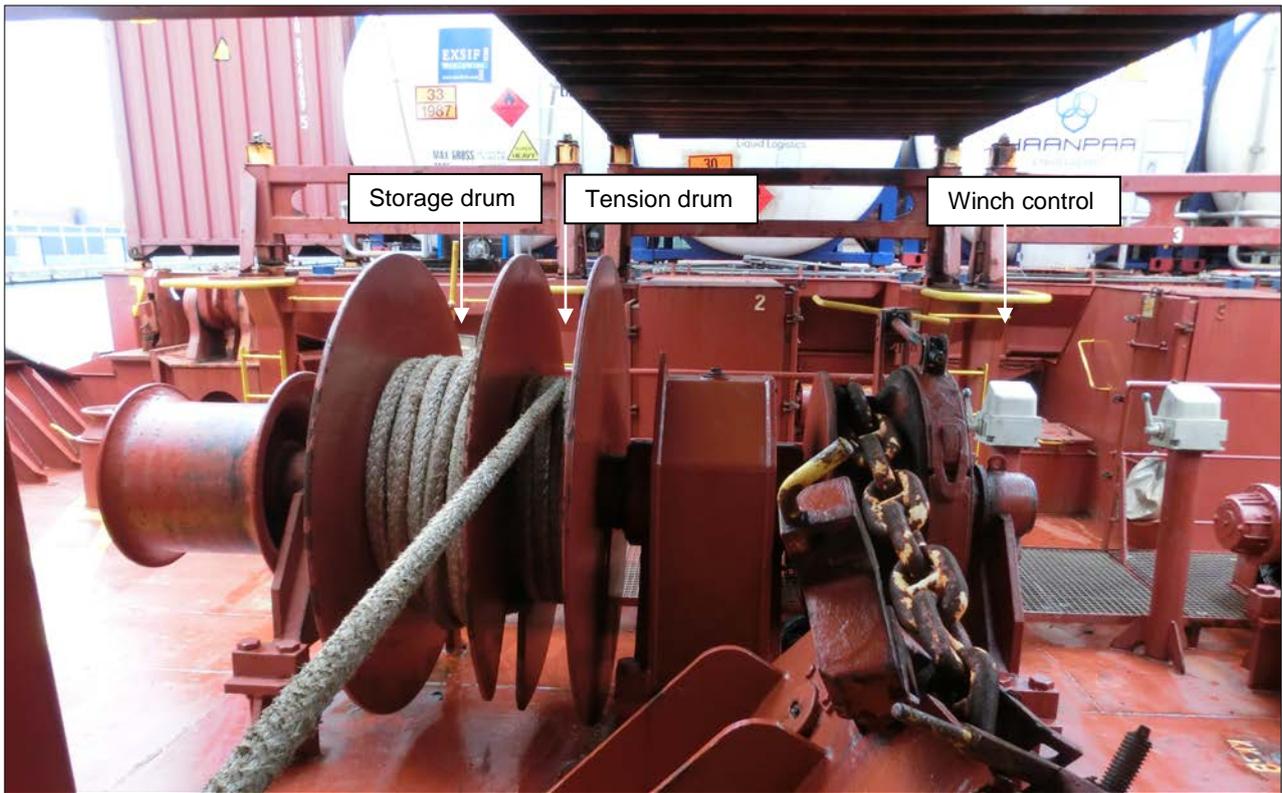
The mooring arrangement consisted of two winches with split drums – one storage drum and one tension drum that were situated in the centre of the deck area (figure 5 below). Both winches were combined anchor and mooring winches with electric drives with pole changing multi-speed motors and were operated by a control box located at the winches. There was thus a three step regulation of the speed of the winch.

At the time of the accident, the winch on the starboard and port side functioned normally and had no technical defects that influenced the operation of the winch.

Figure 5: View of starboard winch
Source: DMAIB

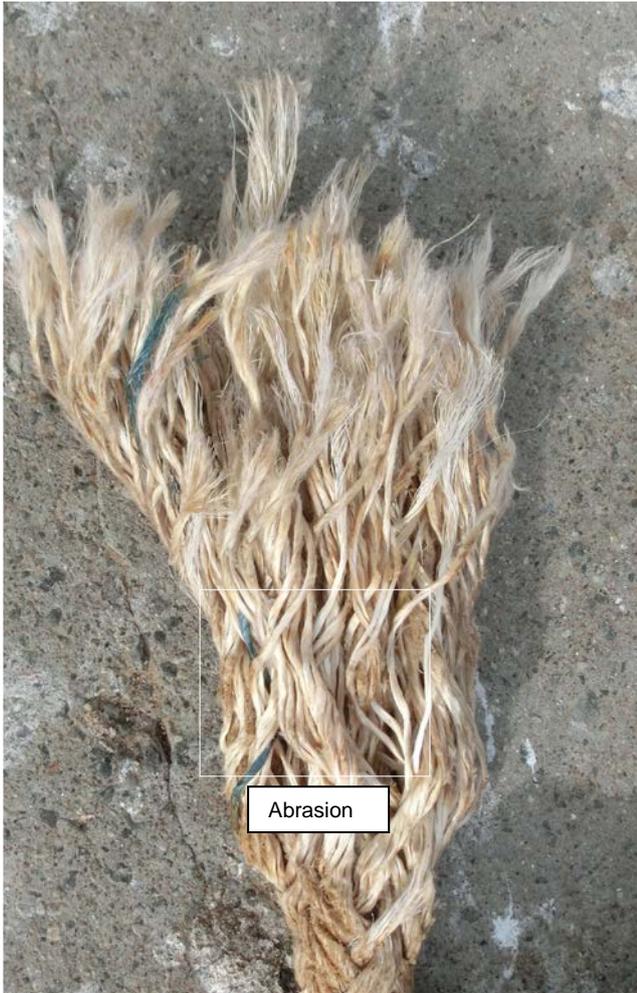
On figures 6 and 7 below, are two pictures showing the rope that broke. There are many variables that affect rope strength. Factors like load history, bending radius, abrasion, chemical exposure or a combination of some of these factors are important when evaluating the state of the rope. The rope that broke had suffered medium to severe abrasions on the outer as well as on the inner strands. The abrasions were a result of normal tear and wear as it was subjected to rough edges and surfaces on deck, on rollers, and on the ship side when it was used as a spring line.

Figure 6: Mooring rope where it broke. View of the strands.
Source: DMAIB

The stretching capabilities and breaking load of a mooring rope can be reduced by applying excessive loads either as creep¹ or shock loads causing permanent elongation. After a permanent elongation, the crewmembers would not be able to visually judge the actual load on the rope by observing the stretching of the rope. It is uncertain how much the broken rope had been damaged by stretching.

The rope parted approximately 18 metres from the eye on the bollard, which means that the rope parted approximately 10-20 metres from the fairlead.

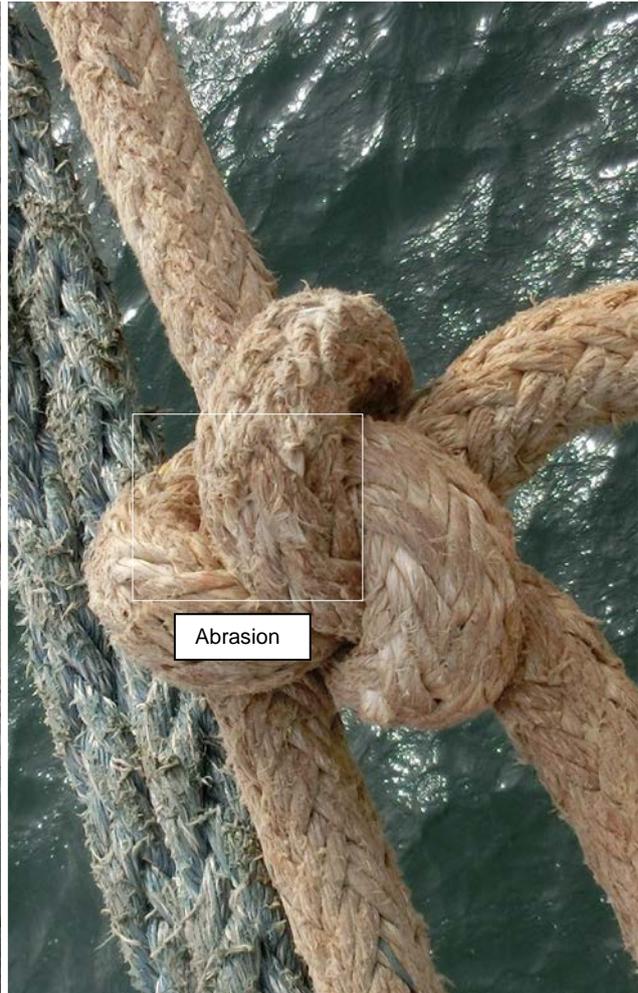
Figure 7: Knot tied on mooring rope after it broke. Showing general condition of the rope.
Source: DMAIB

The crewmembers did not realize that the mooring rope was in a questionable condition. It can be difficult to judge the condition of the mooring rope without in-depth knowledge about the specific type of rope, its age and prior history. During the actual mooring operation, the crewmembers had limited options for discarding a rope as no extra ropes were readily available on the winches. The ship did not have a formalized way of evaluating the condition of the ropes. Therefore, the evaluation was based on the judgment by the crewmember and not the actual limitations stated by the manufacturer of the rope.

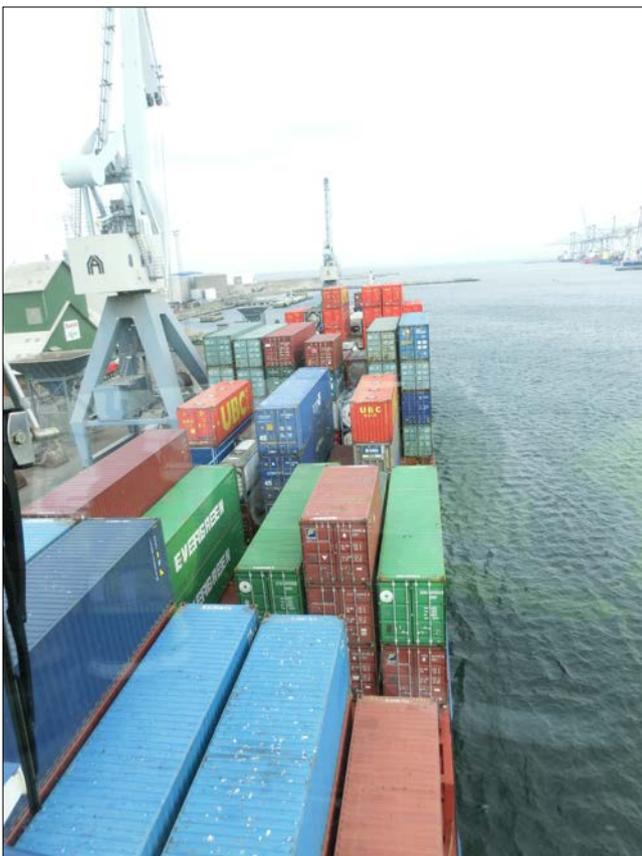
The distance from the bridge to the forecastle was 120.5 metres. With cargo on deck, the master had little view of the mooring situation forward (figure 8). Therefore, the master relied on the effectiveness of the communication between the crewmembers on deck and the chief officer who relayed the information to the master. During manoeuvring, the chief officer was usually stationed by the conning station (figure 9), and he was the only one on the bridge in direct communication with the crewmembers on deck.

Figure 8: View from starboard bridge wing on the day of the accident
Source: DMAIB

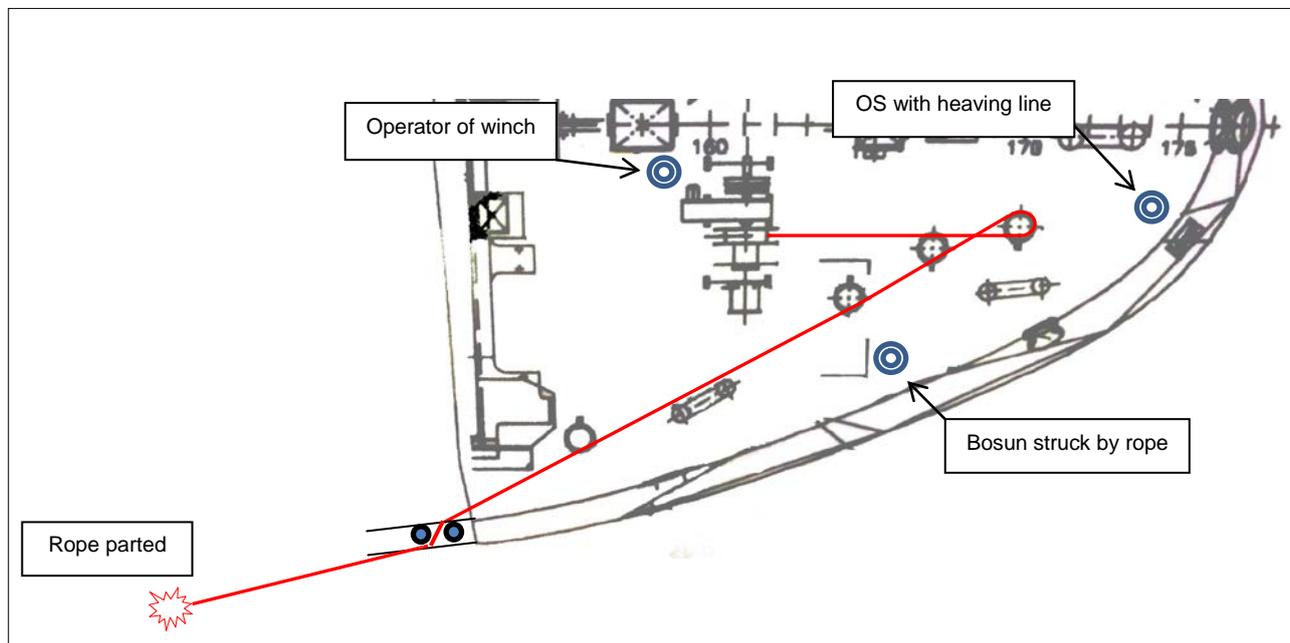
The spring line was usually configured as seen on figure 10 below. ATAIR J was typically moored two and one – i.e. two head lines and one spring line. As there were only two winches with one storage drum each, one of the head lines was tightened by the capstan on the winch and fastened on a bitt. The spring lines were usually 30 to 50 metres long, allowing the rope to stretch in order to lower the tension on it when manoeuvring the ship alongside.

Figure 10: Overview of scene of accident
Source: DMAIB

Only little space was available on the mooring deck for carrying out the normal operations as indicated in figures 10 and 11. This influenced the decision not to have snap-back zones painted on deck. The underlying thinking in painting snap-back zones is that the mooring rope parts in a specific place when it is under tension within a specific angle. However, ATAIR J used a variety of mooring configurations dependent on the design of the berth and position of the ship. Therefore, it was not possible to define safe and unsafe areas without creating a confusing workplace on the mooring deck.

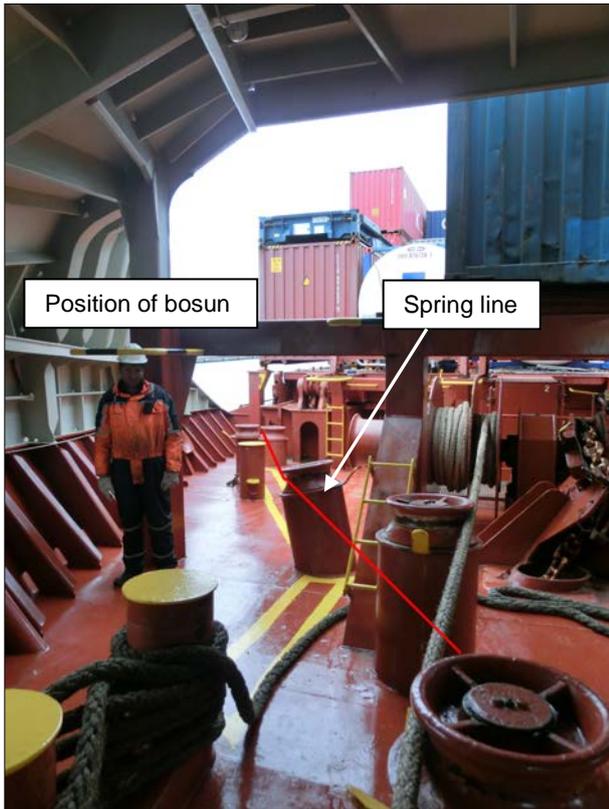
On the day of the accident, the bosun had instructed the OS operating the winch control to slowly slacken the spring line to take some of the tension of the rope. Without warning the rope parted, hit a pillar, whipped around it and hit the bosun across the chest area (figures 11 and 12).

Figure 11: Position of bosun when he was struck by rope.
Source: DMAIB

As indicated in figures 5 and 11, the operator of the winch had little or no overview of the mooring situation and therefore relied on instructions from the bosun. Once the spring line was secured, the crewmembers had to prepare the head lines, throw heaving lines, guide the ropes from the storage drum to the tension drum and communicate with the linesmen ashore – while giving the winch operator instructions. In this stressful environment, the design properties of the deck area challenged the deck hands' ability to create an overview of the situation and assess the real-time risk factors.

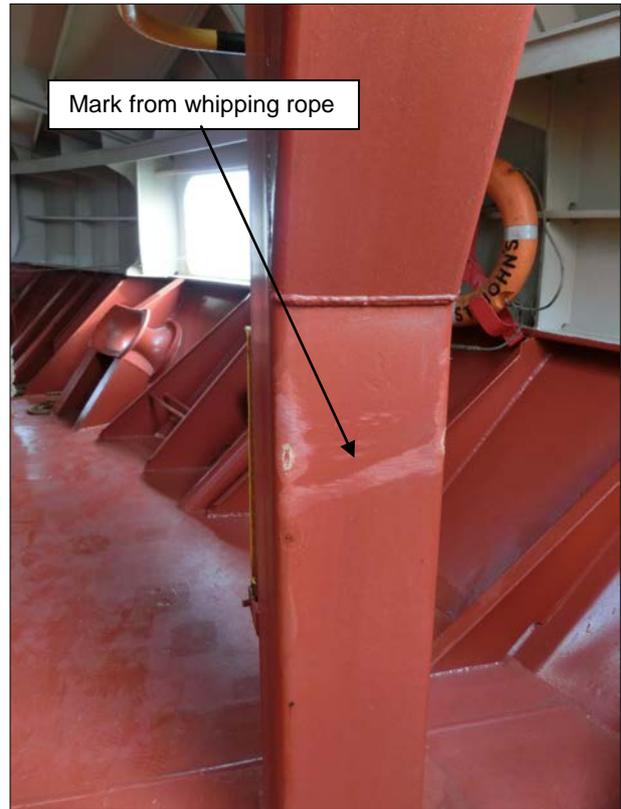
Figure 12: Pillar with marks from rope.
Source: DMAIB

As the rope parted, it whipped back through the fairlead in its entire length. It is, however, uncertain how the parted rope travelled in order to hit the bosun. The other crewmembers on the forecastle were having their attention occupied by different tasks related to the mooring operation and did not see the actual event. Furthermore, immediately after the accident, the parted rope was used as a head line and therefore the position of the rope after the accident was uncertain.
