This marine accident report is issued on 4 April 2014.

Case no.: 2012011094

Front page: Forward mooring station on PACHUCA. **Source:** DMAIB

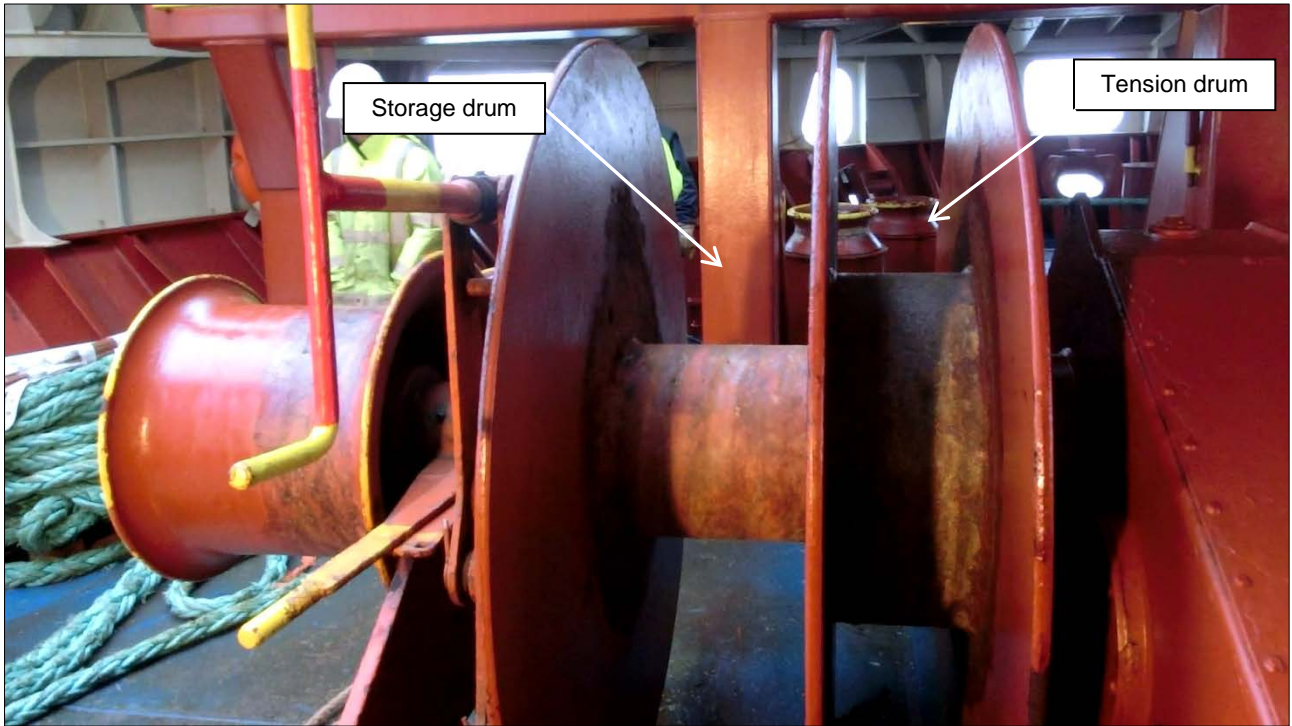
Figure 3: Forecastle deck
Source: DMAIB/PACHUCA

The fore-castle on PACHUCA was enclosed. There was a mooring arrangement that consisted of two winches with split drums with one storage drum and one tension drum (figure 3). The winches were situated in the centre of the deck (figure 6). On the starboard side, the winch was a combined anchor and mooring winch.

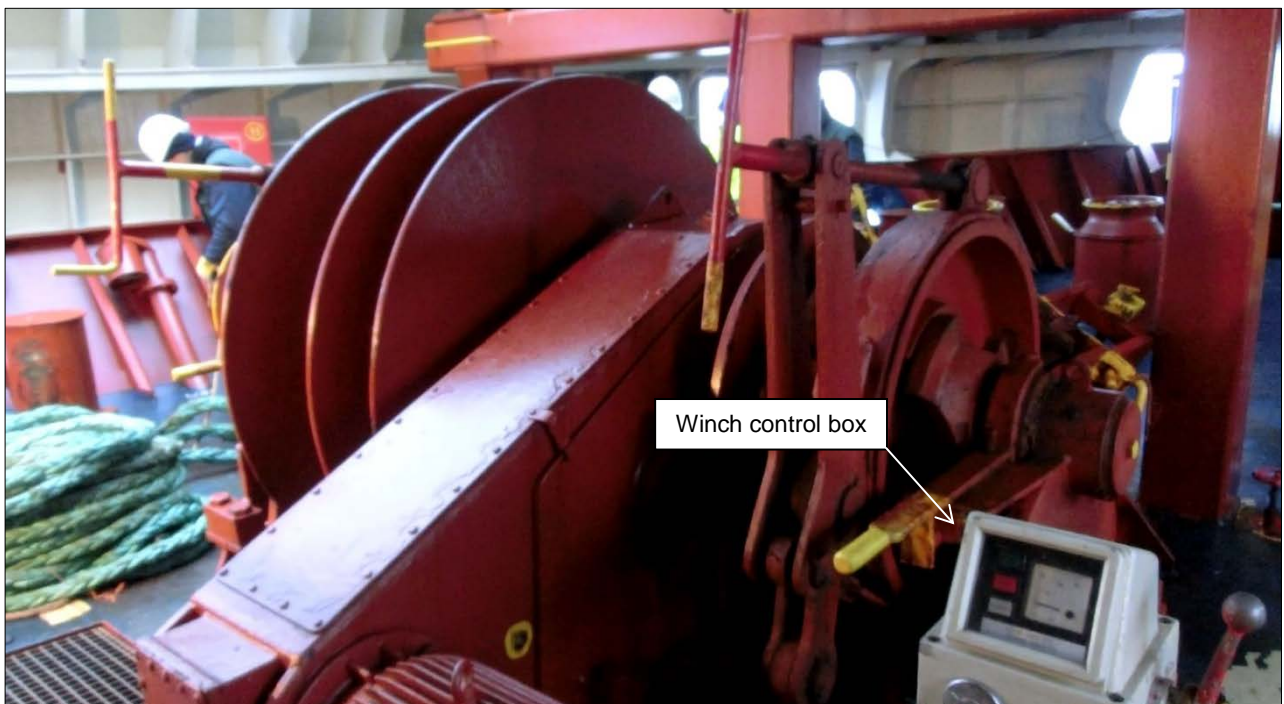
Figure 4: Approximate view from the position of the operator of the winch
Source: DMAIB

The position of the control box gave little or no view of the deck area in front of the winch and to the port side of the winch or of the mooring line on the winch drums (figure 4). Furthermore, the fairlead that was typically used for the spring lines was not visible. Therefore, the operator of the winches relied on communication and signalling from the other crewmembers when determining when to heave or slack the mooring line.

The winch control was positioned in such a way that the operator of the winch had little or no overview of the mooring situation. Therefore, any response to the changing circumstances would be delayed because the information was passed on between several crewmembers.

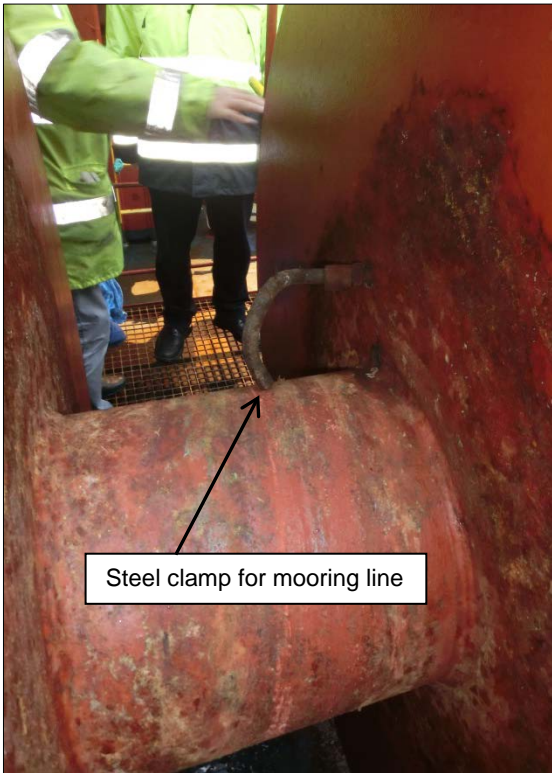
Figure 5: Storage drum and steel ring
Source: DMAIB

Within 10-15 seconds, the spring line was slacked until there was no mooring rope left on the winch drum. The clamp, where the mooring line was fastened, broke and the line struck the bosun.

The two mooring lines were 6-strand cross lay fibre ropes with a diameter of 56 mm and a breaking strength of 652 kN. One of them was 220 metres long and the other one 80 metres long. Both ropes were certified. The mooring line was fastened to the storage drum by a steel clamp (figure 5).

As the line was slacked, they ran out of rope on the drum, it parted from the clamp on the drum and hit the bosun. It has not been established with certainty how the snap-back from the rope managed to come in contact with the bosun.

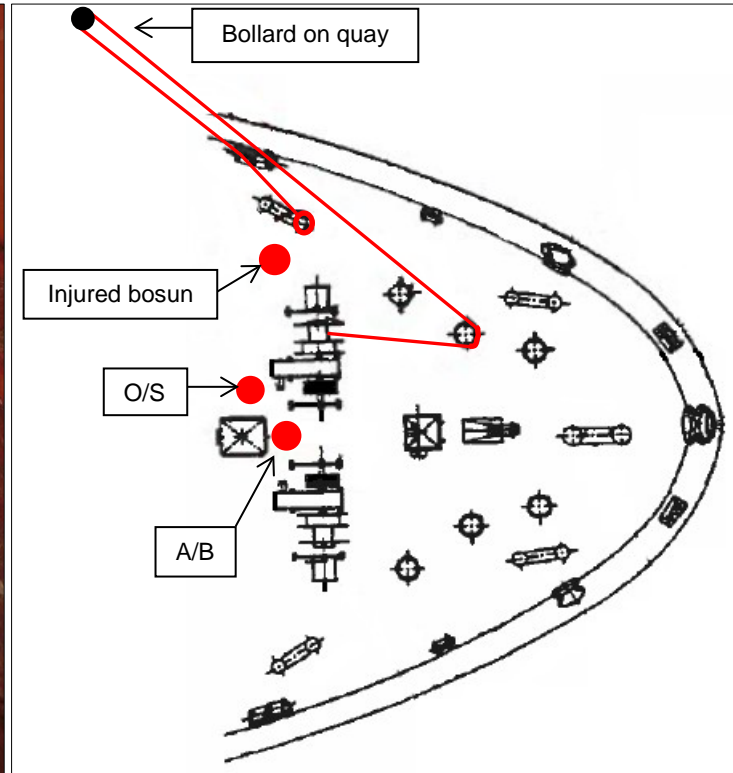
Figure 6: Forecastle deck
Source: DMAIB/PACHUCA

The operator of the winch had difficulty judging the tension applied on the mooring line, as the distance from the winch to the pedestal bitt in front of the winch (figure 6) was short,

approximately 2-3 metres, and thus offered little slack on the rope.

The crewmembers had a limited overview of the operation from their positions on the forward deck (figure 6). Therefore none of them had the realization that the mooring line was slackened until there was no rope left on the drum.

On the day of the accident, the forward mooring of the spring line was configured as seen in figure 6. The line was brought from the working drum on the port winch onto a pedestal fairlead and from there out through the shipside fairlead. From the bollard on the quay, the mooring line was fastened in a loop and brought back through the shipside fairlead and fastened on a bitt on the portside of the forecastle.

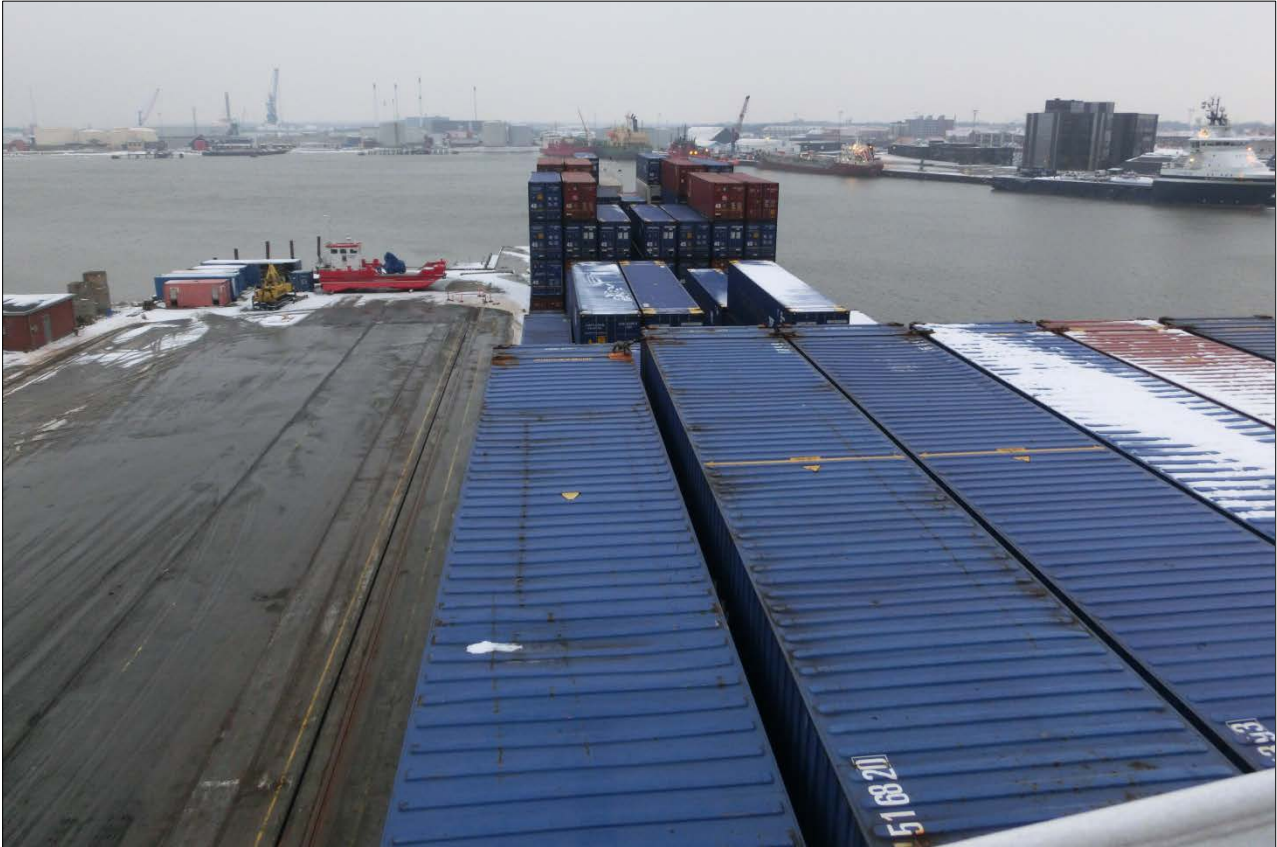
Figure 7: View from bridge on the day of the accident
Source: DMAIB

There was a limited view of the forward mooring station from the bridge (figure 7) and the master therefore relied on the effectiveness of the communication with the crewmembers on deck.
