Danish Maritime Accident  
Investigation Board

# SAFETY REPORT

**PACHUCA**  
**Mooring accident on 14 December 2012**

**This marine accident report is issued on 4 April 2014.**

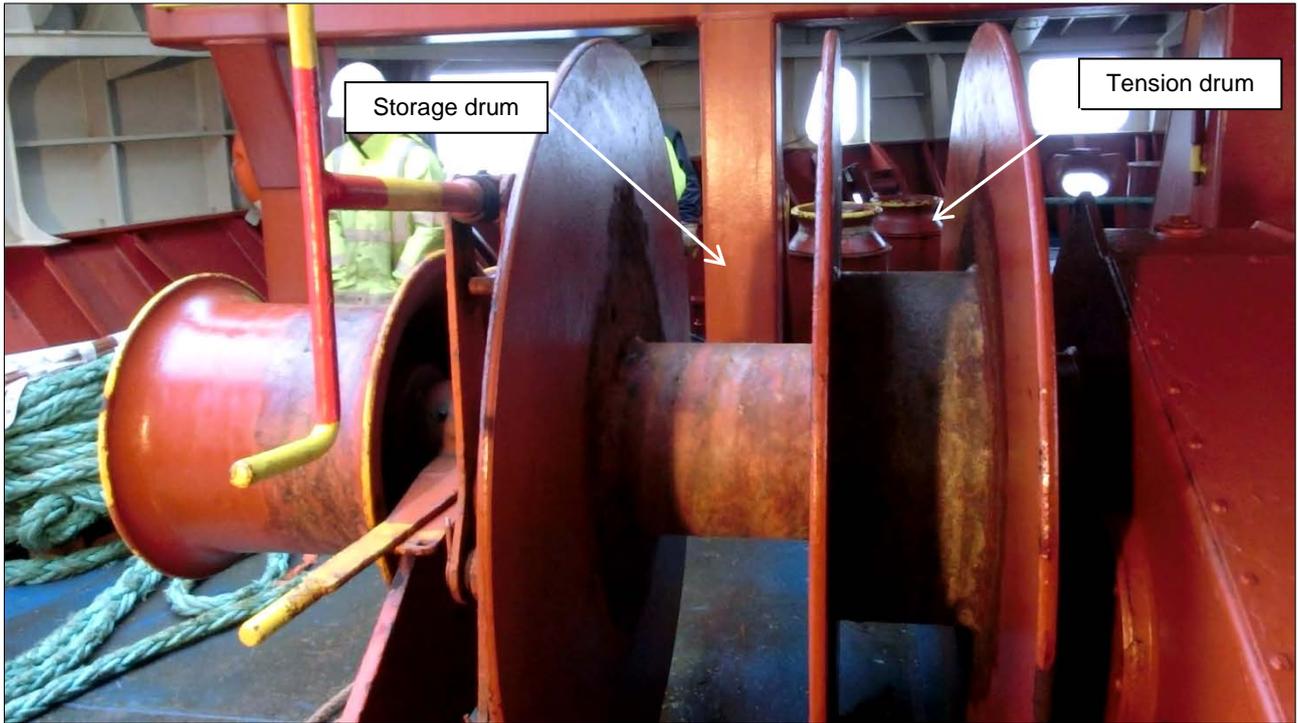
Figure 3: Forecastle deck  
Source: DMAIB/PACHUCA

The fore-castle on PACHUCA was enclosed. There was a mooring arrangement that consisted of two winches with split drums with one storage drum and one tension drum (figure 3). The winches were situated in the centre of the deck (figure 6). On the starboard side, the winch was a combined anchor and mooring winch.

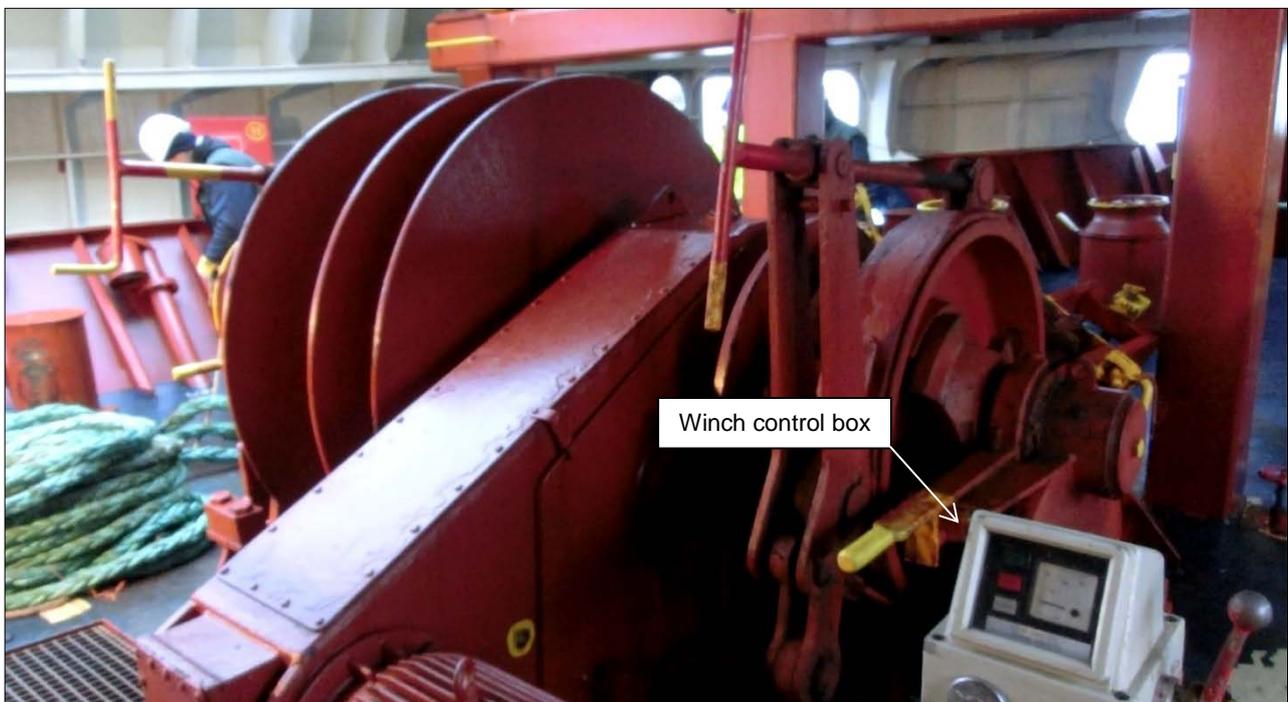
Figure 4: Approximate view from the position of the operator of the winch  
Source: DMAIB

The position of the control box gave little or no view of the deck area in front of the winch and to the port side of the winch or of the mooring line on the winch drums (figure 4). Furthermore, the fairlead that was typically used for the spring lines was not visible. Therefore, the operator of the winches relied on communication and signalling from the other crewmembers when determining when to heave or slack the mooring line.

The winch control was positioned in such a way that the operator of the winch had little or no overview of the mooring situation. Therefore, any response to the changing circumstances would be delayed because the information was passed on between several crewmembers.

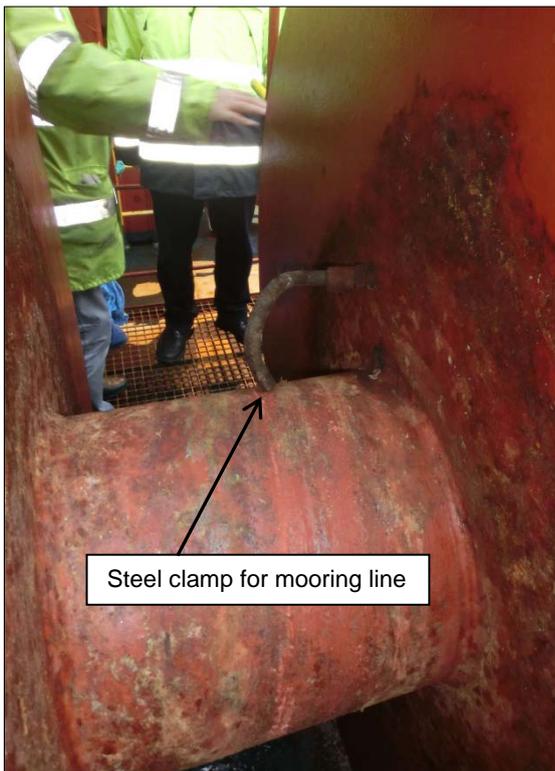
Figure 5: Storage drum and steel ring  
Source: DMAIB

The two mooring lines were 6-strand cross lay fibre ropes with a diameter of 56 mm and a breaking strength of 652 kN. One of them was 220 metres long and the other one 80 metres long. Both ropes were certified. The mooring line was fastened to the storage drum by a steel clamp (figure 5).

As the line was slacked, they ran out of rope on the drum, it parted from the clamp on the drum and hit the bosun. It has not been established with certainty how the snap-back from the rope managed to come in contact with the bosun.

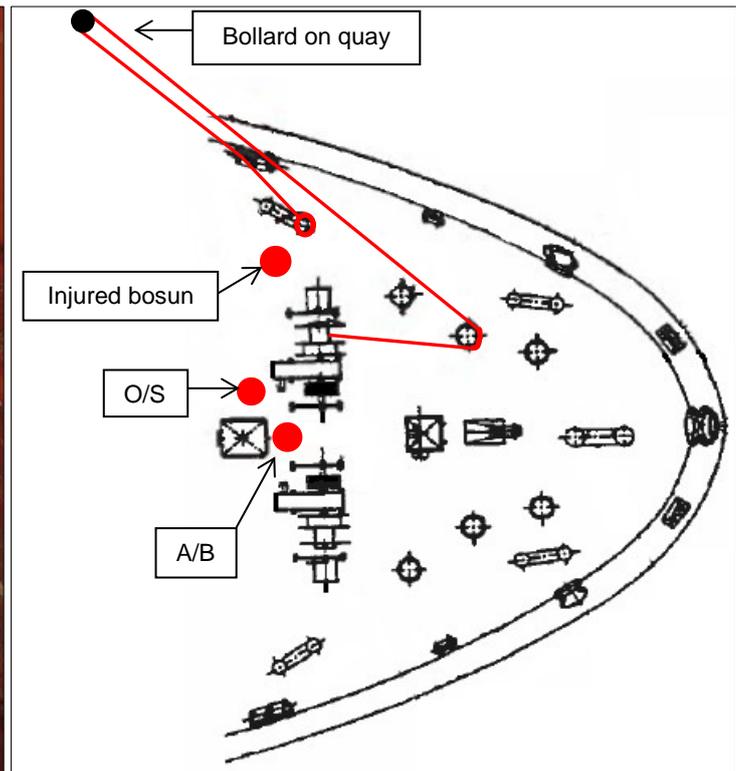
Figure 6: Forecastle deck  
Source: DMAIB/PACHUCA

The operator of the winch had difficulty judging the tension applied on the mooring line, as the distance from the winch to the pedestal bitt in front of the winch (figure 6) was short,

approximately 2-3 metres, and thus offered little slack on the rope.

The crewmembers had a limited overview of the operation from their positions on the forward deck (figure 6). Therefore none of them had the realization that the mooring line was slackened until there was no rope left on the drum.

On the day of the accident, the forward mooring of the spring line was configured as seen in figure 6. The line was brought from the working drum on the port winch onto a pedestal fairlead and from there out through the shipside fairlead. From the bollard on the quay, the mooring line was fastened in a loop and brought back through the shipside fairlead and fastened on a bitt on the portside of the forecastle.

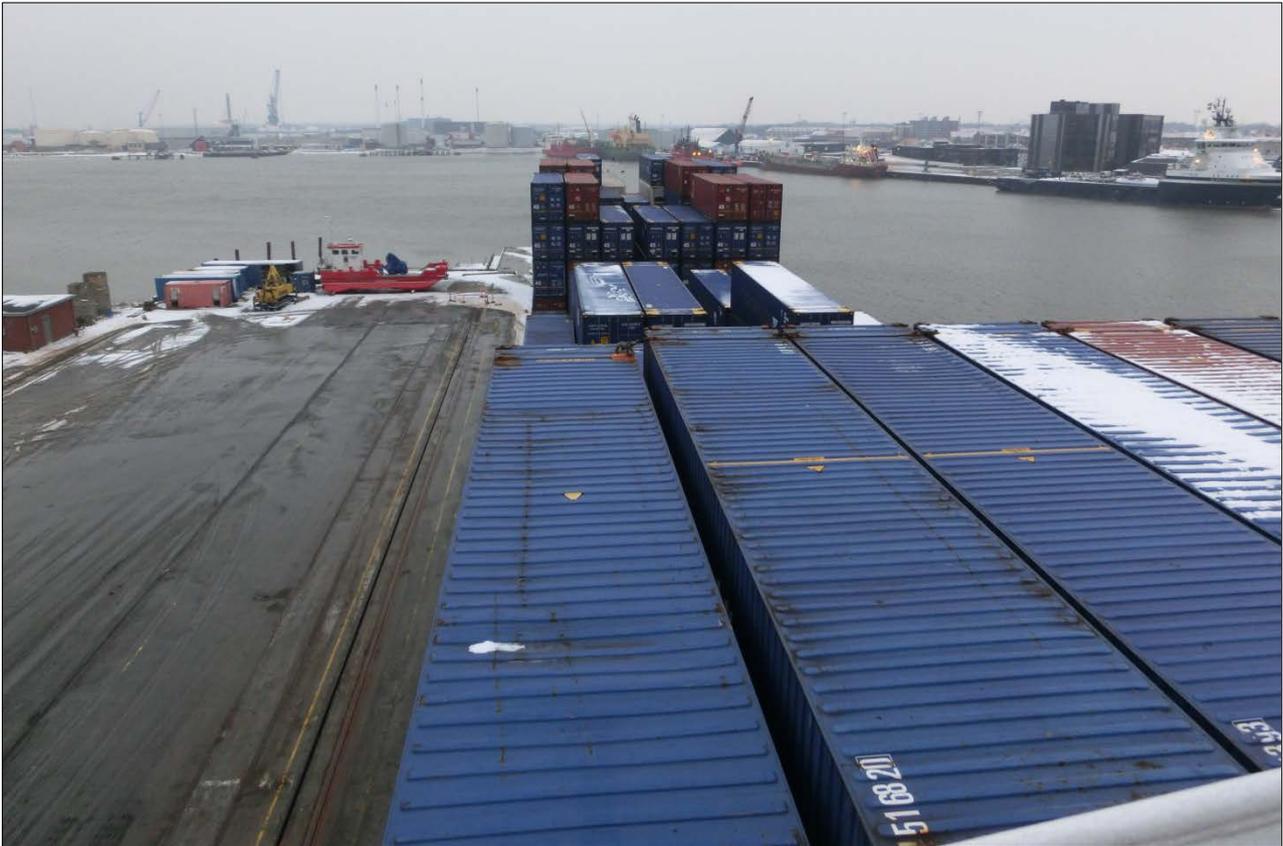
Figure 7: View from bridge on the day of the accident  
Source: DMAIB

There was a limited view of the forward mooring station from the bridge (figure 7) and the master therefore relied on the effectiveness of the communication with the crewmembers on deck.
