Danish Maritime Accident
Investigation Board

MARINE ACCIDENT REPORT

VEGA SAGITTARIUS
Grounding on 16 August 2012

Case number: 2012003009

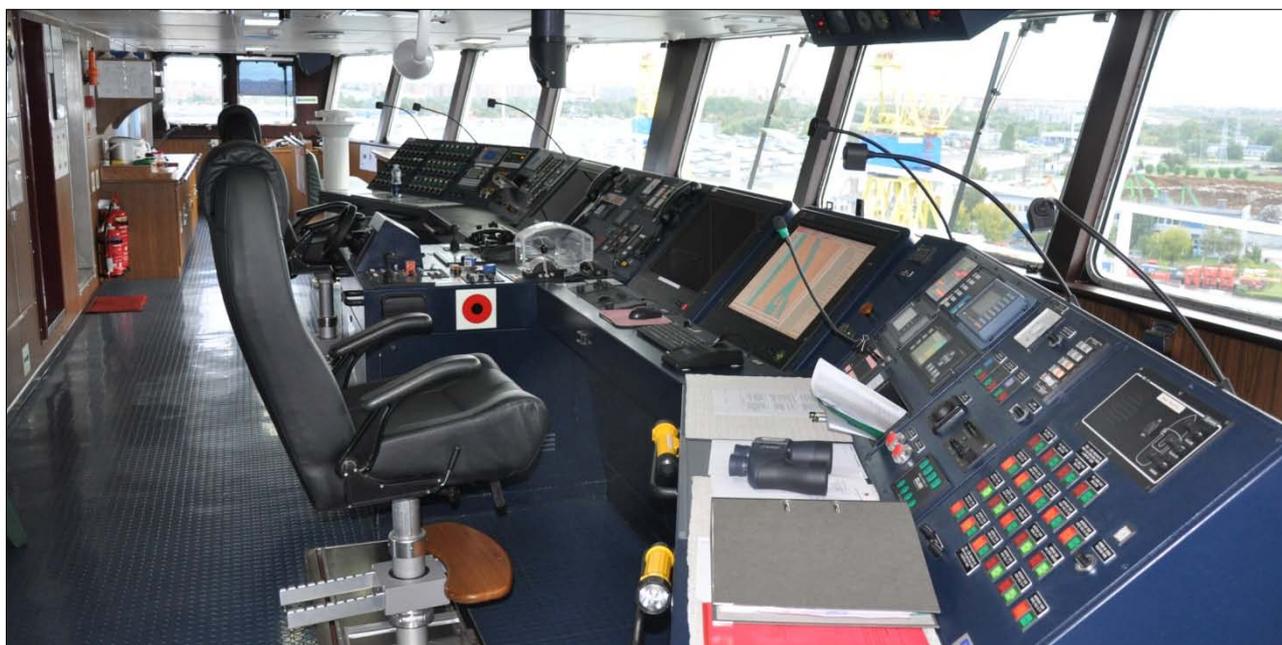
Figure 3: View of the bridge from the starboard side
Source: DMAIB

Below in figure 3 is a picture of the bridge and the conning stations. The one that was typically used was the one by the chair. The chart table was placed behind the conning station at the exit to the stairway. While plotting positions on the chart, there is a limited view out of the bridge front end windows.

The echo sounder is mounted on the bulkhead above the chart table. The alarm settings on the echo sounder were not used by some crew members as it was considered impracticable since the water depth would often vary during arrival and departure and resetting and continuously changing the alarm limits would increase the work load with little added value.

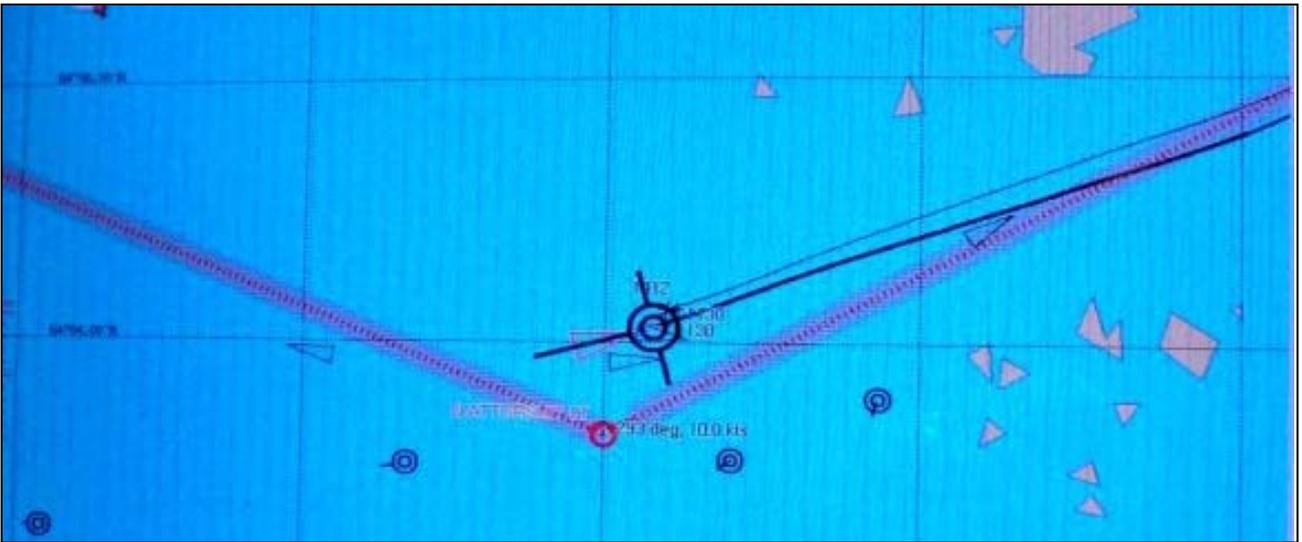
Figure 4: Picture of display on ECS
Source: Danish police

The navigational officers relied on the ECS for navigation purposes. The passage plan was made in the ECS and then transferred to the radar. The route was not programmed in either of the GPSs. There was one GPS on the front end bridge consol and one by the chart table. Usually, the position was established by GPS and plotted on the chart. This was done as a matter of habit and for documentation purposes – real time navigation was usually carried out on the ECS because experience had shown that this was an effective way of navigating.

No ARCS³ or digital charts were available on board for the area of Nuuk or other areas in Greenland. The ARCS charts for Greenland are available only in the scale 1:10 mill which was not suitable for navigation in the approaches to Nuuk. Therefore, no approved chart was available on the ECS. On figure 4 below is a picture of the information available to the navigator on the ECS.

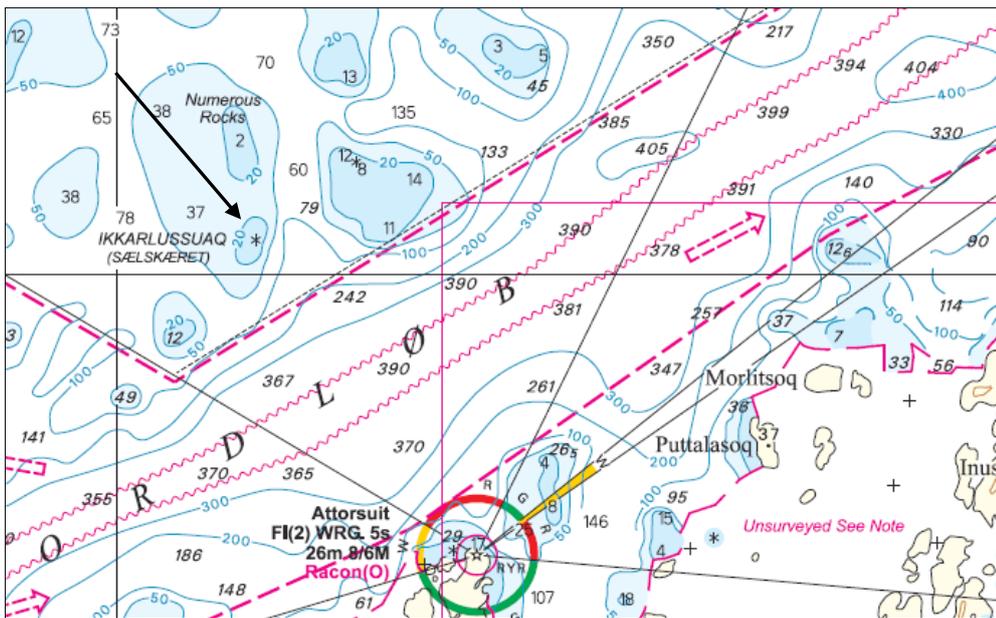
Figure 5: Picture of Sælskæret from chart 1331
Source: DMAIB

The paper chart used during the time of the accident was chart 1331 from the Danish Geodata Agency as seen in figure 5 below. The arrow points towards a symbol in the chart that indicates that there is a rock which covers and uncovers depending on the tide. This was the position of the grounding. There was no buoyage indicating the low water depth.

No buoyage was observed indicating shallow waters. With a speed of 16-17 knots and a distance of approximately 150 metres from the 100 metre depth contour line to the shallow area, any setting on the echo sounder would not have been capable of giving sufficient warning to prevent the grounding.

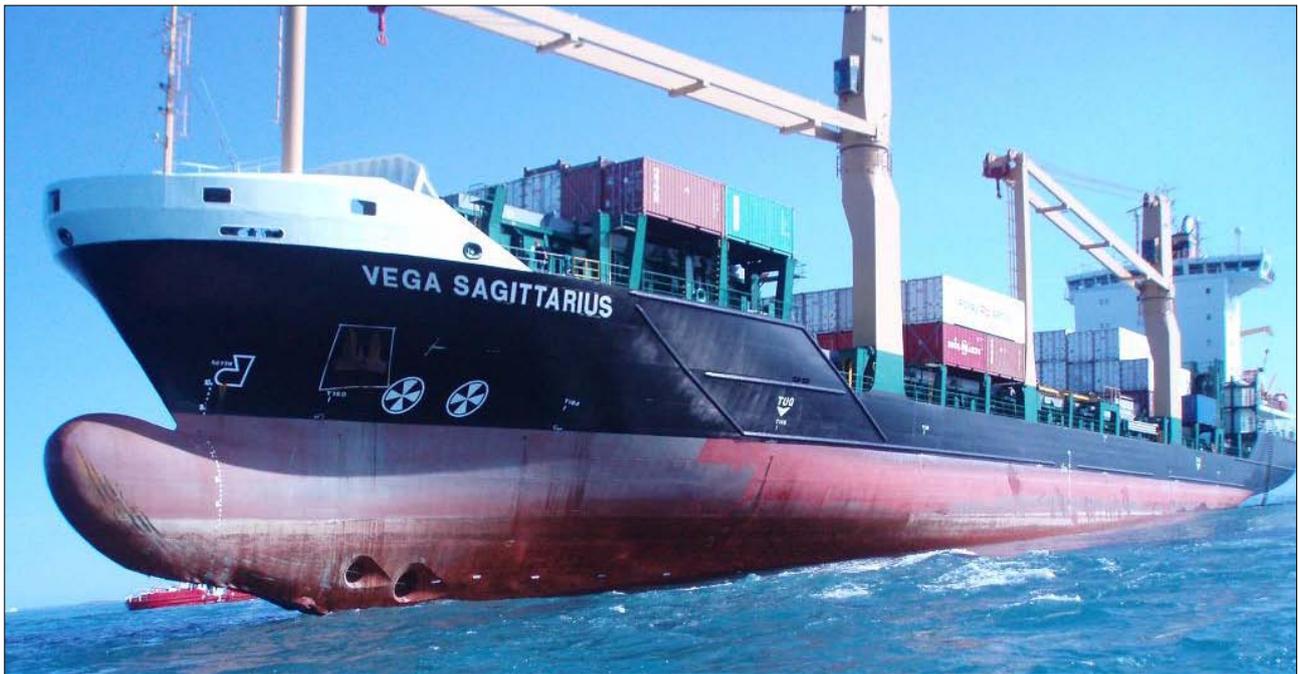
Figure 3: VEGA SAGITTARIUS
Source: Danish police

At 1347, it was established that the vessel was on the ground amidships and on each side on the forward part of the vessel, see figure 3 below.
