MARINE ACCIDENT REPORT

April 2013

ANNA MÆRSK

Fatal accident to seafarer on 27 March 2012

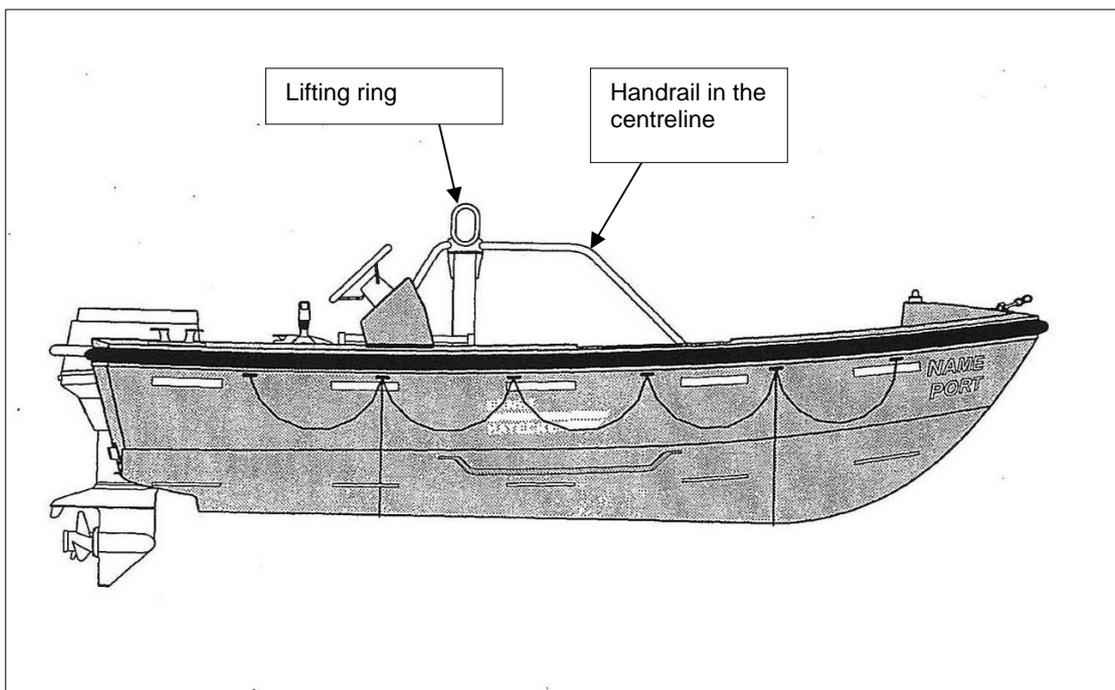
Figure 3: The rescue boat
Source: A.P. Moeller-Maersk

The later deceased AB embarked the rescue boat first. He moved to a standing position in the port side just aft of the centreline handrail (see figure 3 below). At this time nothing out of the ordinary was noticed by any of the crewmembers participating in the exercise. When the AB had positioned himself in the boat, the chief officer embarked. The chief officer took approximately two steps forward and passed forward of the centreline handrail to the port side in the boat when suddenly without warning the boat fell approximately 18 metres to the water.

The rescue boat on board ANNA MÆRSK consisted of a RB 430 rescue boat manufactured by "Ernst Hatecke" as seen in figure 3 below. The complete rescue boat arrangement as seen in figure 4 below was a combined stores crane and rescue boat crane. The two functions, stores crane and rescue boat crane, were separated and used different hook systems.

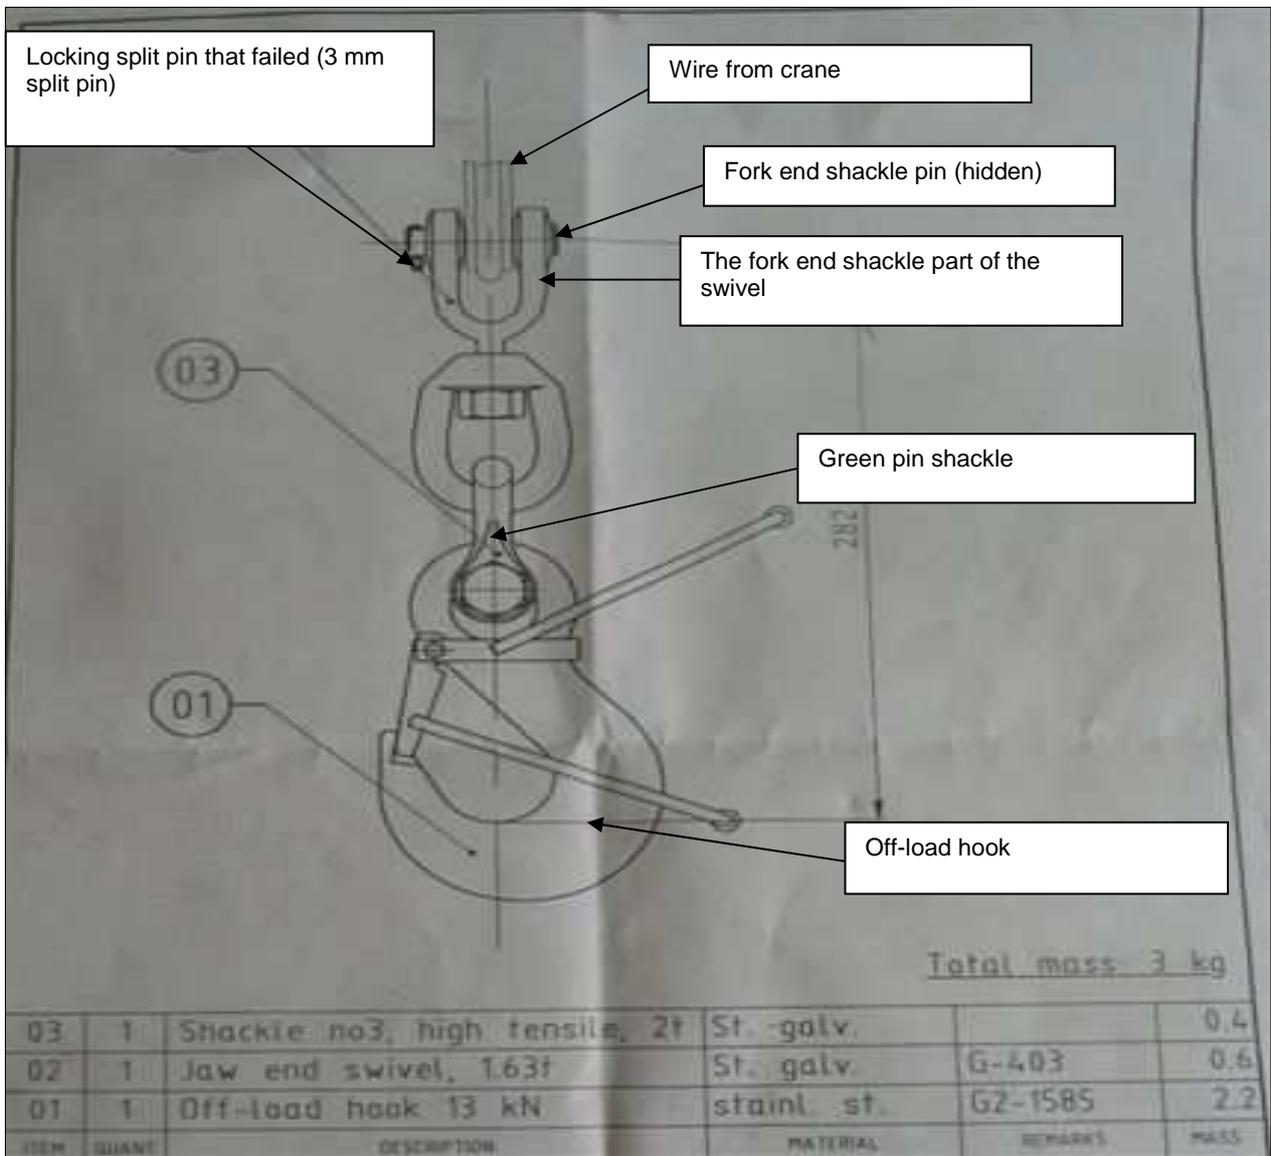
Figure 5: Picture of manufacturer's drawing of the hook arrangement
 Source: Davit International/A.P. Moller-Maersk

From the wire fall the boat was suspended in a hook arrangement consisting of an off-load hook and a swivel. The swivel was composed of a fork end shackle and a green pin shackle as seen in figure 5 below. The actual hook arrangement can be seen in figure 6 below.

Compared to the intended direction of installing the hook arrangement, the actual arrangement was installed upside down. It has not been possible to establish when the arrangement was first installed upside down. All involved personnel who were interviewed by the investigation board only remember having seen the arrangement installed as on the day of the accident.

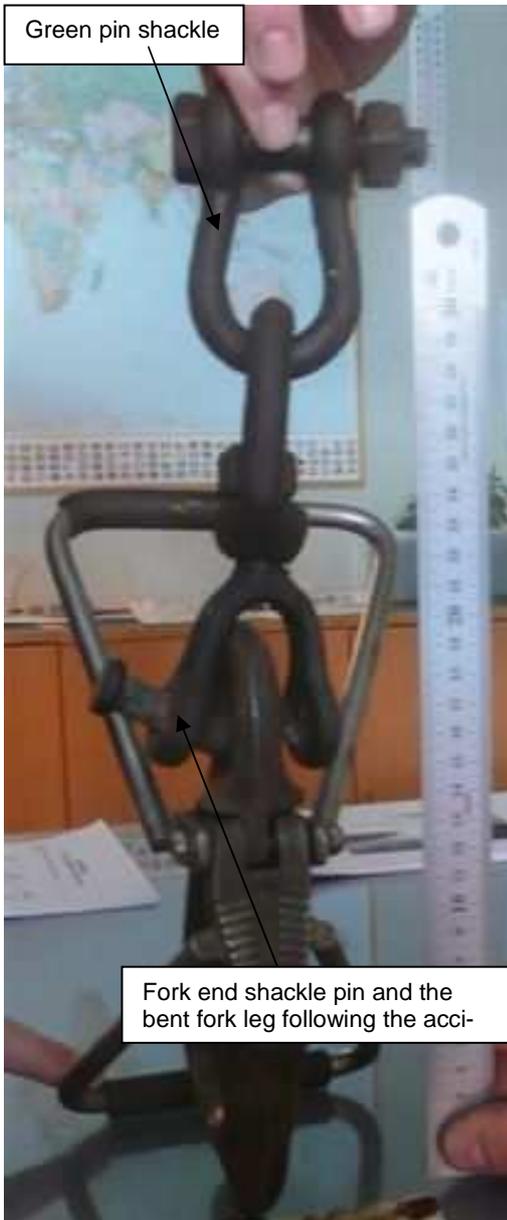
Figure 6: The hook arrangement following the accident
Source: DMAIB

In the green pin shackle end of the arrangement, the pin was secured with a nut and a split pin. In contrast, in the fork end shackle the pin was secured only by one 3 mm split pin made of mild steel. As this split pin broke away, the pin was able to work itself out of the swivel fork. When this happened, all the weight from the rescue boat, equipment and crew was in an instant transferred to the pin and one side of the fork. This created a bending moment that caused the opposite leg of the fork to bend as seen in figure 6 below. The opening caused by the bending leg in the fork enabled the off-load hook to pass between the pin and the other side of the fork.

Following the accident, the swivel was found as seen in figure 5 above and it was still attached to the wire by the green pin shackle. It was apparent that the visible parts of the split pin on the fork end shackle pin had broken off thereby allowing the pin to work itself out of the fork.

The breakdown was caused by the split pin failing. Due to the missing split pin, the fork end shackle pin was able to work itself out of the fork leg.

The breakdown was caused by the split pin in the fork end shackle pin having sheared off, thereby allowing the fork end shackle pin to move out of one of the fork ends.

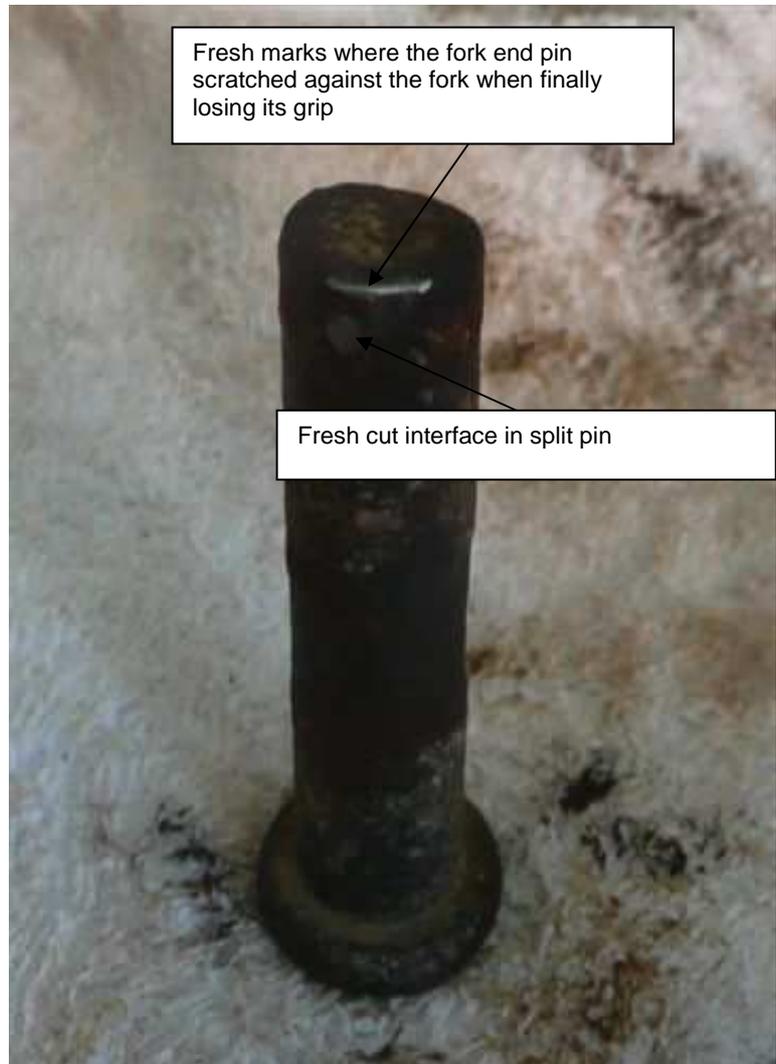
Figure 7: The fork end shackle pin with marks after split pin and scrape marks from losing grip and contact with the fork end
Source: DMAIB

Figure 7 below shows the fork end shackle pin with the remaining parts of the split pin. Also seen is the scrape mark from the fork end shackle pin losing its grip in the fork.

The split pin was made of mild steel. Considering the environment in which it was supposed to fulfil its function, it is considered very likely that the surface of such a split pin has been exposed to and affected by the effects of the environment. These effects of exposure may have made it more difficult to observe any damage to the arrangement, including the split pin.
