MARINE ACCIDENT REPORT

NORDIC NADJA
Accident to seafarer on 8 October 2011

This marine accident report is issued on 12 March 2012

Case number: 201111721

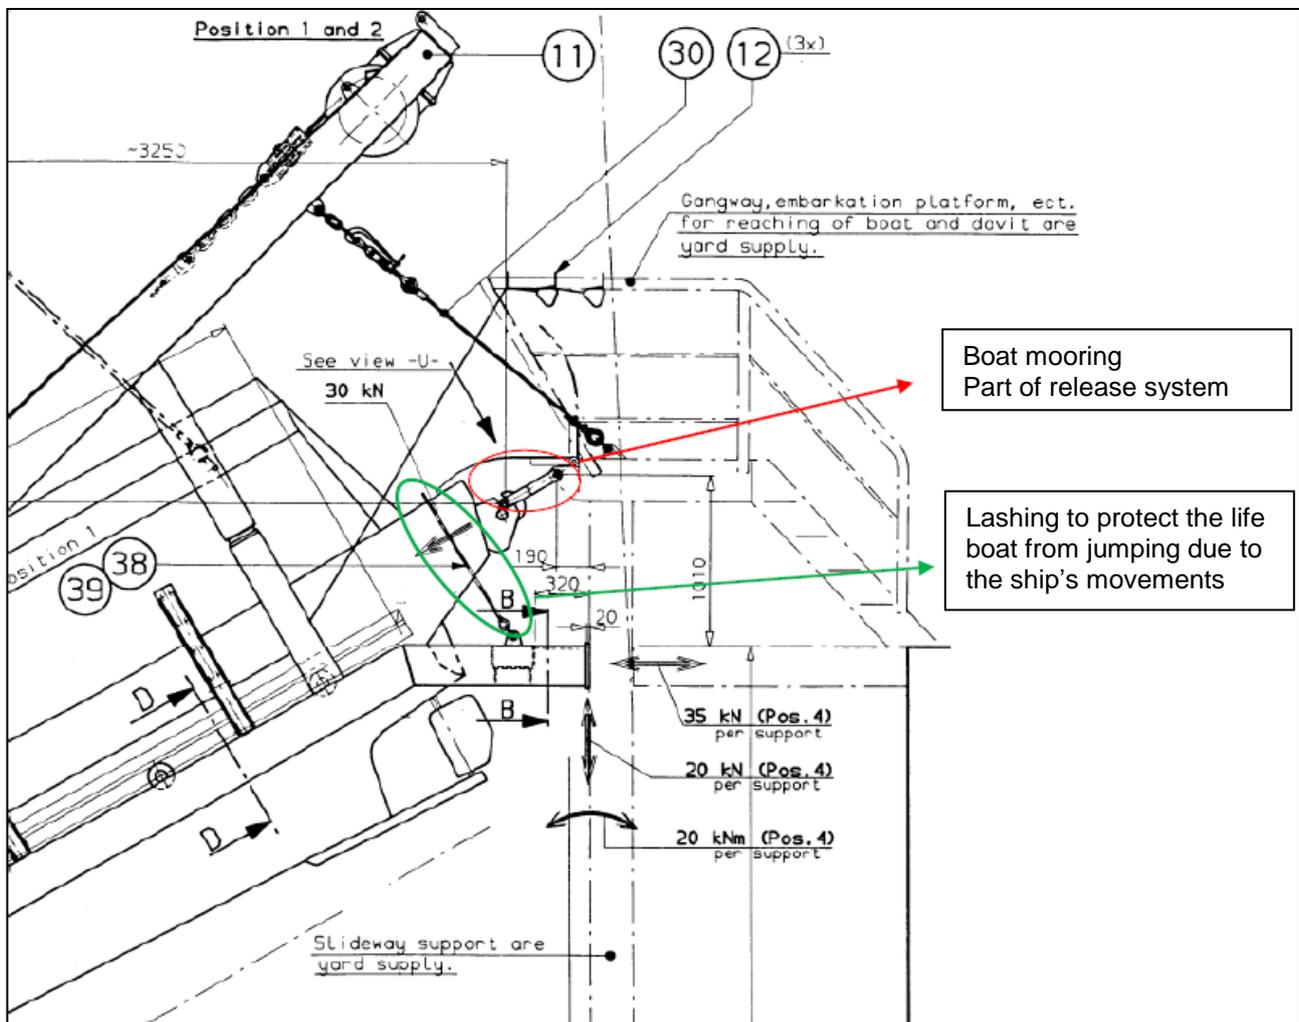
The figure below shows the aft end of the FFB secured on its platform. Encircled in red is the boat mooring which is part of the release system, and encircled in green is the lashing intended to protect the boat from jumping in heavy seas.

Figure 3 showing the FFB on its platform.

A lashing to protect the life boat from jumping up and down due to the ship's movements was torn apart at the accidental release of the FFB

At the inspection on 8 October 2011, there was no safety strap around the FFB, and no fall prevention wire or other means of protection had been mounted. The FFB was thus only attached to the platform by the FFB boat mooring, which is part of the release system.

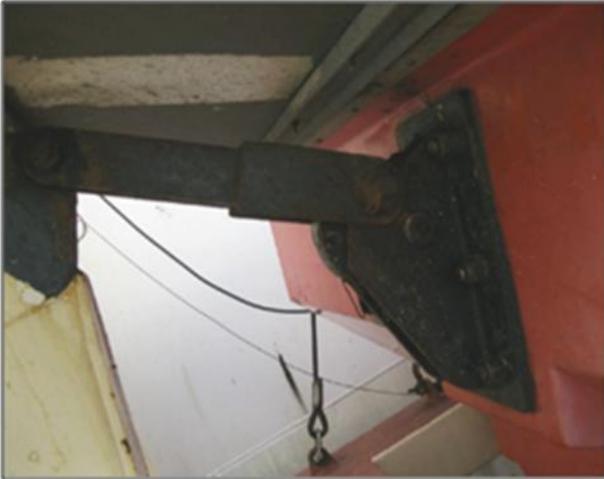
Figure 4 Boat mooring with release hook

It is the assessment of the Investigation Board that a contributing factor to the unintentional fall of the FFB was the lack of a safety strap and fall prevention wire or other means of preventing an unintentional fall.

It was ordered that the free fall boat was to be fastened to lifting hooks before any entry for service or repair.

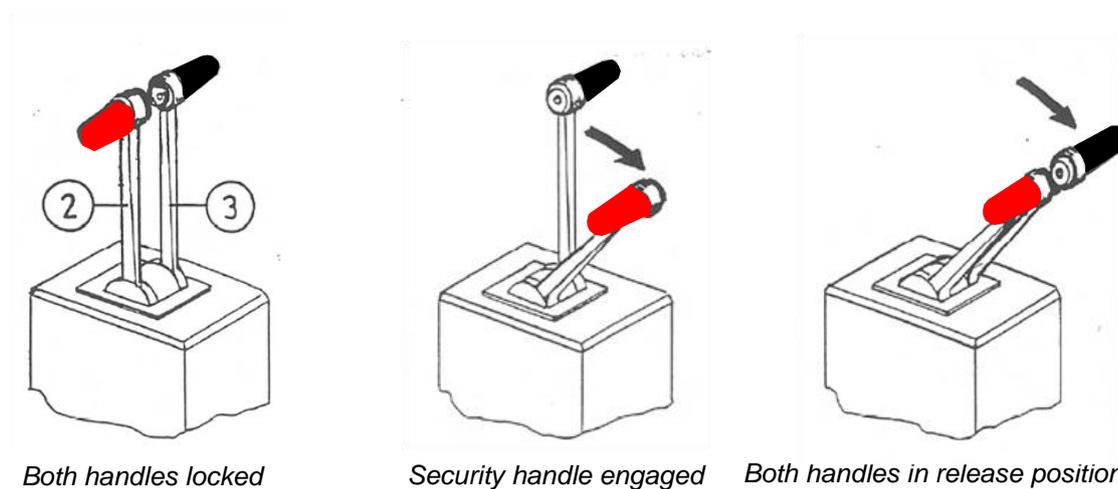
Both handles locked

Security handle engaged

Both handles in release position

Figure 5 – Operation of the handles to release the FFB.

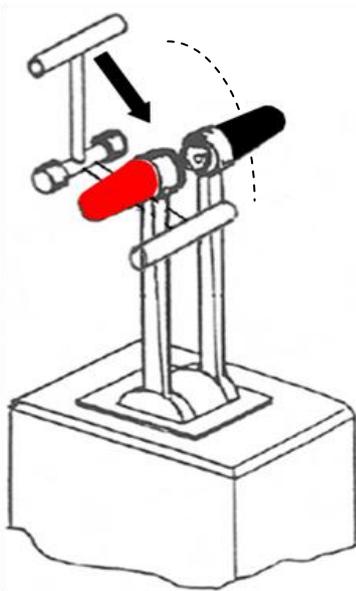
Figure 6 – Safety device to lock the operating handles.

The investigation revealed that the design of the safety device attached to the handles was not in accordance with the description in the manual on board NORDIC NADJA.

The manufacturer confirmed that no such system as shown in the manual was installed in the FFB on board NORDIC NADJA.

Instead, the safety system for preventing unintentional release of the boat should consist of a ring surrounding both shafts of the handles and fastened to the FFB by a chain. This system was not installed in the FFB on board NORDIC NADJA or two sister ships carrying the same mark of FFB.

No other or additional safety device was installed in the free fall boat. Thus, there was no safety system to prevent release of the hook holding the boat to the boarding platform.

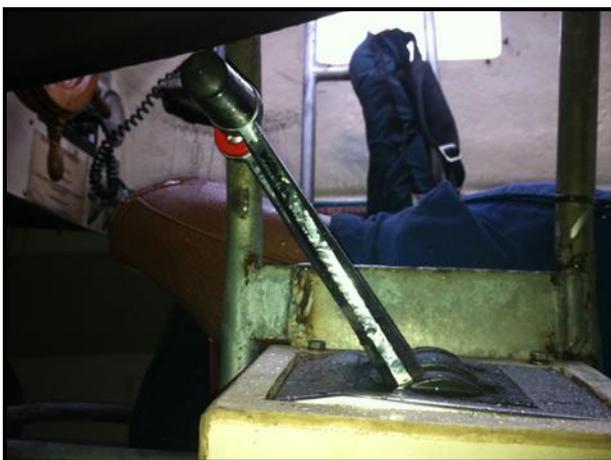
After the accident, the FFB was inspected. The inspection revealed that both the security handle and the release handle had been pushed backward, causing the hook holding the life boat to disengage.

Figure 7 showing the security and release handles in the released position.

A test revealed that it was possible to move both handles simultaneously from the upright position to the position releasing the FFB. It has not been possible to establish the cause of this malfunction.

Subsequently, an examination of the FFBs of the same mark on board two sister ships showed that it was impossible to move the security and release handles simultaneously from the upright position.

The manufacturer has informed that under normal circumstances it is impossible to operate both handles simultaneously. The security handles operate the brake. Not until the brake has been released, can the release handle release the boat.

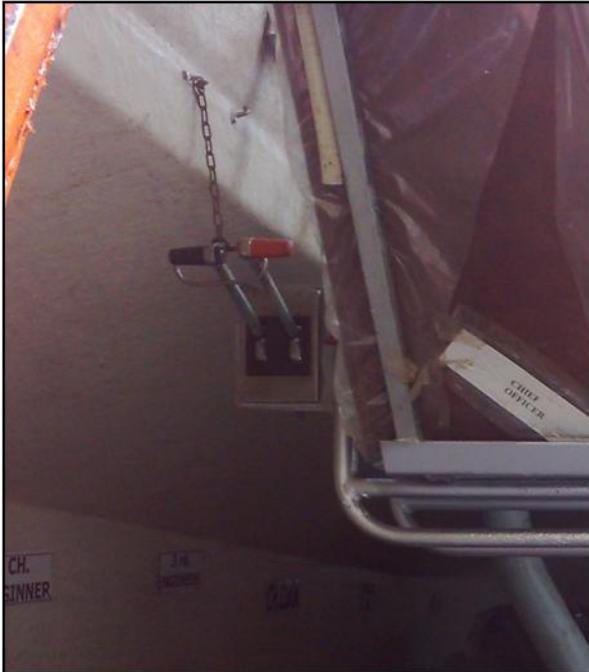
Figure 8. Safety device on NORDIC NADJA

Subsequently, all vessels with free fall boats missing a safety device to prevent unintentional release of the boat were ordered to make immediate temporary modifications in the life boats to prevent the release handles from being unintentionally released.

The three FFBs of the mark FBB PESBO BSL 20 M in the fleet have been fitted with temporary safety devices to prevent unintentional release of the boats. See figures 8 and 9.

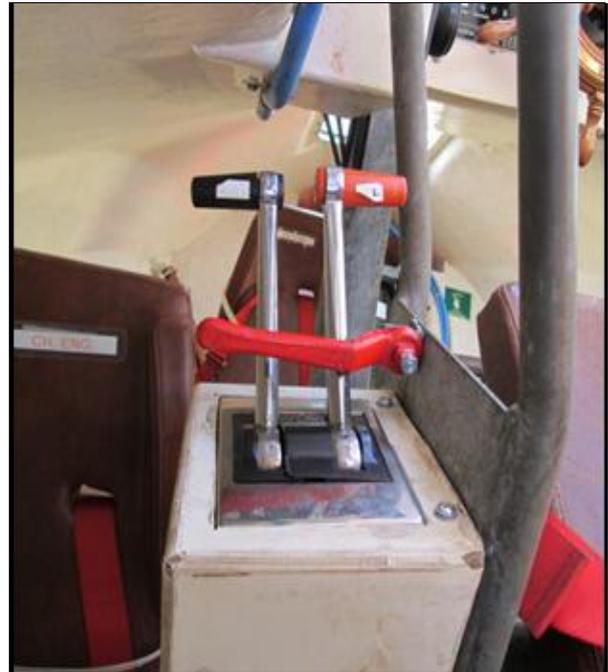
Figure 9. Safety device on NORDIC NORA
