MARINE ACCIDENT REPORT

**CHARLOTTE MAERSK
FIRE
7 July 2010**

Danish Maritime Accident Investigation Board

Case: 201008066

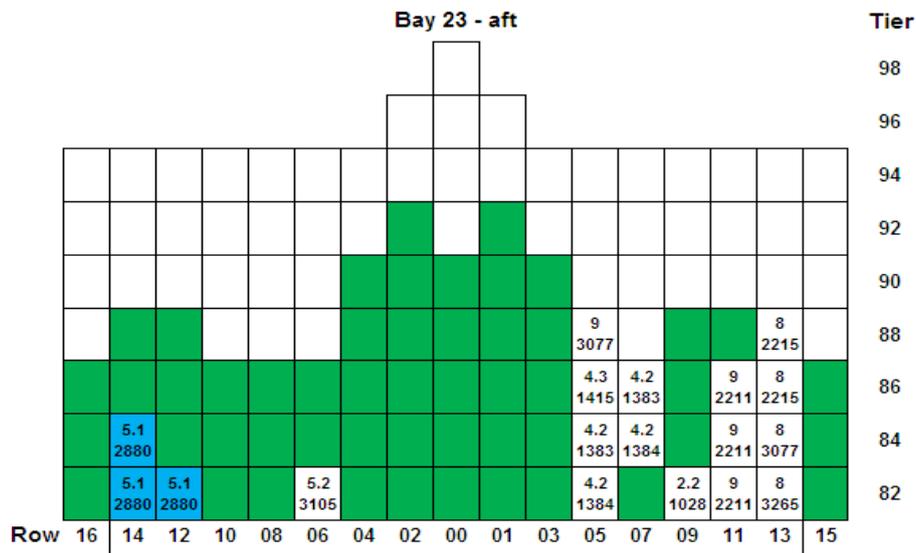
Figure 3

On bay 21/23 (22), there were 32 containers containing various IMO classes and divisions. On the port side on bay 21, there was only one IMDG container in stowage position 211488. On bay 23, there were 18 IMDG containers four of which were on the port side. See figure 3 below of bay 23 seen from the aft.

The numbers refer to the IMO class and UN number. The stowage positions marked with blue colour are reefer containers. The stowage positions marked with green colour are dry general cargo containers.

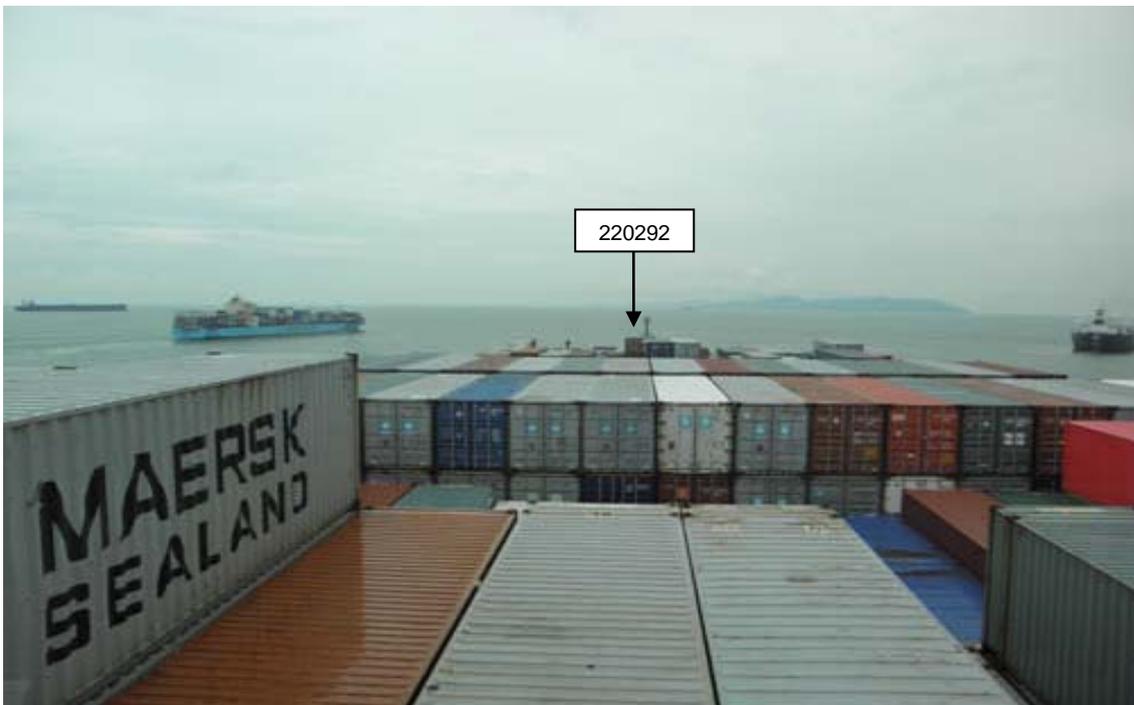
View from bridge

The crew on the bridge who first saw the smoke and flames have given statements that indicate that the smoke came from the port side of the ship. It was also stated that a slight breeze came in from about 30° on the starboard bow and the ship was at full navigational speed. Below is a photograph of the view that the officers had.

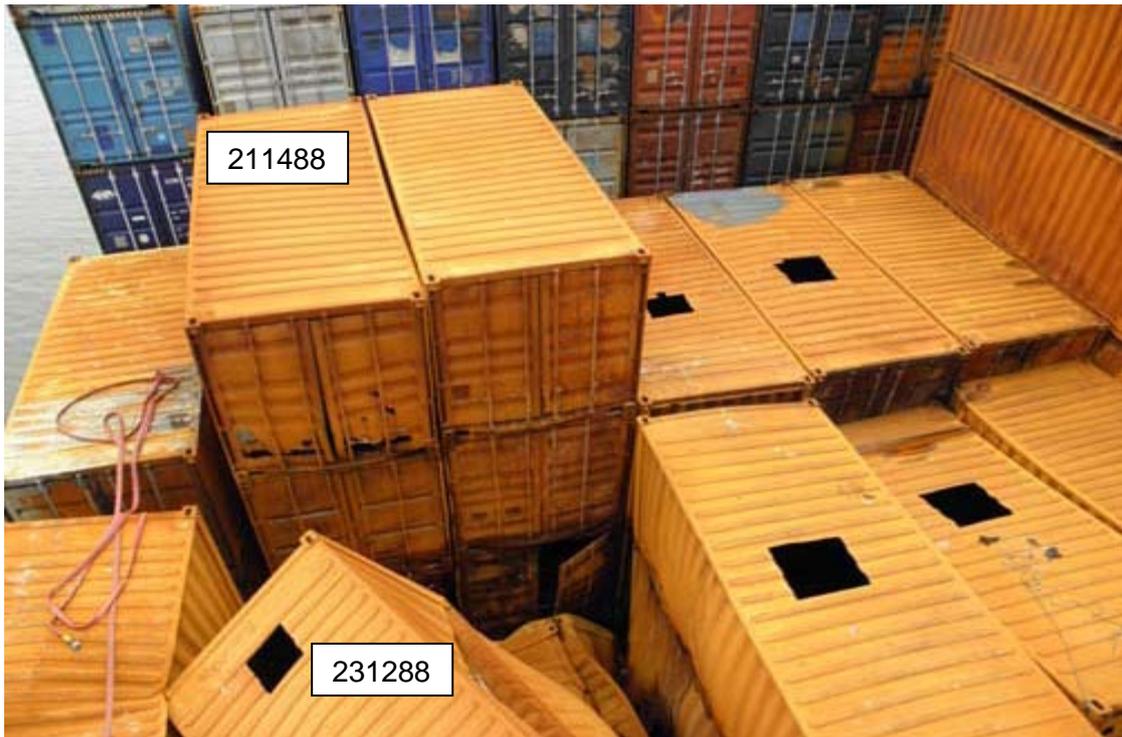
View of bay 22 port side

The circumstantial evidence indicates that the origin of the fire was not in the container containing trichloroisocyanuric acid in stowage position 211488. It is supported by the intensity of the fire during the early stages on bay 23, tier 82, and the limited localized heat damages at the bottom of the doors of the container. The container was otherwise intact. See photograph below.

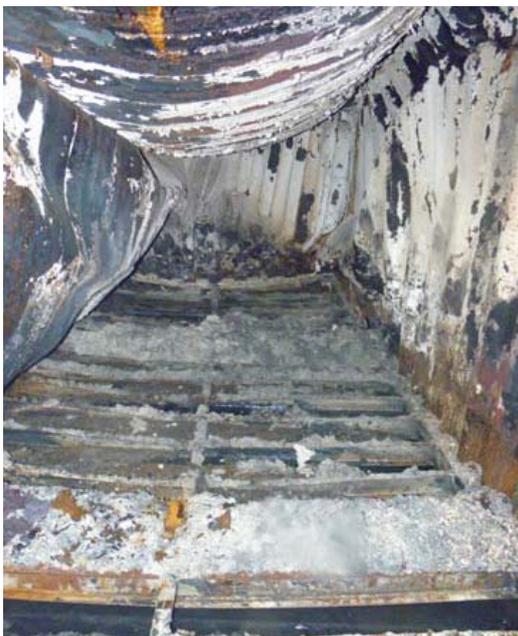
Inside view of MEKP container Photo: Burgoynes

After the fire, there were no remains of the chemical and only small remains of cardboard and plastic were found in the aft end of the container.

The witness evidence suggests that the fire started in a location approximately in the position of the MEKP container.
