**MARINE ACCIDENT REPORT  
DIVISION FOR INVESTIGATION OF MARITIME ACCIDENTS**

**PEARL OF SCANDINAVIA  
Fire  
17 November 2010**

**The casualty report has been issued on 02 August 2011**

**Case:** 201012794

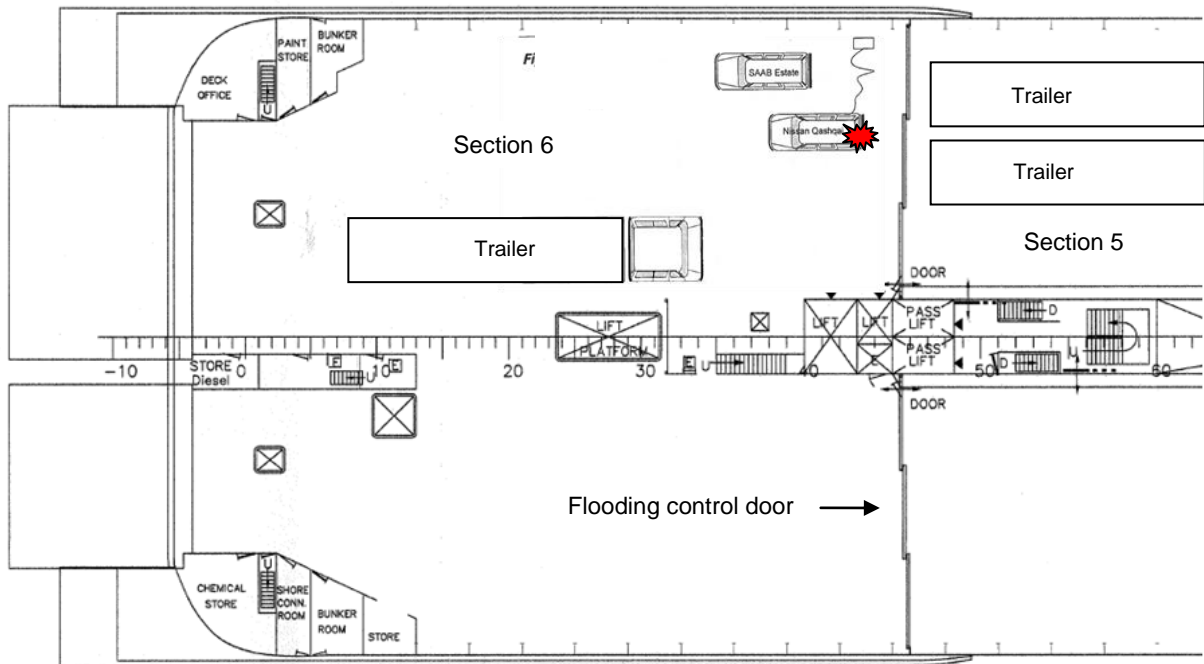
The electric car was parked in the port side just behind such a flooding control door in close proximity to a charging station. The flooding control door divided the car deck into sections 5 and 6 in the port side.

The car's front end was pointing toward the rear end of the ship. The distance between the rear end of the car and the flooding control door was approximately 1 metre.

*The car deck aft showing where the electric car was parked*

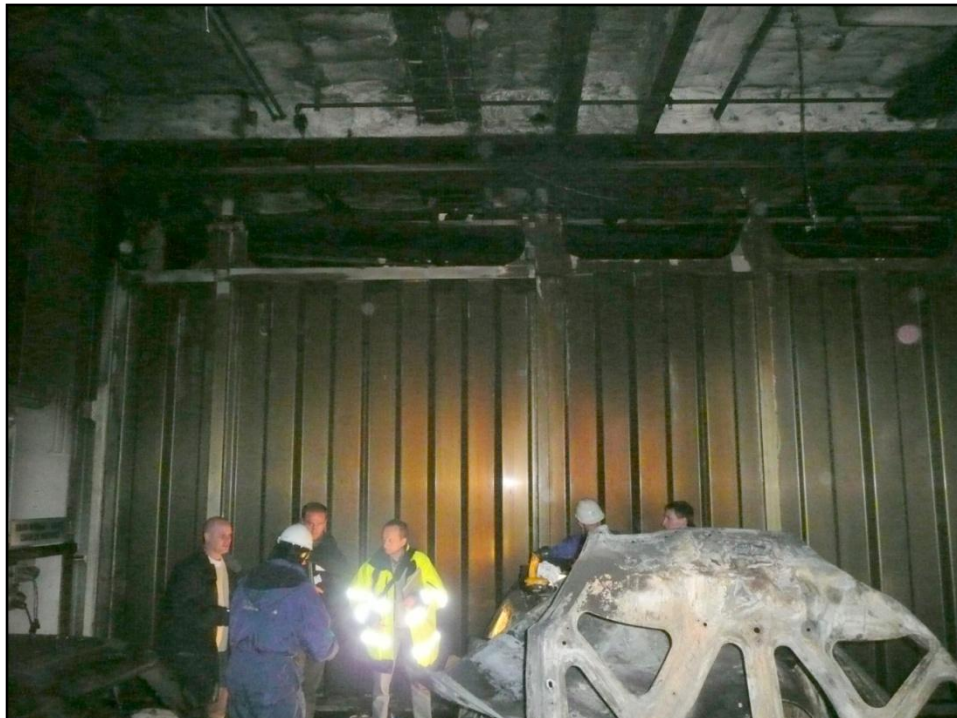
The scene of the fire was deck 3, the car deck. The car deck is divided into sections by flooding control doors. The purpose of these walls is to prevent water from flowing freely between the sections. The flooding control doors do not fit tight to the deck above. From the upper edge of the flooding control door and up to the deck, there is a gap with a height of approximately 0.5 metres.

*The flooding control door and the gap between the door and the deck above*

Some red-hot metal fragments found their way through the gap between the flooding control door and into section 5. This caused two trailers to catch fire in this section.

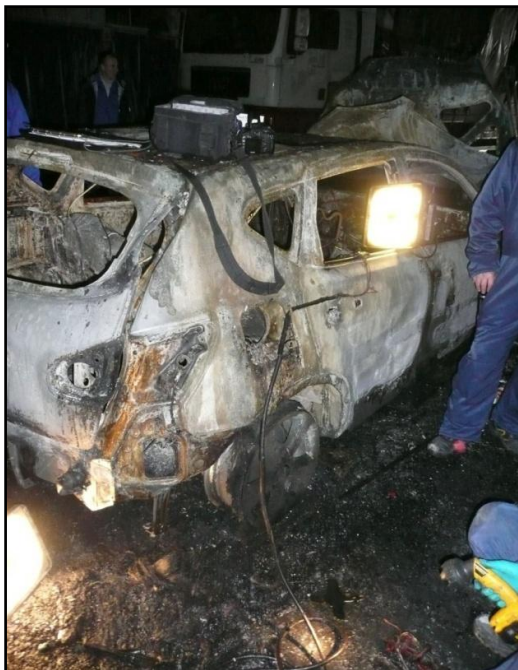
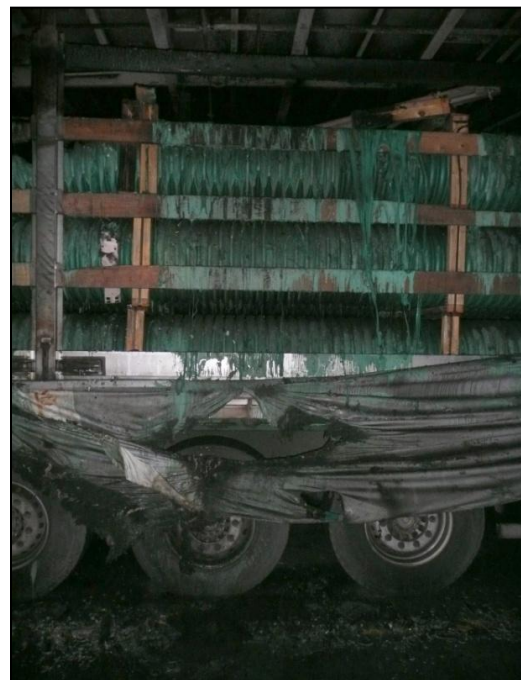
*The electric car and a trailer carrying plastic pipes*

Besides the electric car, a trailer and a car aft of the flooding control door in section 6 caught fire. In front of the flooding control door, two trailers in the port side caught fire as fragments of red-hot metal from the car batteries and flames and heat passed through the gap between the top of the flooding control door and the deck above, the gap having a height of approximately 0.5 metres.

It has been established by the DBI – the Danish Institute of Fire and Security Technology – that the origin of the fire was in a battery pack in the rear end of the electric car.

An explosion in the battery pack in the rear end of the car spread fragments of red-hot metal in section 6.

Immediately after the fire, it was announced that charging of batteries in electric cars, caravans, auto campers, etc. would not be allowed in the companies' ships until further notice.
