Danish Maritime Accident  
Investigation Board

# MARINE ACCIDENT REPORT

**VESTURLAND**  
**Fire on 7 January 2017**

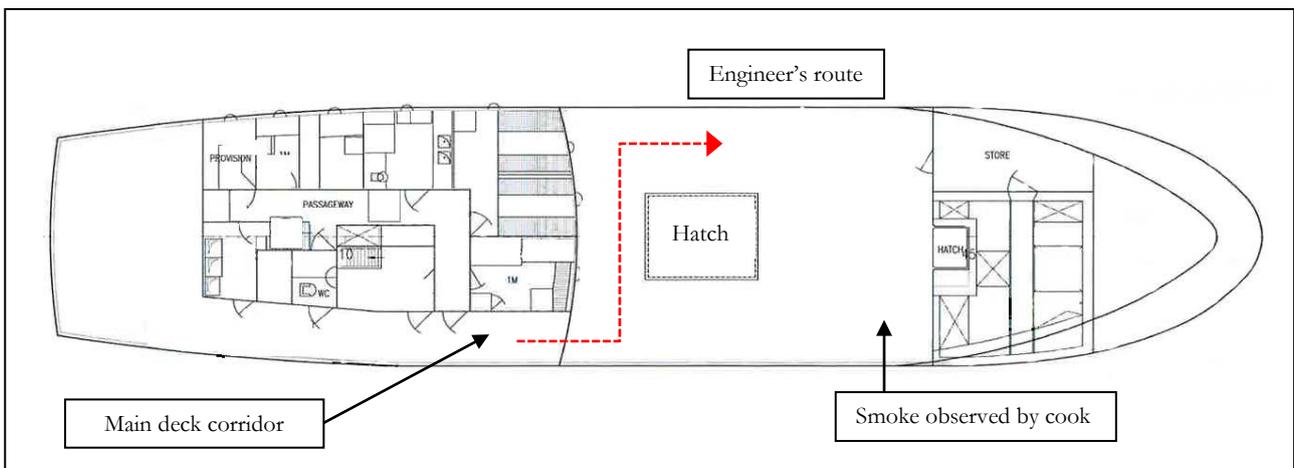
Figure 3: Layout of main deck on VESTURLAND  
Source: Thor P/F and DMAIB

The engineer went to the master's cabin and alerted him about the presence of smoke on deck. The master immediately went to the main deck corridor (figure 3) and met one of the mates and the engineer. He told them to don their breathing apparatuses and inspect the forward part of the vessel to determine where the smoke came from. The master then rushed to his cabin to get dressed. Meanwhile, the deckhands prepared two fire hoses and connected them to the fire hydrants located in the corridor on the starboard side of the main deck. Other crewmembers collected the fire extinguishers from the accommodation and engine room. As the smoke drifted aftwards, some crewmembers noticed the distinct smell of burning wood.

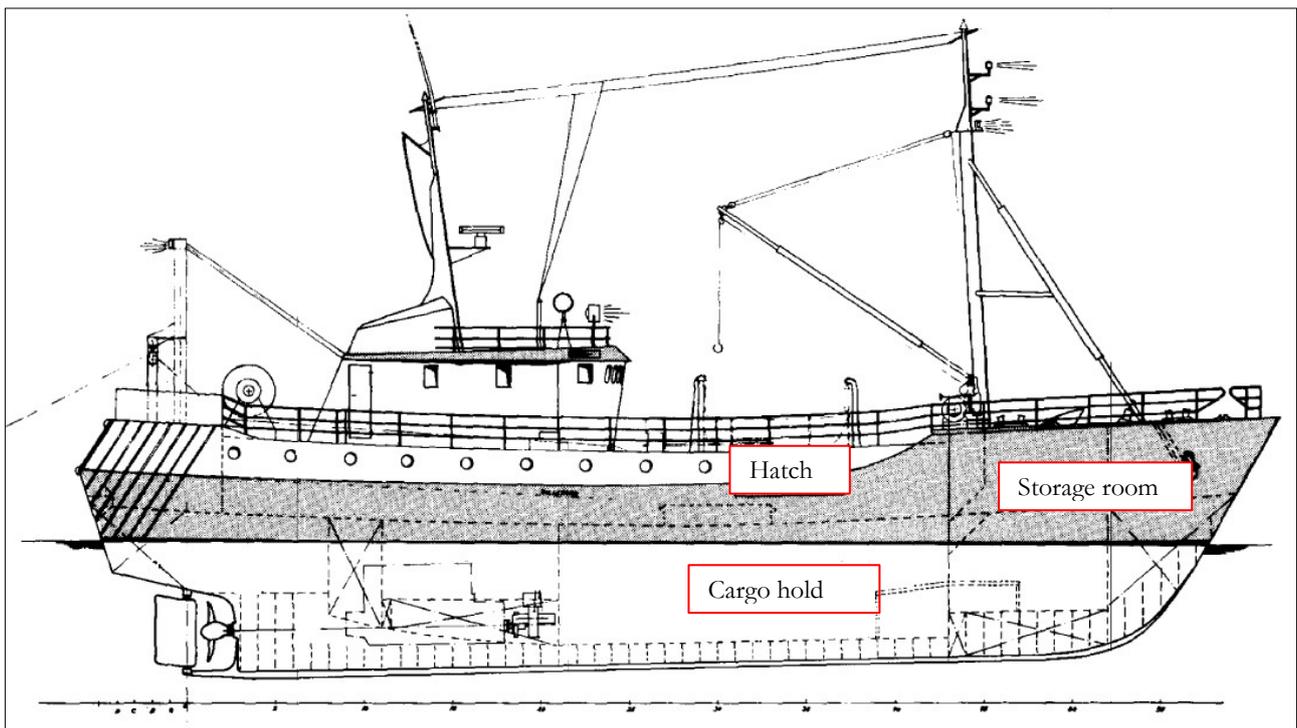
Figure 5: Extract from an original GA plan – VESTURLAND

The ship's forward and aft main deck was sheltered, enabling the crew to work without being exposed to the rain and sea. This also meant that the officer on watch did not have an overview of the deck area when the main hatch on the main deck was closed (figure 5). The roof was made partly of steel, partly of aluminium. The nets were brought on board via the hatches (figure 5) on port and starboard side forward. Once the nets were on the deck, the fish was sorted and gutted before it was stowed in fish boxes and iced in the freezing hold. There was a hydraulic motor driven by an electric pump mounted on the forward part of the main deck and a hydraulic oil tank was located behind the door to the forecastle storage rooms. The hydraulic system was used for the anchor winch and the net windlass.
