# RIGI

Marine accident report on foundering

23 APRIL 2018

**MARINE ACCIDENT REPORT ON THE FOUNDERING  
OF RIGI ON 23 APRIL 2018**

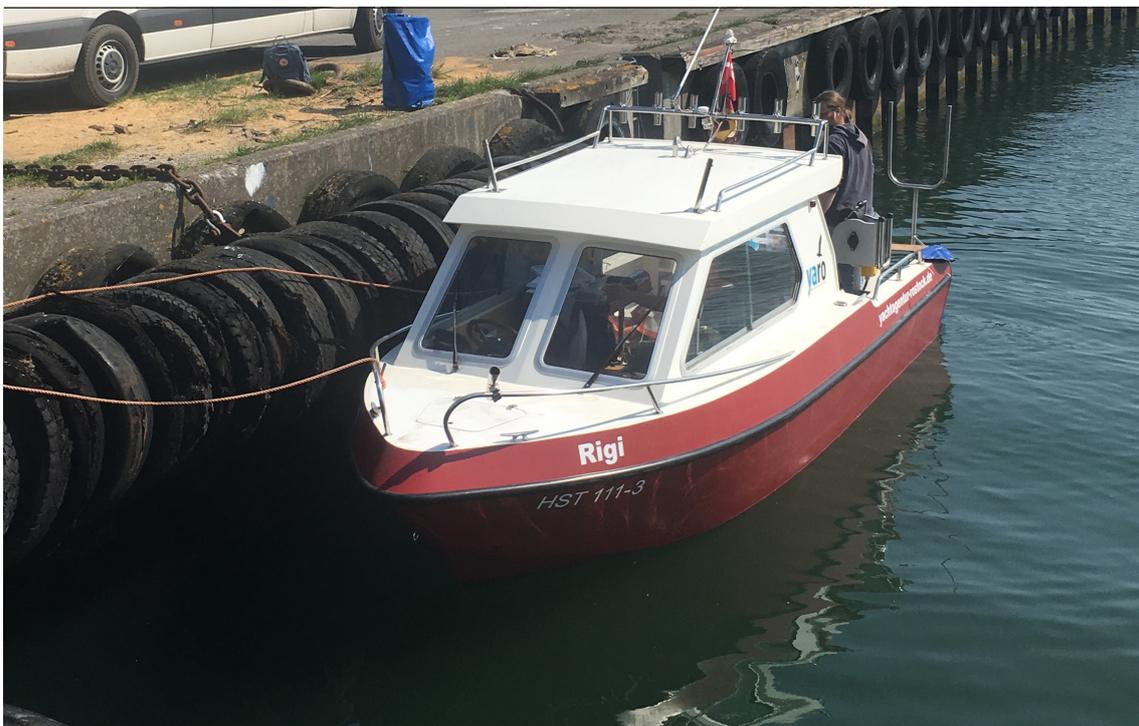
Figure 2: RIGI  
Source: Private photo

The motorboat RIGI (fig. 12) was of the type Loon Fishing 642, produced in 2011 by the Swiss company Loon-Yachts. It was built and certified as a recreational craft intended for angling and leisure trips. At the time of the accident, the boat was owned by Yachtagentur Rostock, a company that designed, built, traded and hired out boats. The boat was hired by the company IfAÖ and brought to Denmark for the Faxe Bay research project.

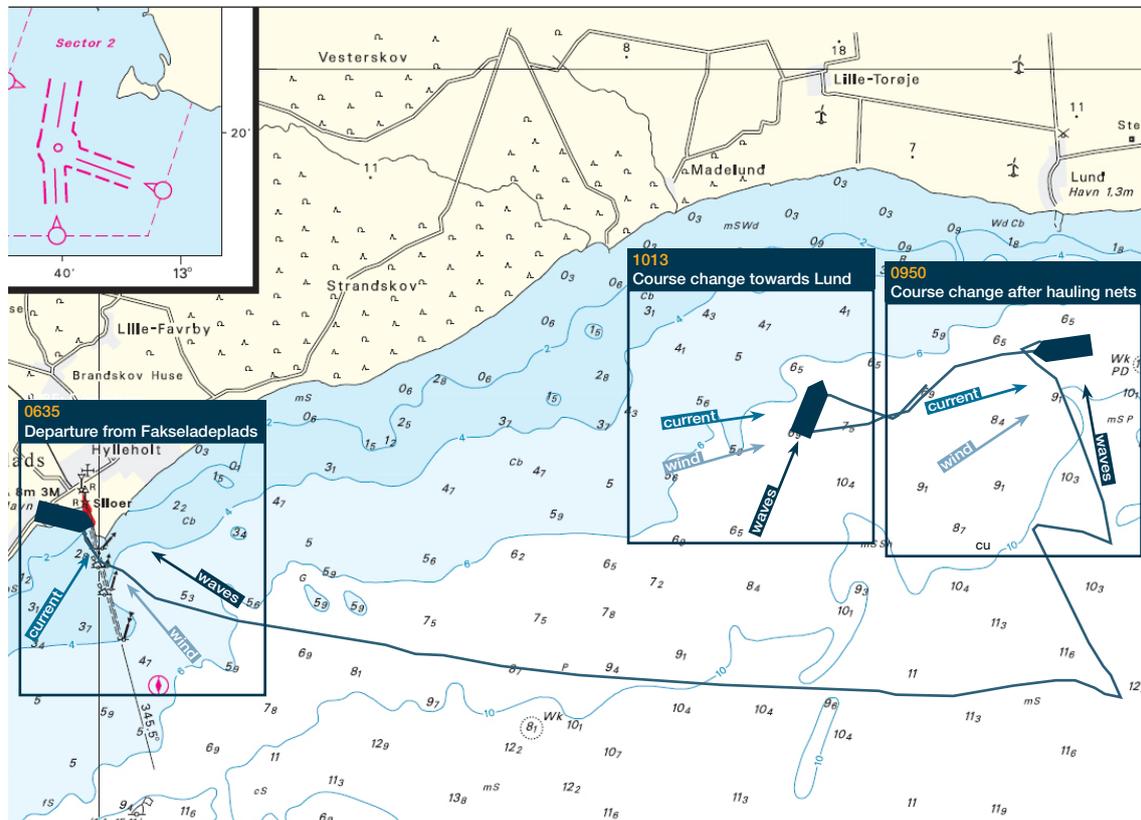
When a significant change in wind direction occurs, a period will follow where the direction of wind, waves, current and swell will interfere, resulting in choppy, irregular sea. Experienced from a small boat, close to the surface of the sea, such waves can appear quite forceful, and perhaps higher than they are. Figure 20 illustrates the approximate changes in the directions of wind, waves and current at the time of departure, after hauling the last nets, and around the course change towards Lund.

Figure 20: Weather and sea changes on the day of the accident  
Source: Danish Geodata Agency/DMAIB

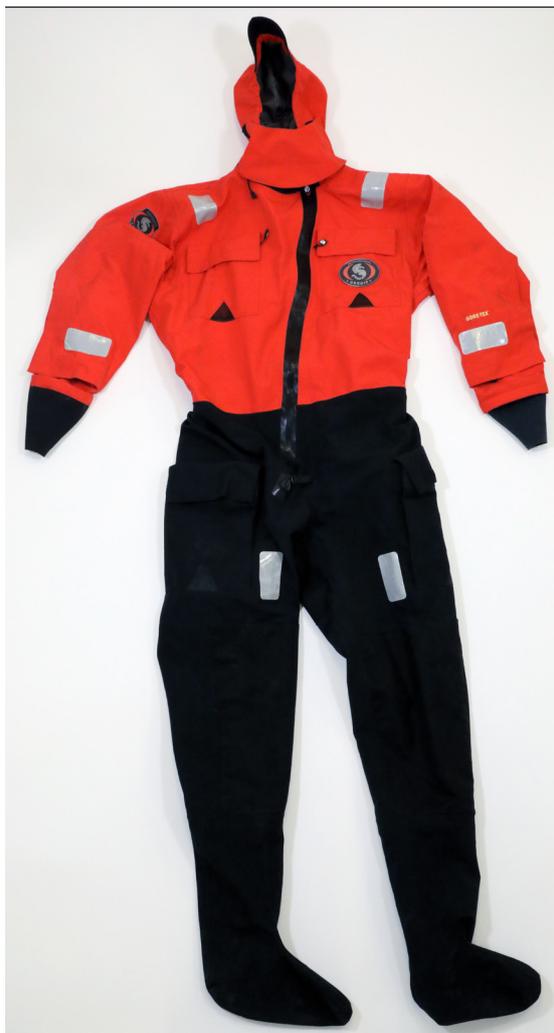
The immersion suits on RIGI were constant wear immersion suits designed for wind farm transit and were to be worn as a working suit (fig. 21).

Figure 21: Immersion suit from RIGI  
Source: DMAIB

In case of accidental immersion in water, this type of suit provides thermal protection with the purpose of reducing the risk of cold shock and delaying the onset of hypothermia. The suits' protection time for water temperatures between 5-10° C is estimated to be 2.5 hours. The suit is a watertight, non-insulated shell without integrated buoyancy.

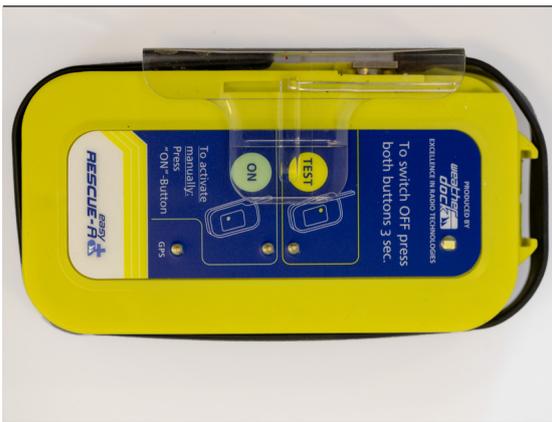
Figure 25: AIS-SART attached to Secumar lifejacket  
Source: DMAIB

DMAIB has concluded that the AIS-SART was in working order, however it was not activated until the boat was towed during salvage.

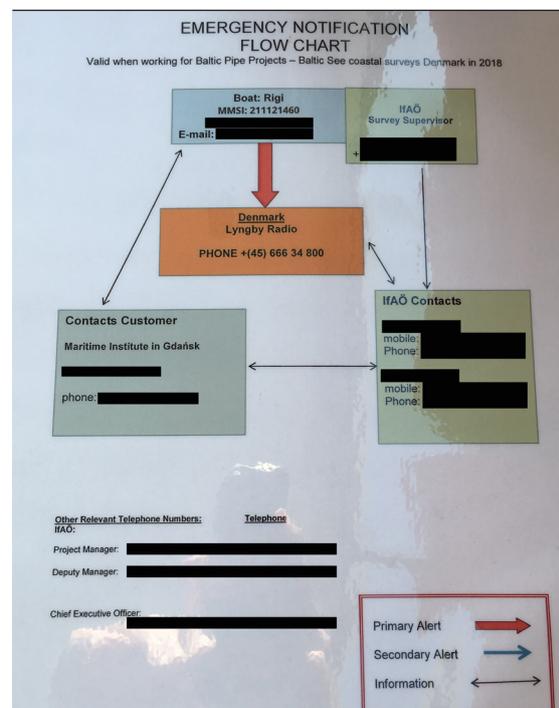
The scientists and the observer carried their personal mobile phones on board. One of the phones was stored in a watertight box which was stowed in a locker bench in the cabin. If an emergency situation occurred, the persons on RIGI were to call for help by means of a mobile phone. A laminated flowchart (fig. 26) showing who to contact in a prioritised sequence was situated next to the wheel. As the mobile phones were not waterproof, the emergency communication by phone was only possible in dry conditions on board the boat.

Figure 26: Instruction for emergency notification on RIGI. The flowchart has been anonymised by DMAIB.  
Source: Private photo

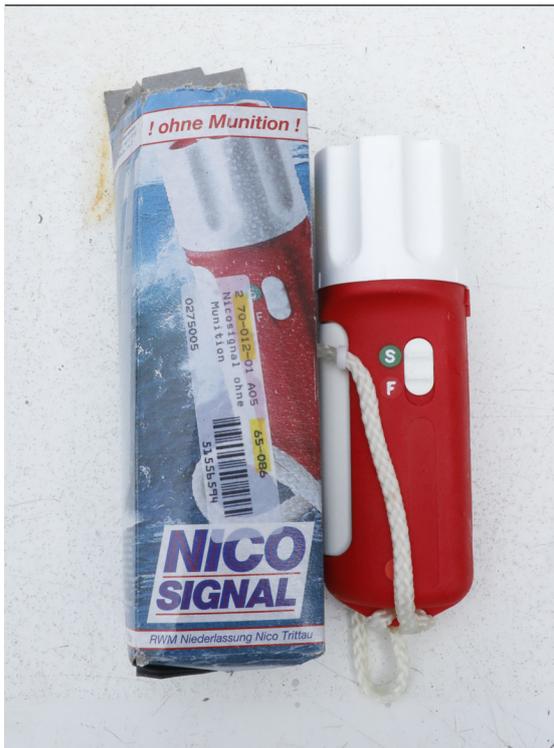
A distress signal flare was stowed in the locker benches in RIGI's cabin. In case of emergency, the flares could be launched from the boat or by a person in the water to signal the need for help. The distress flare was kept in its package and was of the type NICO Signal (fig. 27, next page). The flare has a shot height of 80 m, a burning time of 6 seconds, and has the capacity for six shots.

Figure 27: Distress flare  
Source: DMAIB

Because the scientists were unable to call the rescue services by phone, the scientists were dependent on the AIS-SART to send a distress message to AIS receivers nearby. Because the scientists lacked distress flares they could not signal for help. Therefore, their only option was to swim to shore in order to alarm persons. Due to their trust in the AIS-SART and the subsequent wait at the boat, followed by the time it took to swim for help, the rescue services were not notified of the emergency until 3½-4½ hours after the foundering.

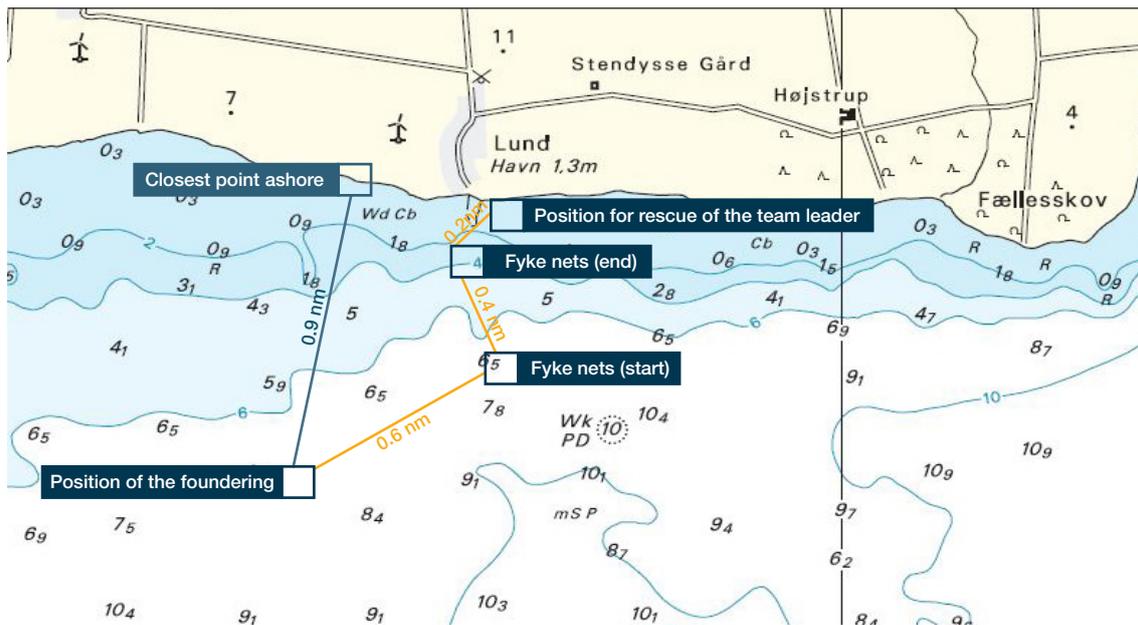
The forward movements of their swimming were obstructed considerably by the waves, and the current made them drift east of the closest point to the shore, the pier at Lund Harbour, which made the distance longer. It took approx. 3 hours for the team leader to swim the distance of approx. 1.1 nm to shore where he received help from passing persons, who contacted the emergency services (fig. 28, next page).

Figure 28: Distances for swimming for help. Team leader's route marked in yellow.  
Source: Danish Geodata Agency/DMAIB

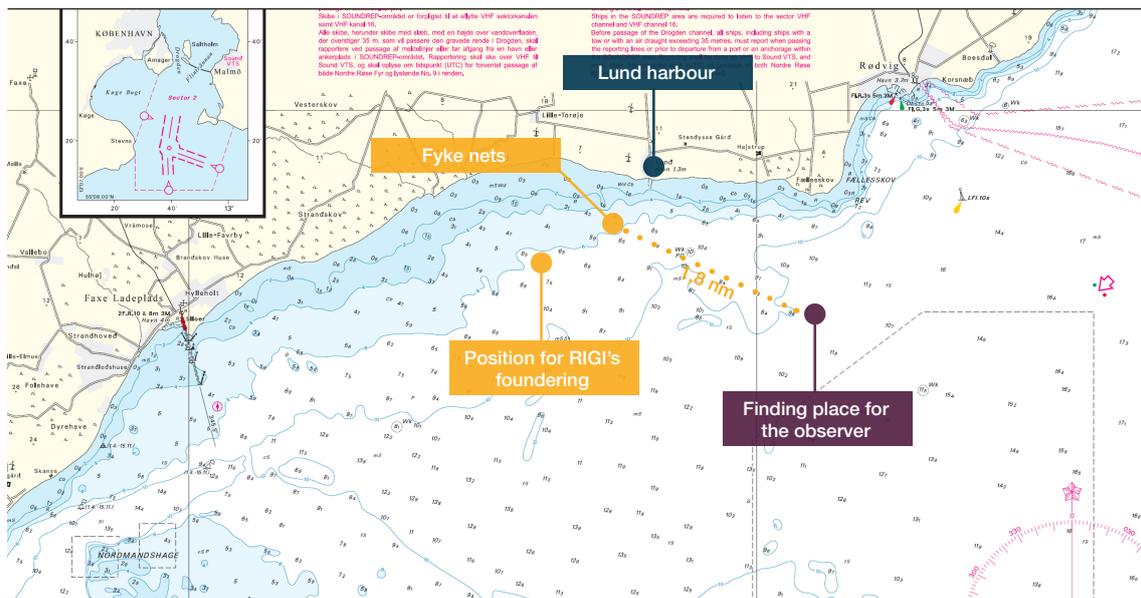
What happened while the observer stayed at the nets, and the team leader continued towards shore, is unknown. The observer was located by the rescue helicopter crew approx. 1 hour and 20 minutes later, after the team leader had reached the shore and made contact with the assisting persons. They in turn had initiated the search and rescue operation by alerting the emergency services. The observer was found lifeless, approx. 1.8 nm east-southeast of the fyke nets, upright in the water with her face near the surface (fig. 29).

Figure 29: Finding place for the observer during the SAR operation  
Source: Danish Geodata Agency/DMAIB
