Danish Maritime Accident
Investigation Board

MARINE ACCIDENT REPORT

DIVER MASTER
Foundering on 4 August 2014

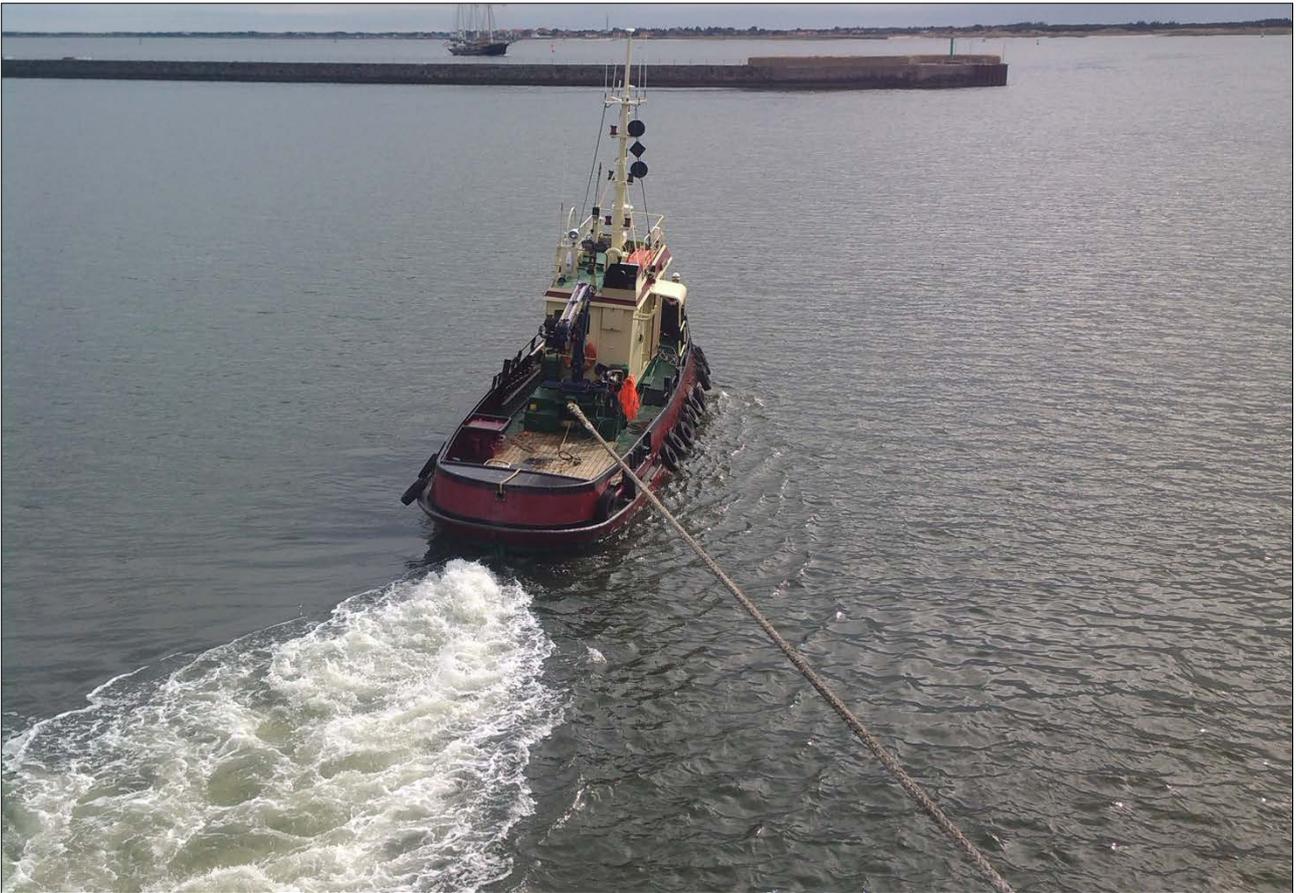
Initially, the master of DIVER MASTER was under the impression that he was only to assist in pulling KRUZENSHTERN off the berth, and he assumed that his involvement in the operation would be over before exiting through the breakwaters of the port entrance. When this assumption proved to be wrong, he continued as he did not find that there was any other appropriate or possible option at that stage.

Figure 6: DIVER MASTER pulling KRUZENSHTERN at full power towards the port entrance
 Source: Private photo from KRUZENSHTERN

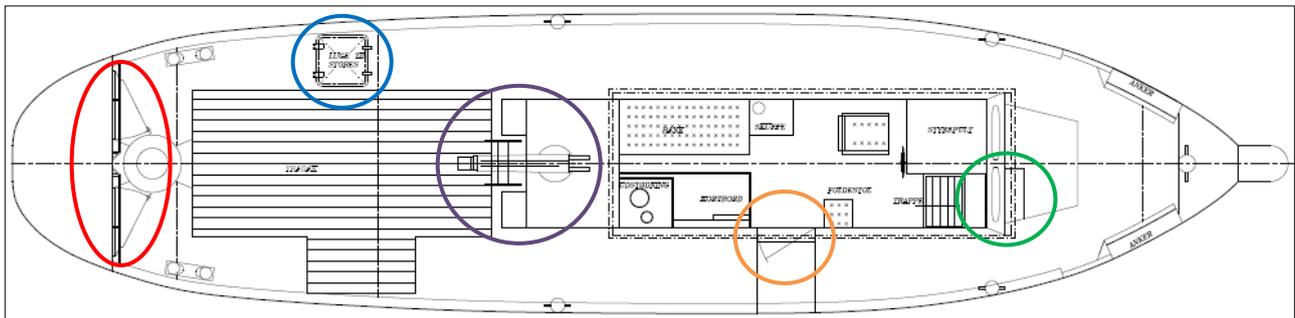
Figure 14: DIVER MASTER main deck. Stores hatch encircled in blue, steering gear room hatches encircled in red, entrance to wheelhouse encircled in orange, emergency exit from accommodation encircled in green, towing hook & gog rope winch encircled in purple
 Source: BB Towing & Diving

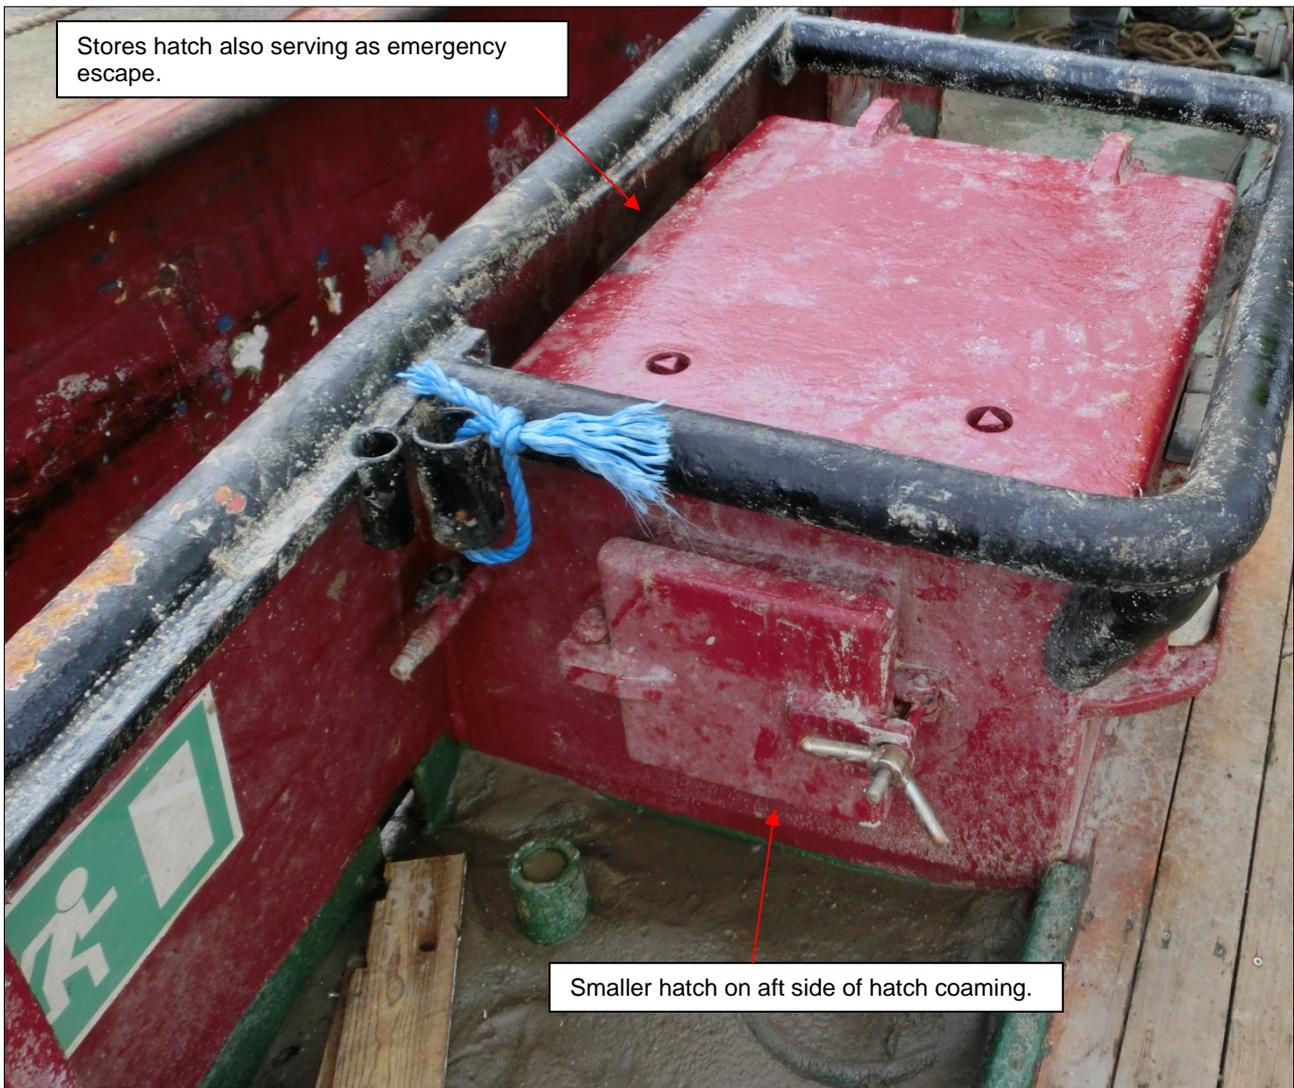
DIVER MASTER had the wheelhouse placed forward of the working deck, where the towing equipment was situated. Entrance to the wheelhouse was via a door on the starboard side of the main deck. There was no door on the port side. In the forward end of the wheelhouse, there was a stairway down to the lower deck where the accommodation and engine room were located. This stairway had an emergency exit leading to the forecastle. A watertight door connected the accommodation in the forward end with the engine room. Aft of the engine room there was a stores room likewise connected to the engine room with a watertight door. From the stores room there was a hatch for stores, also serving as an emergency exit, leading to the port side of the aft main deck. On the main deck level, the hatch coaming had a smaller hatch incorporated on the aft side (figure 16). The smaller hatch was open during the accident as seen in figure 17.

Figure 16: Stores hatch on the aft deck of DIVER MASTER
Source: DMAIB

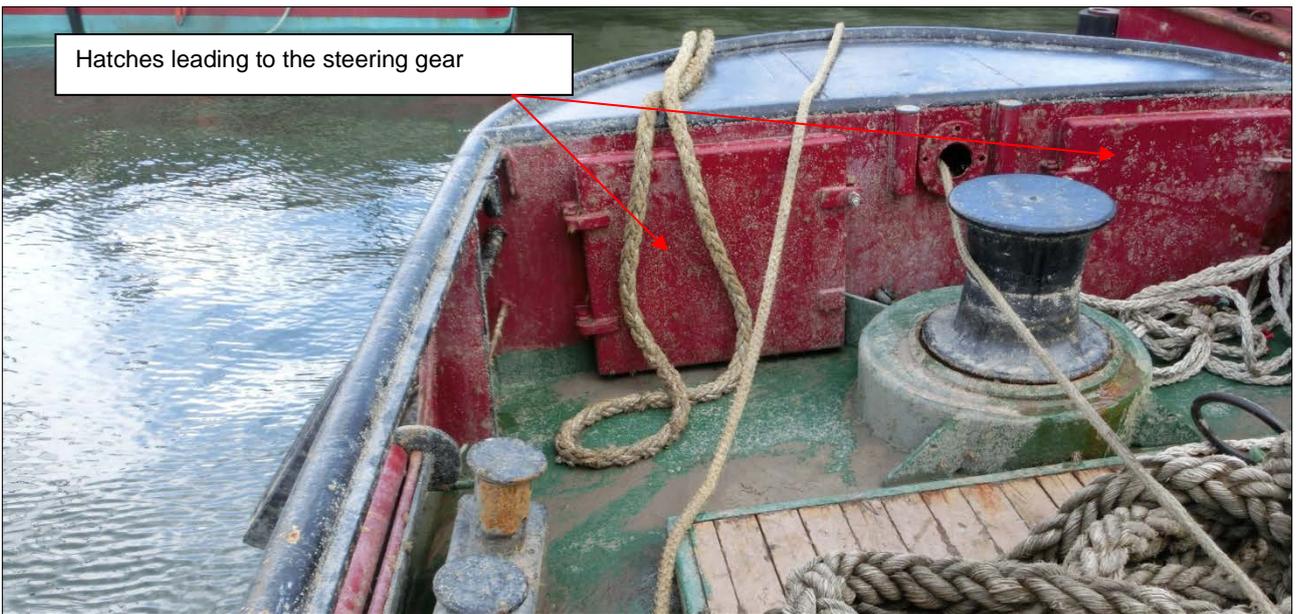
The steering gear was located aft. Two hatches on the aft part of the ship led from the main deck to the steering gear room (figure 18).

Figure 18: DIVER MASTER aft deck hatches to steering gear
Source: DMAIB

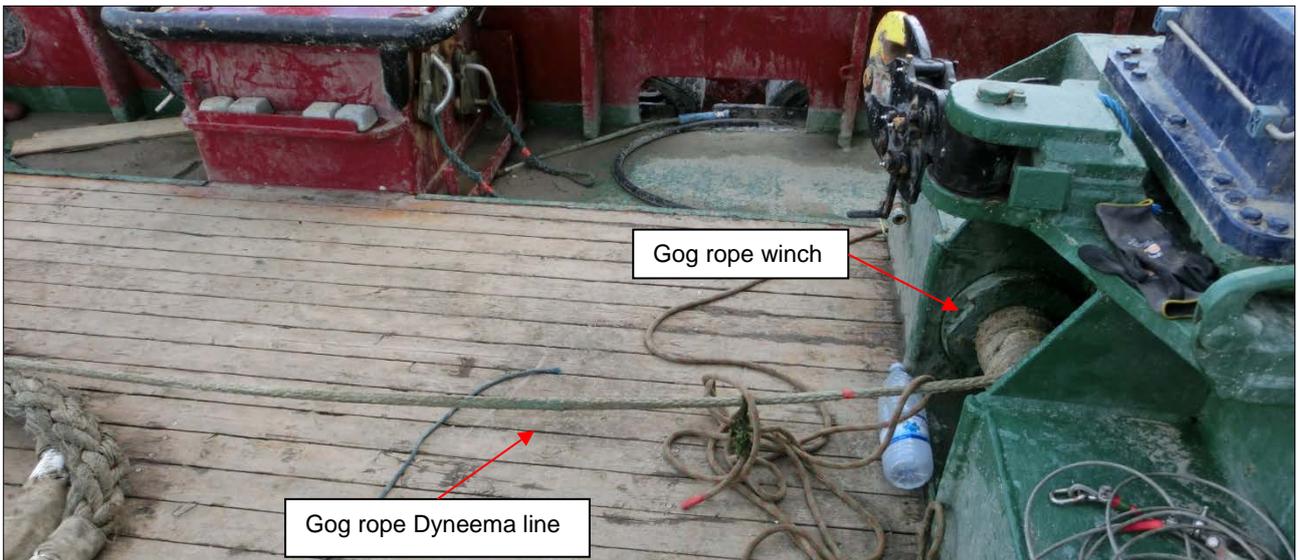
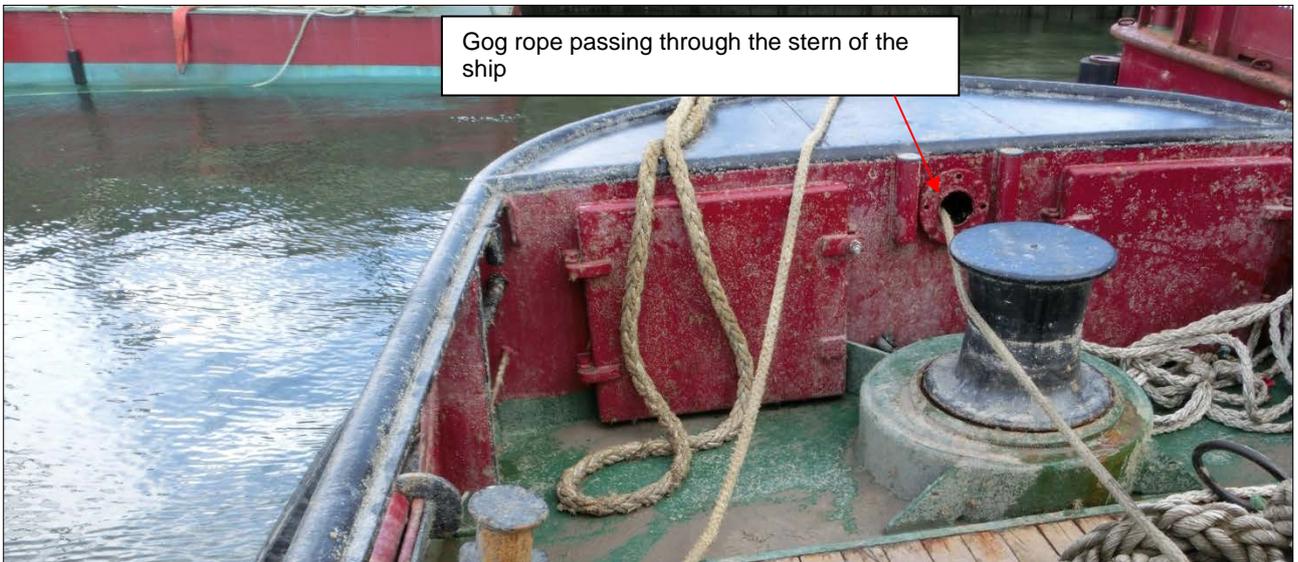
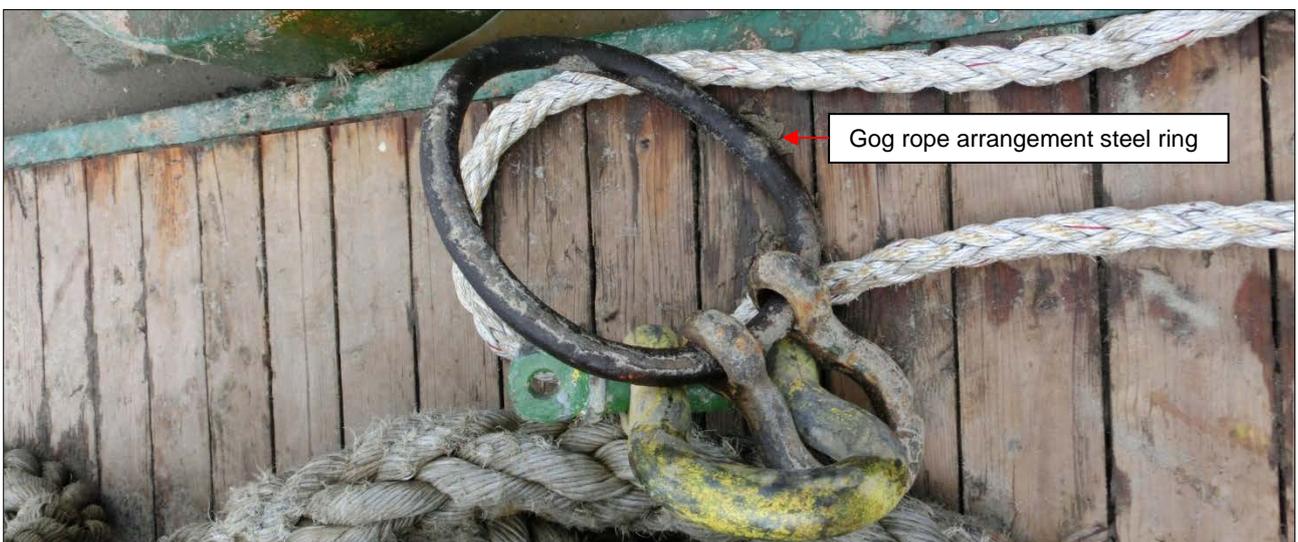
The gog rope arrangement on board DIVER MASTER consisted of a small winch, situated amidships below the towing hook with a connected Dyneema⁵ line, which was led over the deck area through the after side of the ship, and back on board where it was connected to two shackles and a steel ring. The towline would then be led through the steel ring and, when the winch was tensioned, the towline would be held down by the arrangement (figures 24, 25 & 26).

The gog rope arrangement would need to be mounted on the towline prior to towing operations as it would be dangerous, or in the case of DIVER MASTER impossible, to do so when the towline had been made fast on the hook, and under tension.

When in use, the gog rope arrangement would minimize the heeling moment induced on the ship, by transverse tension from the towline, and thus help prevent girting. However, a side effect would be an increase of a turning moment induced on the ship by the tensioned towline causing the hull to rotate around its pivot point by the hook, which would inhibit the tug's ability to manoeuvre easily as illustrated in below figures 27 & 28. This is in particular distinctive on tugs with conventional propeller and rudder located aft as opposed to e.g. azimuth systems.

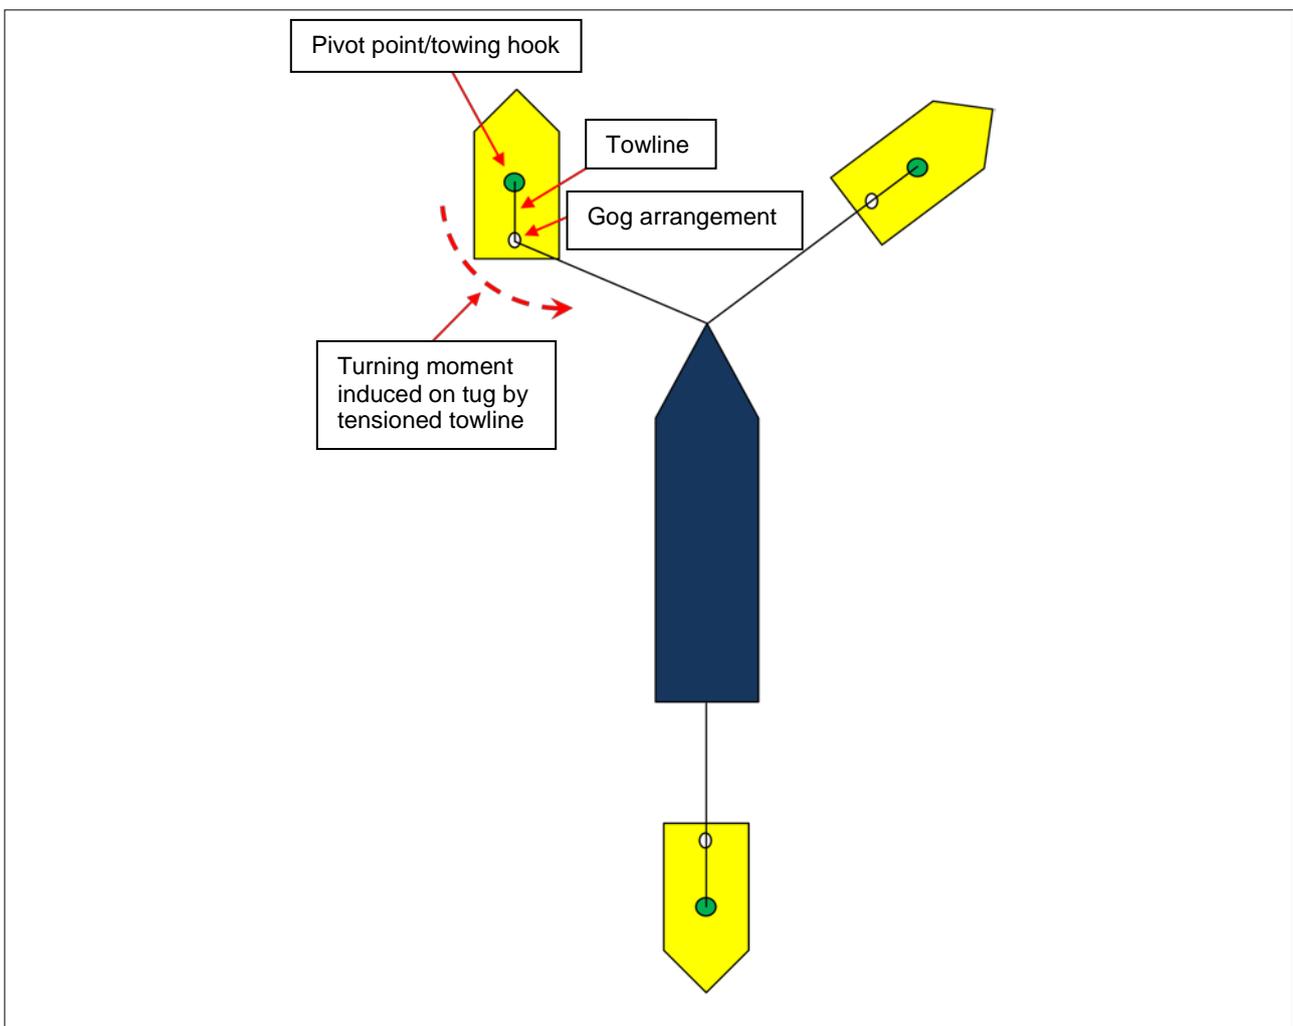
Figure 27: Various situations with a tug boat using gog rope arrangement
Source: DMAIB

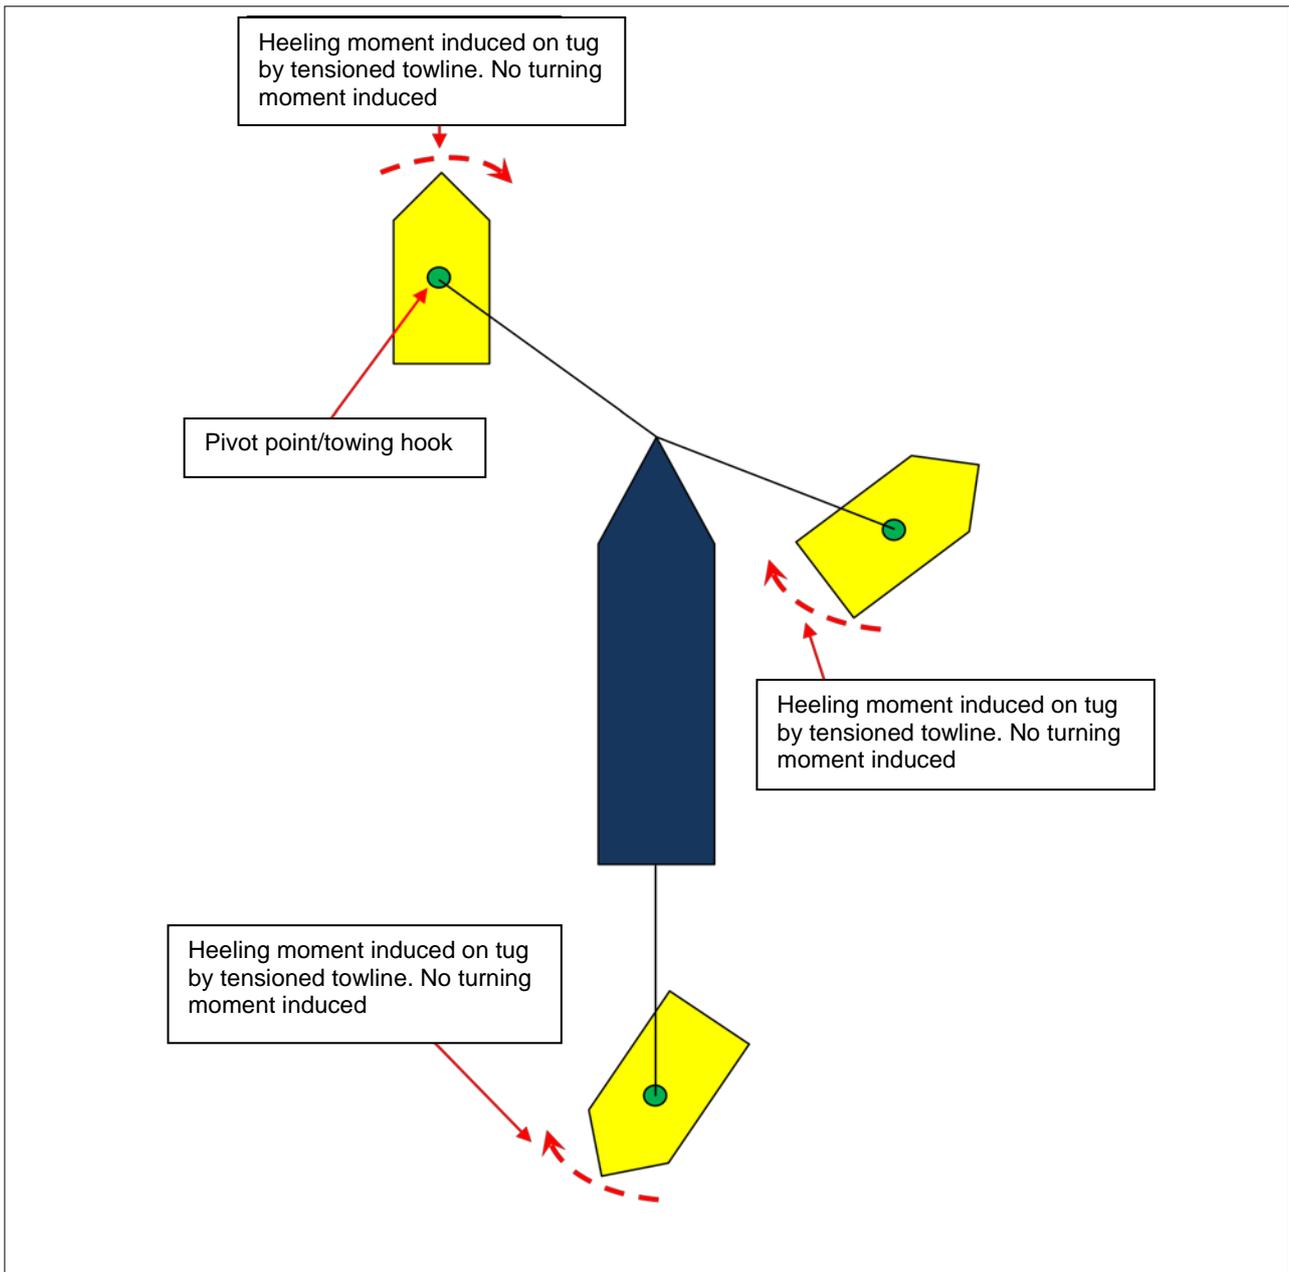
During the towing of KRUZENSHTERN, the gog rope arrangement was not in use on board DIVER MASTER (figure 29). The DMAIB has been informed that it could be considered as normal practice not to use the gog rope arrangement during this kind of towing operation, when acting as a forward tug without the need to move astern.

Figure 28: Various situations with a tug boat not using gog rope arrangement
 Source: DMAIB

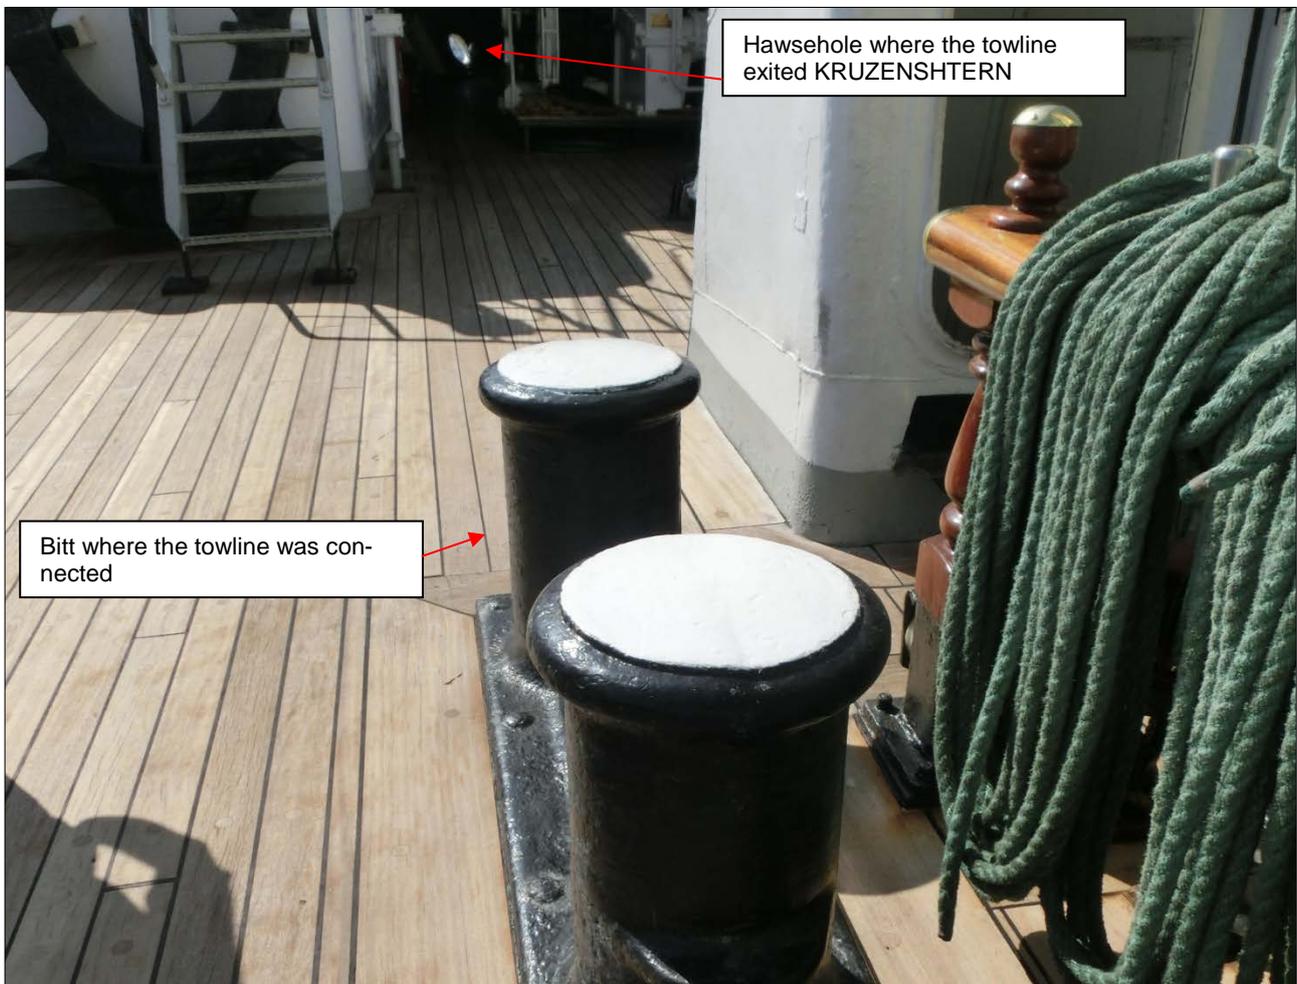
During port operations, it was the general rule on KRUZENSHTERN to make use of tug boats. On the day of the accident, the towline connected to DIVER MASTER was put around a bitt in the forward end of the main deck, from where it was led to a hawsehole and exited the ship on the starboard bow approx. 10 metres further ahead (figure 30).

Figure 30: KRUZENSHTERN. Forward part of the main deck
Source: DMAIB

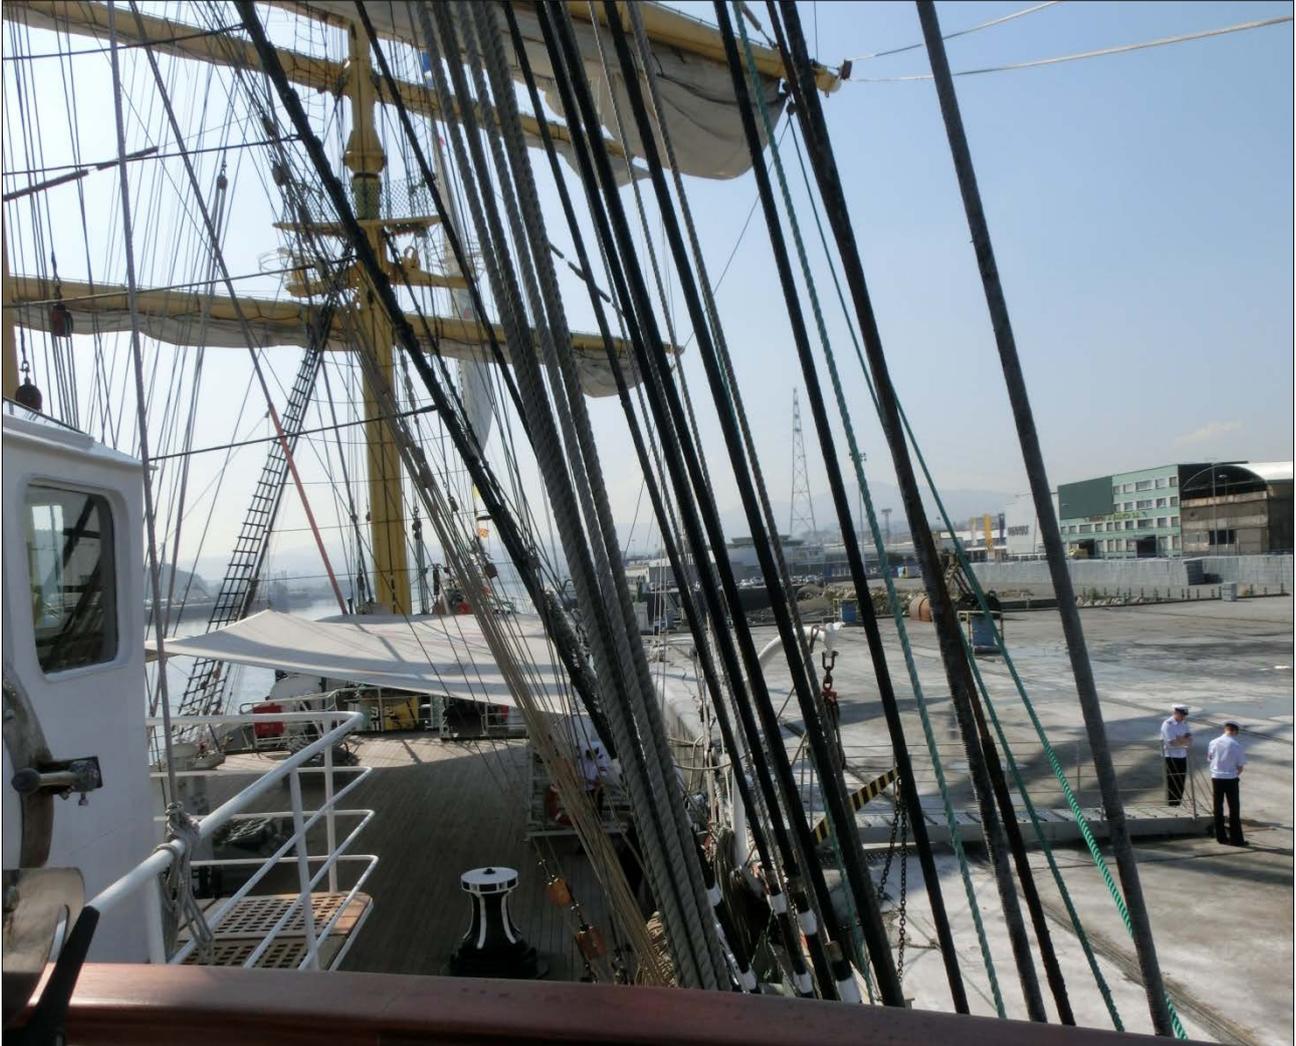
The master and the pilot on board KRUZENSHTERN were standing on the open bridge wing on the ship's starboard side when DIVER MASTER lost its manoeuvrability. The view from their position (figure 31) was obstructed by the rigging and it was difficult to get a clear view of the situation on board DIVER MASTER.

Figure 31: KRUZENSHTERN. View from manoeuvring stand on starboard bridge wing
Source: DMAIB
