# MARINE ACCIDENT REPORT

**SCORPIUS**  
Occupational accident on 8 May 2014

**This marine accident report is issued on 10 December 2014**

**Case number: 2014011309**

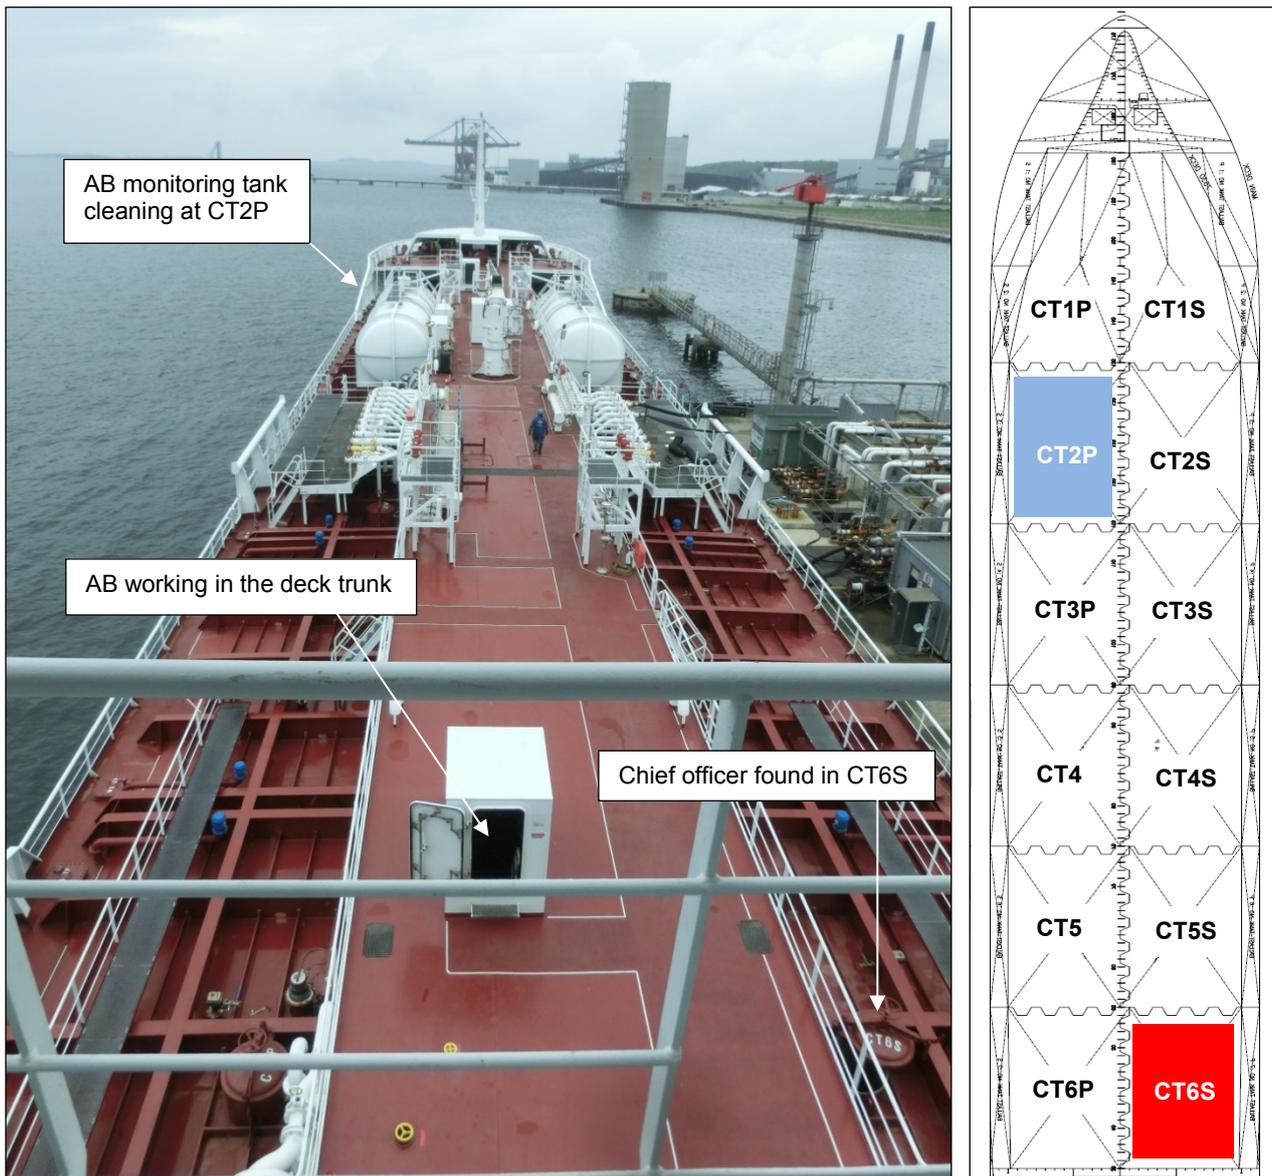
Figures 3 and 4: Overview of the tank deck  
Source: DMAIB

At 1802, the chief officer gave orders over the radio to start the cleaning of the penultimate cargo tank, no. 2 portside (CT2P) (figures 3 and 4). The AB on deck opened the water supply to the tank washing machines at CT2P. While he was monitoring the washing of the cargo tank, the AB saw the chief officer visually checking the port side cargo tanks and noticed him proceeding to the starboard side. The AB lost visual contact but reckoned that the chief officer was about to check the starboard side cargo tanks as well. As the ABs and the 2<sup>nd</sup> officer were busy carrying out their own tasks, none of them noticed whether or not the chief officer measured the levels of oxygen and toxic gasses in the tank atmosphere before he went on visually checking them.
