Danish Maritime Accident  
Investigation Board

# MARINE ACCIDENT REPORT

**BRITANNIA SEAWAYS**  
**Fire on 16 November 2013**

**Case number: 2013024446**

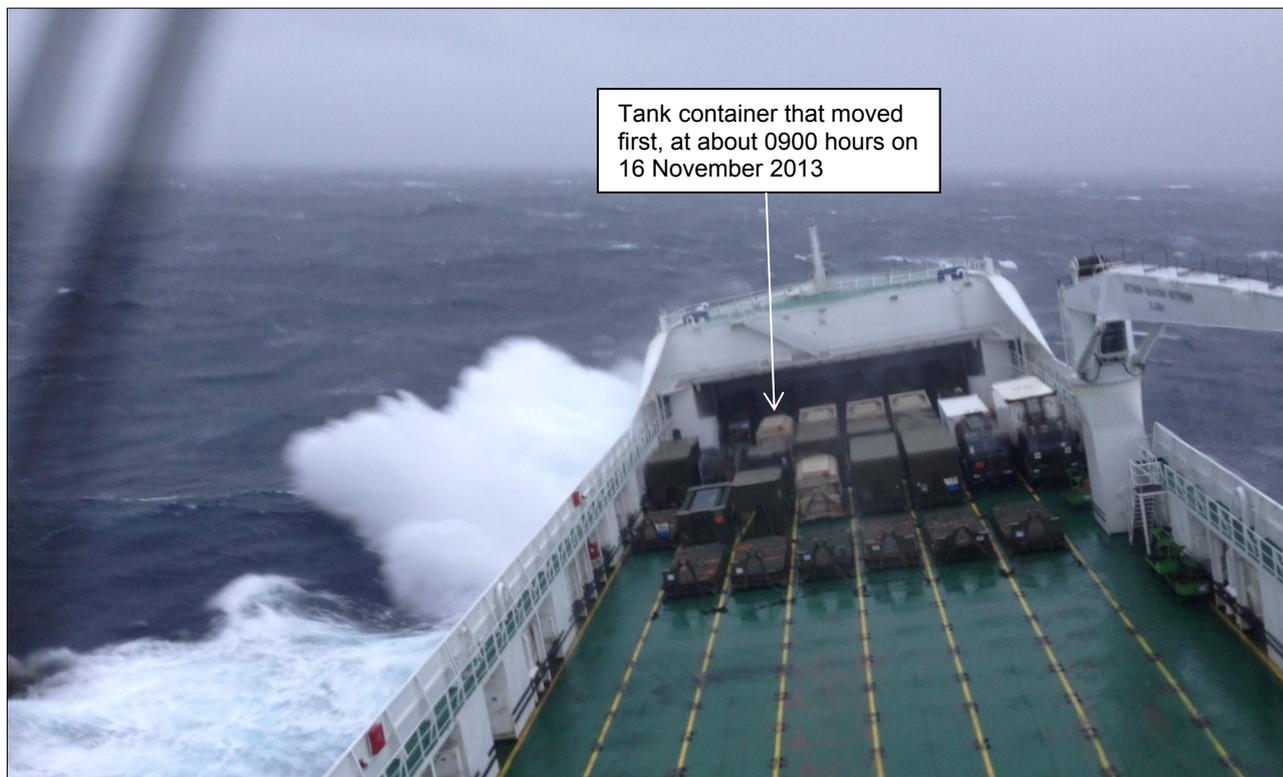
Figure 3: BRITANNIA SEAWAYS in rough weather, 1309 hours on 15 November 2013  
Source: DFDS

At about 1000 hours on 15 November 2013, the weather conditions deteriorated. The sea was getting rough and the ship began rolling and pitching in the seas (figure 3). The master forbade all access to the weather deck to avoid personal injury. The ship's speed was reduced to about 10 knots and later on to about 6 knots. In late afternoon, weather conditions improved and the ship's speed was increased to 12-14 knots. The ship proceeded towards the traffic separation scheme (TSS) Off Runde and the master was confident about his revised voyage plan.

On 16 November 2013 at about 0900 hours, whilst the ship was heading 220° towards the TSS Off Runde and the wind had increased, it was observed from the bridge that one tank container adjacent to a flatrack with jerrycans in the forward row on the weather deck had shifted slightly, about one foot (figure 3). This indicated that the lashings on that tank container had slackened. During the day, it could be observed that the aft part of the tank container moved a little from side to side. The master deemed it unsafe for the crew to enter the weather deck to add lashings and secure the cargo.

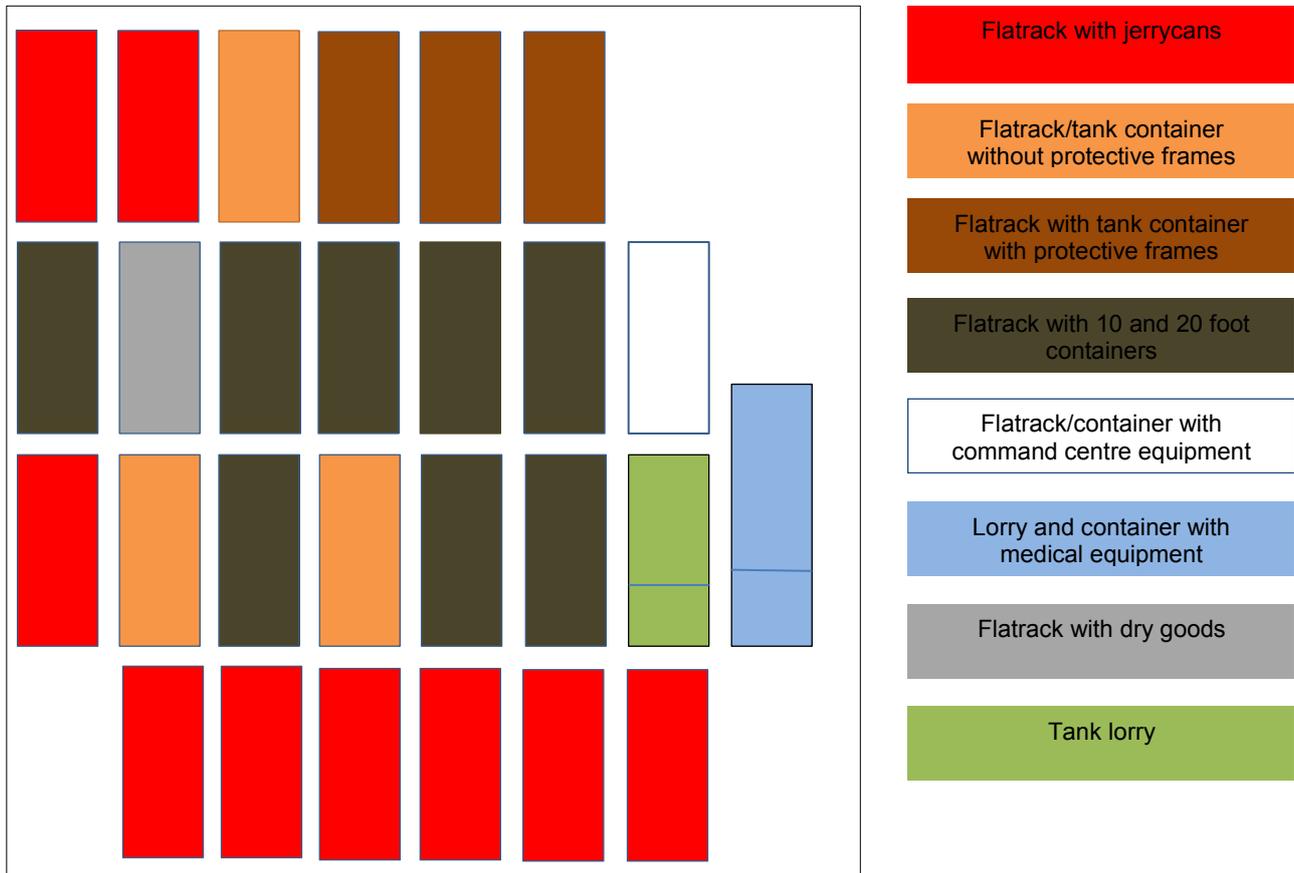
Figure 8: Arrangement of cargo on the open part of the weather deck  
Source: Norwegian Military Police

The cargo on the weather deck consisted of military vehicles, tank containers, flatracks with containers and dry goods and a large number of 20-litre jerrycans on flatracks (figures 8 and 9).
