Danish Maritime Accident
Investigation Board

MARINE ACCIDENT REPORT

ATAIR J
Mooring accident on 3 October 2013

This marine accident report is issued on 3 July 2014.

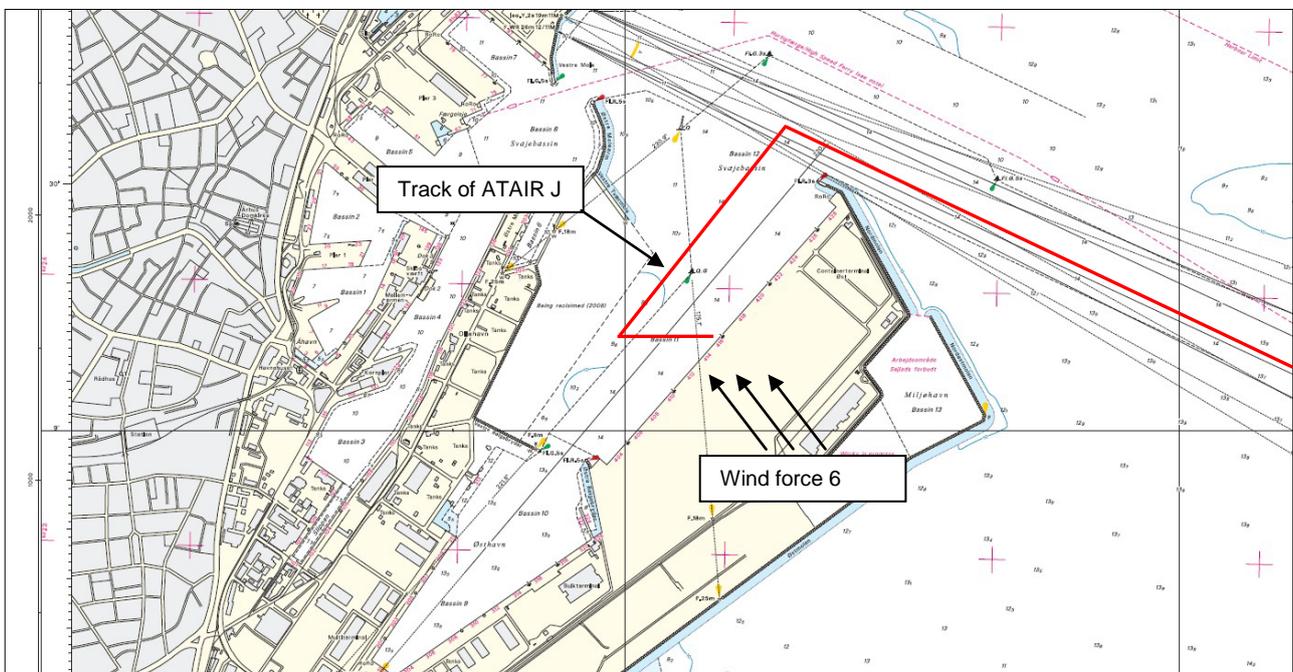
Figure 3: ATAIR J approaching the Port of Aarhus
Source: Danish Geodata Agency

The master and the chief officer had a conversation about how to go about getting the ship alongside the berth. There was a strong south-easterly force 6 breeze that would make it difficult to berth the ship. The chief officer and master believed that the forward thruster did not have sufficient power to move the ship sideways under the given wind conditions. It was, therefore, decided to manoeuvre the ship alongside by steering the bow upwind, thereby enabling them to use the main engine, rudder and forward spring line to get the ship aligned with the berth (figures 3 and 4). The officers on the bridge had used this method before to approach the berth.

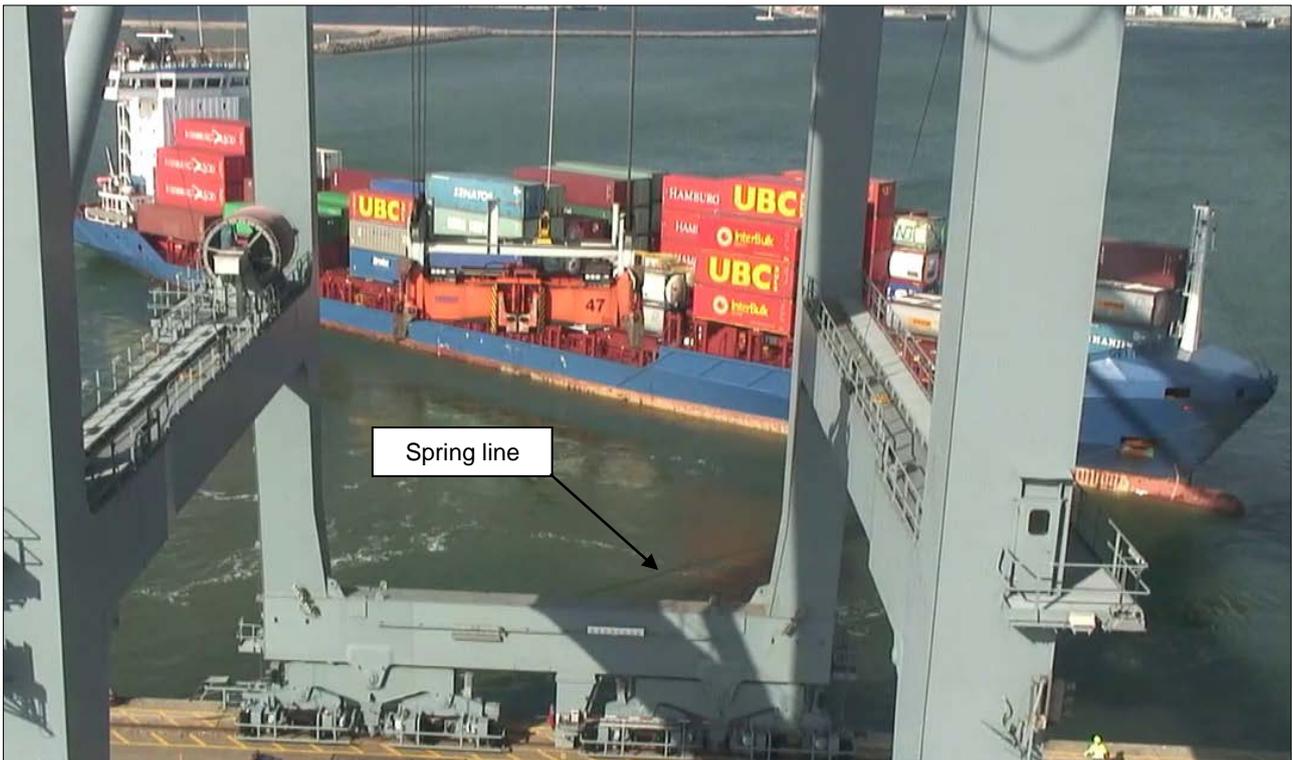
Figure 4: ATAIR J approaching the berth – a few minutes after the accident
Source: Port of Aarhus

Once the ship was in the harbour basin, it was turned to port so that the bow was at a 45° angle to the berth, at a distance of approximately 10 metres, enabling the crew on the forward mooring station to throw the heaving line ashore (figure 4). The master was satisfied with the approach, and everything went according to his plan. As per the usual procedure, the officers on the bridge wanted a relatively long spring line as a first line. The master and chief officer usually ordered a long spring line fastened because they were of the opinion that it would be able to withstand more tension than a short line. They were of the opinion that having a long spring line would enable the rope to stretch more than a short spring line – allowing for the rope to be more flexible and thus avoid excessive tension.

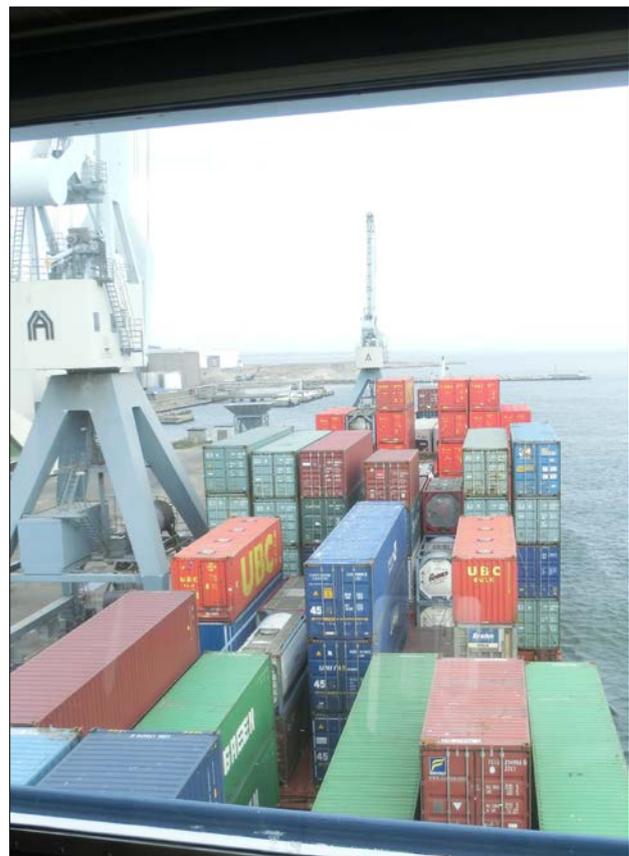
Figure 9: Approximate view from conning station
Source: DMAIB

The distance from the bridge to the forecastle was 120.5 metres. With cargo on deck, the master had little view of the mooring situation forward (figure 8). Therefore, the master relied on the effectiveness of the communication between the crewmembers on deck and the chief officer who relayed the information to the master. During manoeuvring, the chief officer was usually stationed by the conning station (figure 9), and he was the only one on the bridge in direct communication with the crewmembers on deck.
